Significant Incident Report No. 279

Subject: Paste wall failure

Date: 20 March 2020

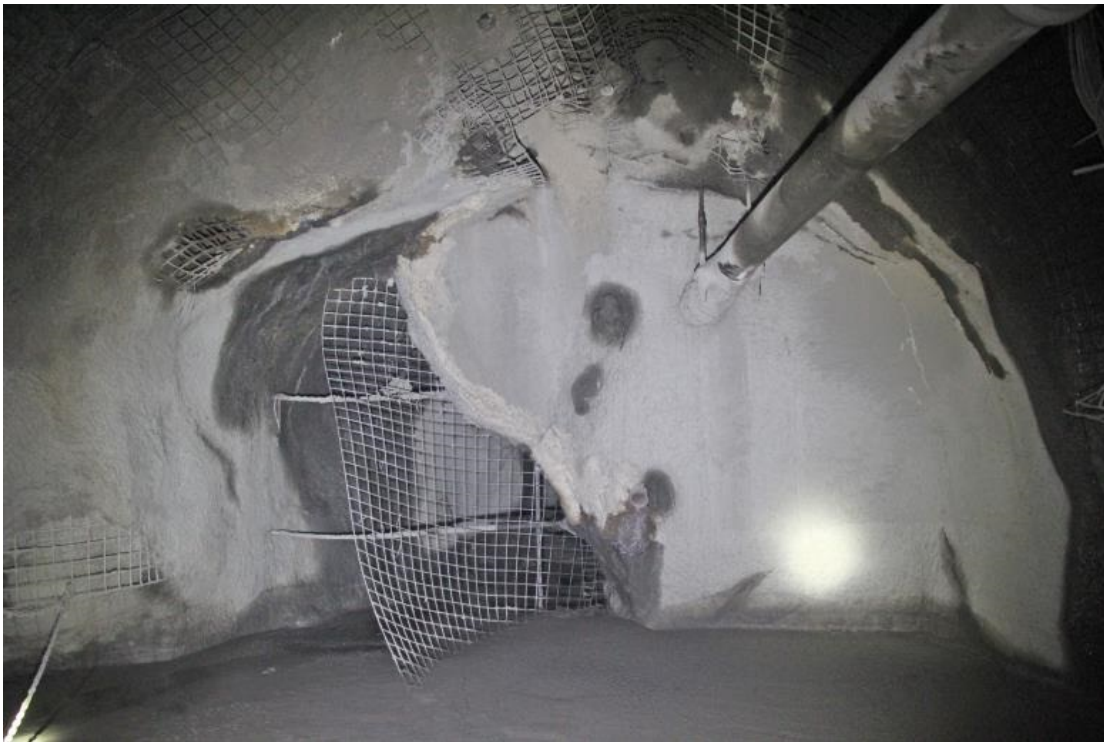
Drive side of failed paste wall with fill pipe through wall

The wall failed due to excessive hydraulic pressure being exerted from the paste fill.

- A paste wall was constructed in a drive at the top of the stope with the paste fill pipe through the wall. This fill method was used, as there was a blind portion of the stope above the drive and a continuation of the stope underneath the drive to the level below.
- The stope was blocked with substantial rock falls from the backs and walls, which prevented a cavity monitoring survey being carried out.
- The rock falls prevented the paste from percolating into the stope and this led to a build-up of hydraulic pressure behind the paste wall.
- No pressure monitoring devices or cameras were in place to assess the fill conditions from a remote location.

- Conduct a detailed engineering and risk assessment for individual stopes when paste fill is used. This is especially important when there are variations to standard layouts and processes.
- Use remote monitoring devices such as cameras and pressure sensors to keep workers out of potential danger zones and away from paste walls in particular.
- Establish and enforce exclusion zones to keep workers away from paste walls during the stope filling process.
- Train workers in all operating aspects of the paste fill process, including hazard exposures resulting from the release of paste fill under pressure.
