NZ Safety Alert

19 May 2023

ADT tips onto side

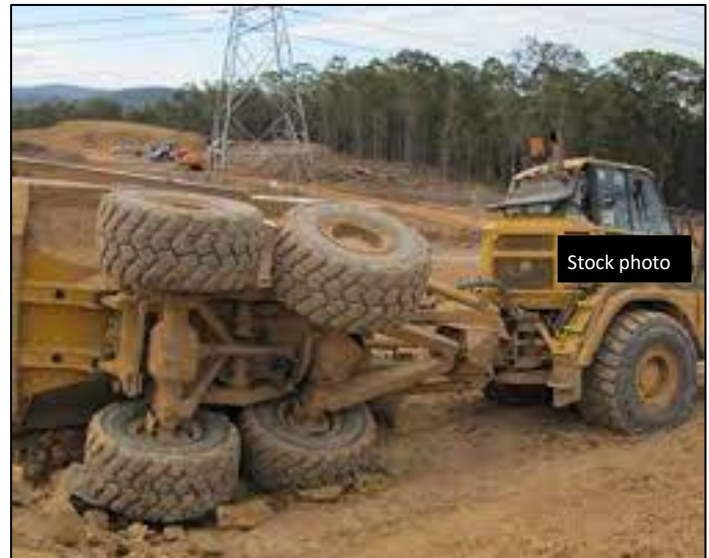
The tray of an ADT rolled onto its side while the loaded truck was travelling on a haul road. The operator and a witness heard a loud clanging, then simultaneously as the truck commenced turning left, the tray lifted and tipped to the right.

The front left suspension block was found broken in half. The front right suspension block had a snapped rod which was believed to have happened during the incident.

This particular ADT was different to others in the fleet as it had hungry boards attached to the tray.

1. Operators of mobile plant are trained and assessed as competent to operate mobile equipment. This needs to include specific model/equipment training and assessment.
2. Mobile plant is regularly maintained in accordance with Original Equipment Manufacturers requirements.
3. Regular workplace inspections are conducted to identify unsafe behaviour and other activities that could put workers at risk of harm.
