NZ Safety Alert

27 January 2023

Another breach of procedure

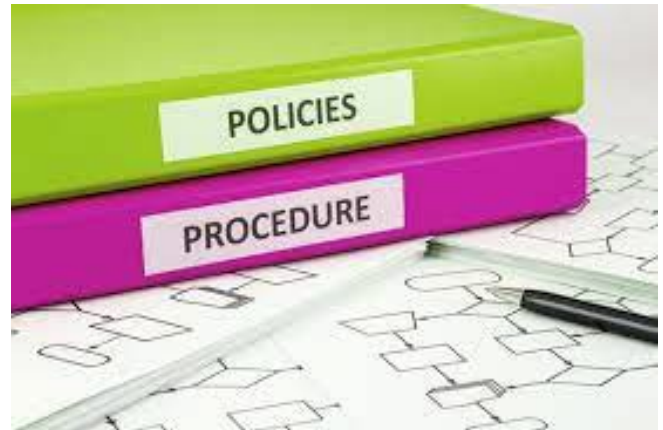
An articulated dump truck passed through a loader exclusion zone while a loader was loading a truck.

The exclusion zone was not well defined, and the ADT operator failed to communicate with the loader operator per documented procedures.

Though no one was injured, the potential for a serious incident was high.

1. That safe work procedures (SWPs) are based on risk assessment and developed by the workers who use them, reflecting how work is done.
2. All workers are trained and assessed as competent in SWPs that they are expected to follow.
3. SWPs are kept up-to-date and are always readily available to workers.
4. SWPs are written in such a way that they are easily understood by all workers.
