Safety Alert

Vehicle Struck by Temporary Traffic Management Barrier

17 March 2022

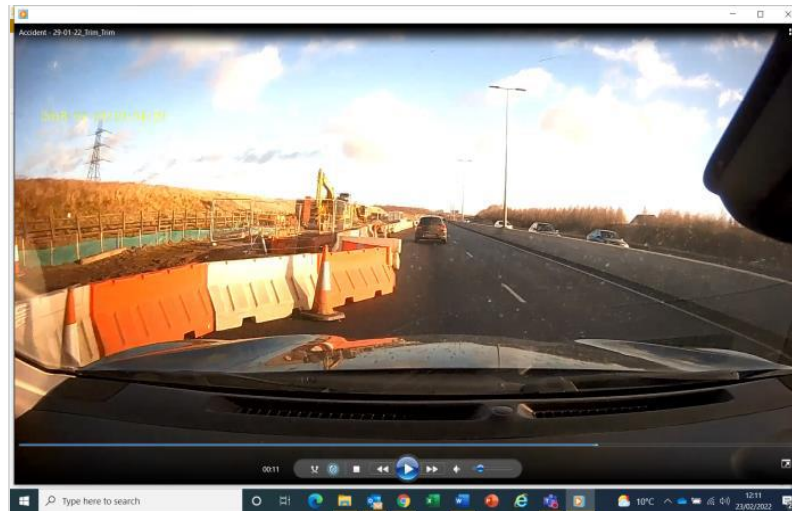
- A customer's vehicle being driven northbound on the A1, between junctions 78 and 79, was struck by traffic barriers which had been moved by winds gusting between 31 and 56mph during storm Malik.

- The traffic barriers had been placed across a usual access / egress point as a temporary demarcation line whilst drainage work was carried out in the area.

- The driver was unharmed, but some damage to their vehicle occurred.
- The investigation found the traffic barriers did not contain sufficient ballast (water) in accordance with the traffic barrier manufacturers guidance.

- It is unclear why the ballast was not at the required level; potential reasons could be evaporation or leakage.
- Only verbal communication was received that they had been filled correctly at deployment, and it is unclear whether subsequent checks had taken place.

- Discuss and review timescales for the monitoring of water levels within traffic barriers (specification states daily).
- Check manufacturer's guidance on fill levels and suitability for use in high winds.
- Critically examine emergency protocols when bad weather is forecast.
- Ensure that effective communication methods are in place with the Regional Operations Centre for emergency situations, to ensure a swift response to unsafe conditions takes place (including non working days).
