Date: 14th April 2022

Package: 2B

Background

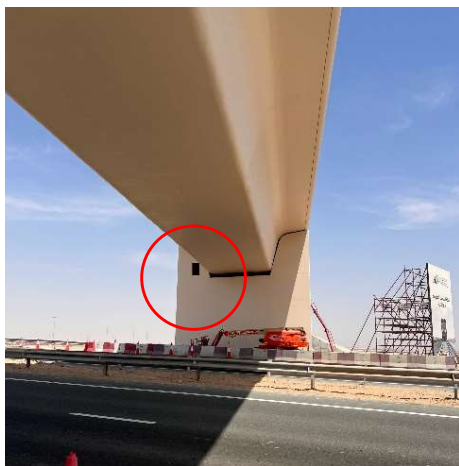
Access to hatch using MEWP

2. OSHAD requirements prohibit persons leaving a MEWP to access another place of work. Therefore, MEWPS are only to be used when work can be carried out from the basket. Access into the bridge abutment and bridge deck void areas must be provided via a scaffold

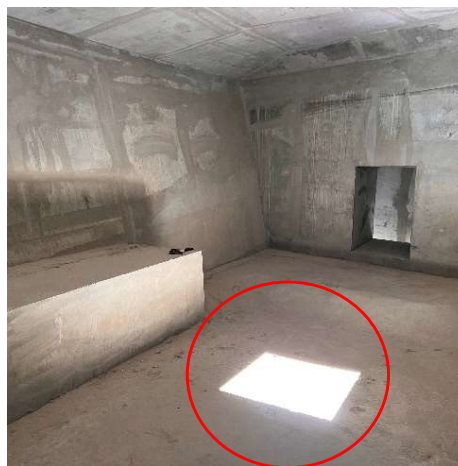
1. The opening in the bridge deck slab was not protected despite it being identified and raised by the contractor's HSE inspector on 3 separate occasions
2. The voids are classed as confined spaces but there was no permit to work procedure in place to cover the inspection activities
3. Whilst there was a method statement and risk assessment in place for bridge works it did not cover the bridge inspection activities in detail

Opening in bottom slab within void

1. Openings in slabs must be securely covered and provided with suitable warning signage. A register of openings shall be maintained and regular checks must be undertaken to ensure protection remains in place. Immediate action to be taken to make safe any deficiencies identified during inspections

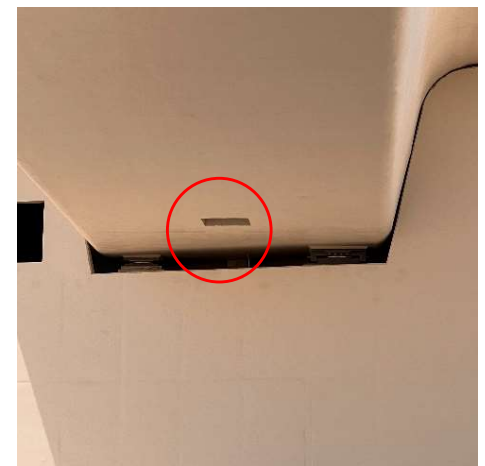
A serious incident occurred on Package 2B when a worker, who was the trained MEWP operator, fell from the bridge deck bottom slab through an unprotected opening. The worker operated the MEWP to the required access hatch in the abutment wall for the purpose of facilitating access for 2 inspectors who needed to inspect the bridge bearings. After the inspectors had climbed out of the MEWP into the abutment void the MEWP operator followed and for an unknown reason entered the bridge deck void. He then walked through the bridge deck void approximately 35 metres towards the opposite abutment. As he approached the other end of the bridge he fell over 8 metres to the ground through an opening in the bottom slab that was 800 x 800mm.

Worker fell through opening here
