DATE: MARCH 2019

Rise in vehicle collisions raises concerns

This safety bulletin provides safety advice for the NSW mining industry.

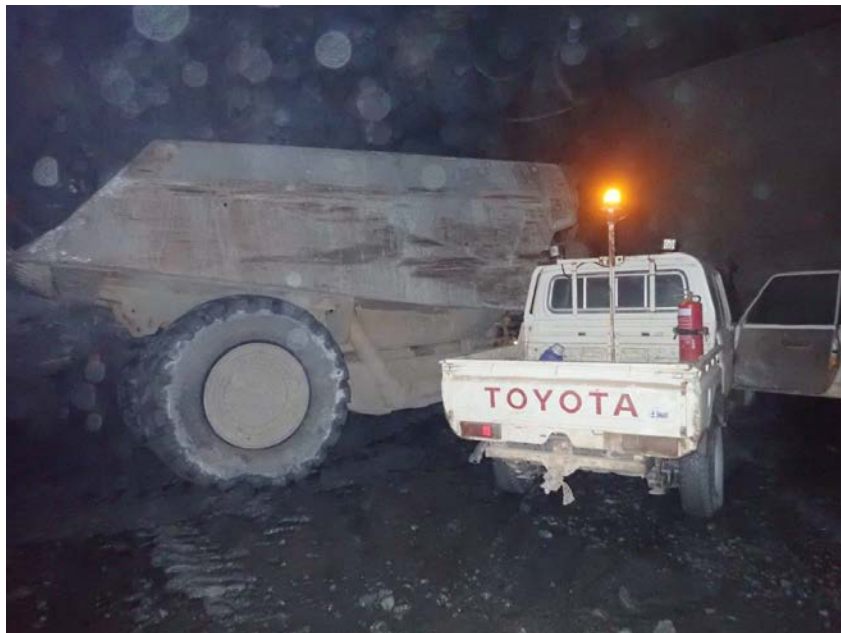
A collision occurred between a light vehicle and an underground haul truck. As the haul truck was leaving a stockpile, the tray hit a wall. The operator reversed the haul truck to move away from the wall. A supervisor driving a light vehicle saw the haul truck and assumed the haul truck driver was reversing to allow the light vehicle to pass. The light vehicle was on the blind side of the haul truck. As the light vehicle started passing the truck, the truck moved and hit the passenger side of the light vehicle. The light vehicle operator called the haul truck on the radio to stop him. There was no radio communication between the truck and light vehicle before the collision. The passenger side window was shattered, and passenger side panels were pushed in and torn. No workers were injured.

Figure 1: Haul truck hits light vehicle (IncNot0033382). Photo by NSW Resources Regulator

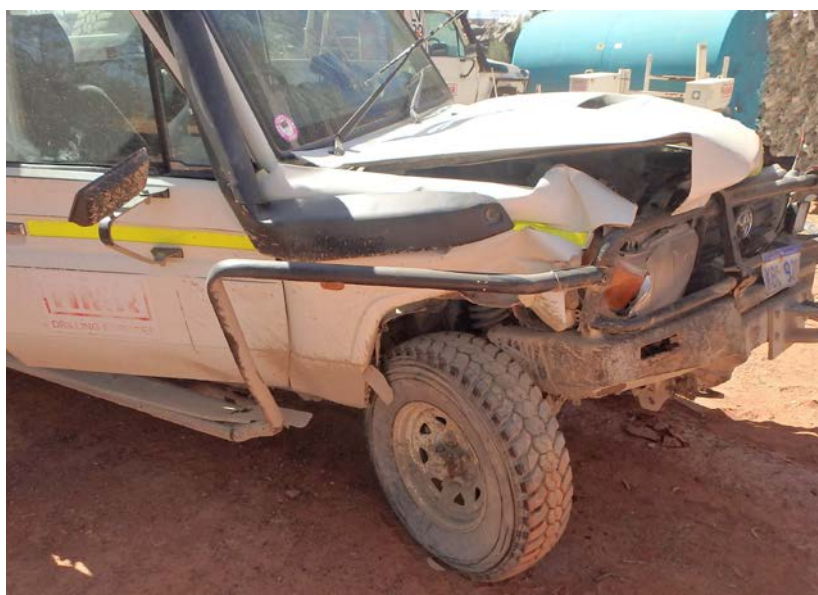
A contractor's light vehicle hit a decline wall. The vehicle had been serviced earlier that day by a third-party contractor. As the vehicle was descending the decline, the driver applied the brakes.

The vehicle then turned hard into the wall with enough force to deploy the air bags. A steering failure was identified during the post incident inspection.

Figure 2: Heavy contact with decline wall (IncNot0033889). Photo by NSW Resources Regulator

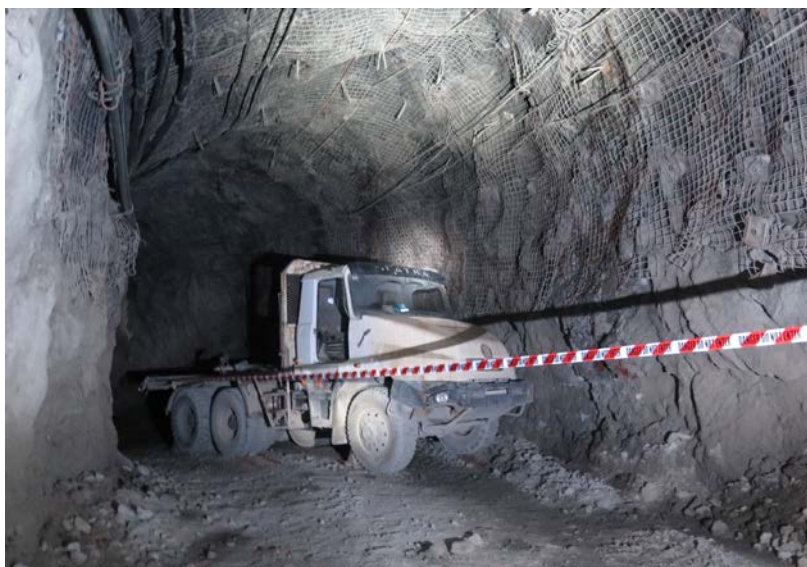
A haul truck was descending a decline. A stores truck had reversed to give way to another truck and started climbing the decline. As the haul truck started to travel around a blind corner, the rigid truck exited the corner. The haul truck hit the rigid truck and pushed it two metres into the decline wall.

Figure 3: Haul truck hits light vehicle (IncNot0033899). Photo by NSW Resources Regulator

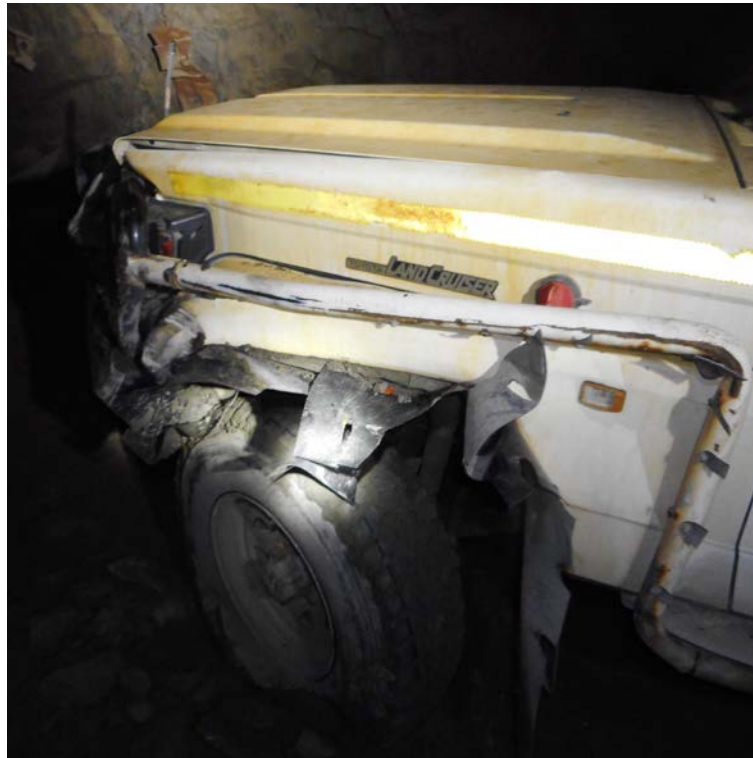
A light vehicle was descending a decline and hit the wall. The vehicle was severely damaged. The driver and passenger escaped injury. The driver then drove the vehicle to a nearby cutting and parked up. An investigation identified that wet road conditions and excessive speed contributed to the collision. A faulty speed limiter and faulty speedometer were identified during the investigation.

Figure 4: Haul truck hits light vehicle (IncNot0033912). Photo by NSW Resources Regulator
