## Significant Incident Report No. 240

**Subject:** Haul truck collides with grader on active dump

**Date:** 13 April 2016

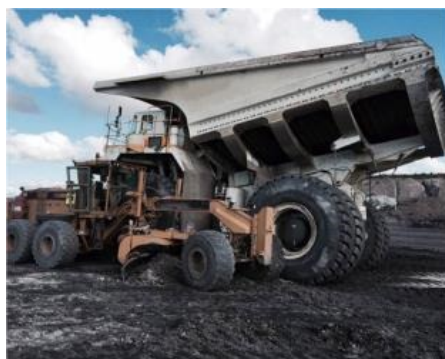
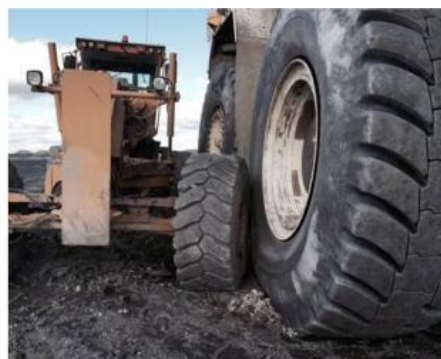
In July 2015, a grader was working in good conditions, near the entrance of an active waste dump, grading into oncoming traffic. As a haul truck drove up the pit ramp and turned off onto the dump's haul road, the truck's driver failed to see the operating grader.

In an effort to avoid a collision, the grader operator moved out of the anticipated path of the oncoming haul truck and stopped. However, the haul truck continued along the haul road, colliding with the left side of the grader.

The haul truck driver did not see the grader until after the collision. Fortunately, no one was injured.

- The driver of the haul truck did not see the grader.

- The gradient of the pit ramp, the sharp corner at the dump entrance, the windrow height and a blind spot created by the cab's pillar and doorframe limited the haul truck driver's visibility.
- There was no communication between personnel:
  - the grader operator did not use the two-way radio to inform haul truck drivers of the grading activity at the entrance to the dump's haul road
  - the proposed grading work was not discussed at the pre-start meeting.
- The grader was operating opposite to traffic flow, near the dump entrance, without physical controls in place (e.g. warning signs, temporary hazard controls).
- Workers and supervisors failed to recognise and manage the risks associated with mobile plant interaction (e.g. no risk assessment).

- Due to noise in the cab (i.e. radio and two-way radio), the haul truck driver did not hear the vehicle proximity alarm, which sounded for 9 seconds before the collision.
- The condition of the dump area was such that it required constant grading, increasing the interaction with haul trucks.

- Design road, intersections and dump areas to reduce the risk of mobile plant interaction.
- Design windrows for optimum visibility (e.g. at dump entrances).
- Separate haul truck and grading operations where practicable.
- Implement systems to help identify the location of mobile plant operating around haul trucks (e.g. warning signage, elevated flag indicators with high-visibility strips, revolving light, working with hazard lights on).

- Maintain effective positive communication between mobile plant operators.
- Managers and supervisors conduct adequate workplace inspections before and during work activities to identify hazards and risks (e.g. grading against the flow of traffic) and implement appropriate control measures.
- Develop effective controls and procedures to manage human error.
- Maintain and regularly test vehicle proximity systems.
- Monitor the effectiveness of, and compliance with, safe systems of work.
- Regularly inspect, audit and review the traffic management plan.

- Personnel should understand the hazards and risks involved with mobile plant interaction.
- Train and assess mobile equipment operators as competent in safe systems of work before undertaking tasks.
