Liebherr Loader Seatbelt Bracket

CAMs #172719

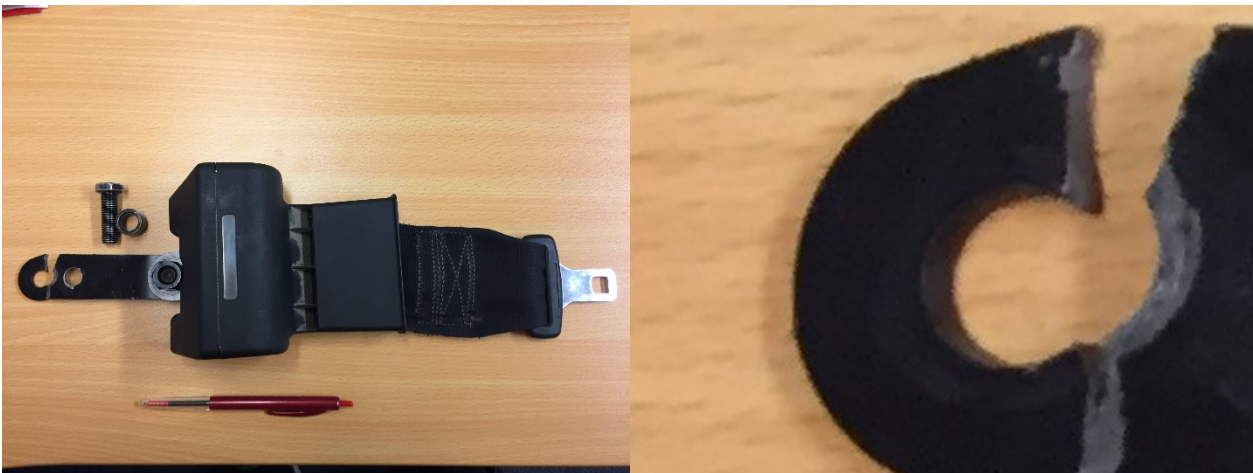
A late model Liebherr 556 loader was operating at a Fulton Hogan sand quarry. The loader drove into the sand stockpile to fill his bucket and as he was doing so the seatbelt bracket failed and the operator was flung forward striking his head against the cab roof and windscreen. Fortunately, the operator received only a minor neck muscle strain in the incident.

The loader in question is less than a year old and the seatbelt is otherwise in excellent condition. An investigation into the failure is underway and the seatbelt and bracket have been taken by the distributor for inspection.

In the interim, we are asking that a visual inspection of the seatbelt assembly is undertaken by a competent person on any other Liebherr loaders that are operating in the business.

All Liebherr loaders operating in the Fulton Hogan business have their seat belt assembly and securing bracket visually inspected by a suitable qualified person.

If any defect is discovered with the seatbelt assembly, the plant should be locked out until the defective part has been replaced.
