NZ Safety Alert

August 2019

Bench failure

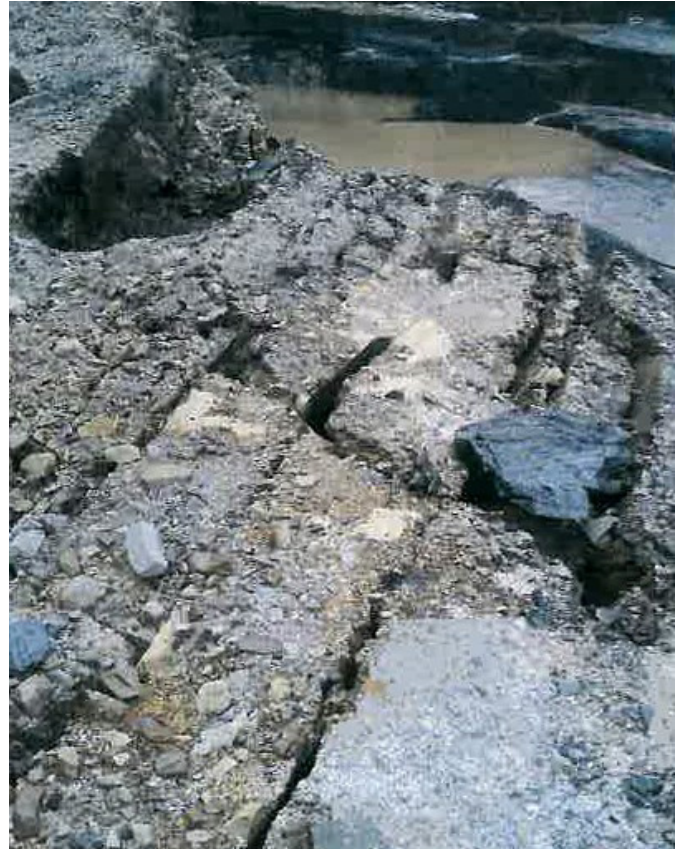
A bench above an area containing compressor and generator began fretting. On inspection of the bench some significant cracks had appeared in the bench.

The area at the toe of the bench was immediately bunded and an exclusion zone put in place. Drainage was also installed on the bench to drain water away from the cracks.

Daily monitoring of the cracks has been put in place to identify potential failure.
