SAFETY ALERT

INCIDENT	Hydrochloric Acid Spray to Face and Eyes A1-P3
SUBJECT	Hydrochloric Acid PVC Fitting Failed
INCIDENT DATE	27 January 2021
BUSINESS UNIT	Higgins Bitumen Manufacturing

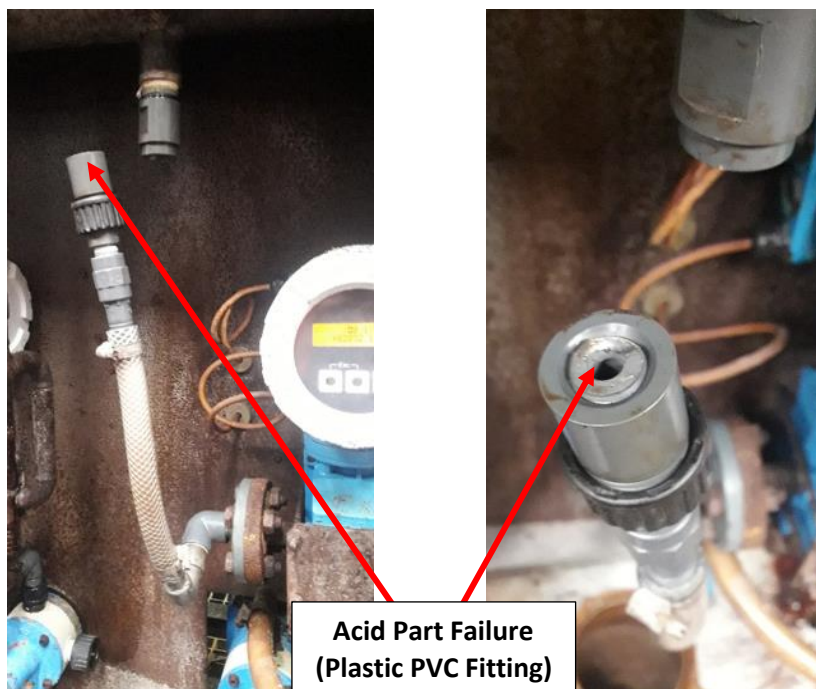
As the operator knelt down to close the acid supply valve the non return PVC plastic fitting failed and sprayed hydrochloric acid on to the operators face and eyes. The estimated volume in the non return valve was between 20ml to 50ml.

Photos: The PVC fitting broke releasing Hydrochloric Acid

- **Mandatory PPE must be worn at all times.**
- **Ensure all first aid showers and wash stations are appropriately positioned and functioning.**
- **For fixed and mobile plant, it is important to have a preventative maintenance plan so timely proactive maintenance can be completed on high risk components minimizing risk of failure.**
