LLE604E

Lessons Learnt Template

PHOTO TITLE: Semi-Trailer transporting culverts overturns.

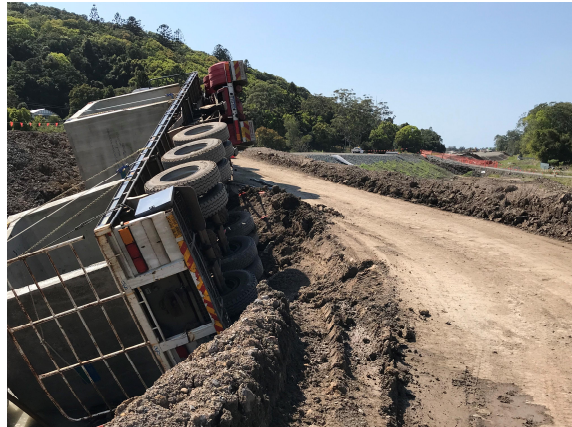
Location where the semi-trailer overturned.

During the delivery and transportation of culverts to site a Semi-Trailer (heavy vehicle) has travelled via an access route around a box culvert (under construction).

The vehicle trailer has inadvertently travelled over a suitable construction berm (windrow) and subsequently overturned. Works were underway near this location as part of the ongoing culvert construction.

The culvert units remained on the trailer held by the load restraints that have been designed as part of the chain of responsibility controls implemented during the procurement of the transport logistics

There was no warning signage to prevent semi-trailer access through culvert crossing and/or to advise escort and driver of an unsuitable route.

The SWMS for regular inspections of the excavation was not completed to determine potential undercutting or compliance with excavation Code of Practice (CoP).

Driver was not aware of the specific travel route, because he wasn't issued delivery instructions.

- § Clear signage preventing access was not installed
- § Planning the design of the workplace resulted in the benching works that accommodates the culvert apron installation contributed to the windrow being located close to edge of excavation;

- § The communication of information is key factor that all stakeholders in the transportation, receipt and escort understand the planned route for heavy oversized vehicles when travelling within the construction boundaries;

- § The design of haul route crossings takes into consideration the restrictions for different vehicle items and effective mitigating controls are physically implemented to prevent non-suitable vehicles accessing the area;

- § Excavations that support haul route crossings are constructed in accordance with the code of practice and regularly inspected for disparities;
- § The consignor requires a systematic process to ensure the transport chain receives delivery instructions prior to the dispatch of vehicles.
