SAFETY ALERT

Safety Alert Number: 09/20

Business Unit: RoadTek Central Qld

EFFER Vehicle Loading Crane**Brief Description – Incident Summary**

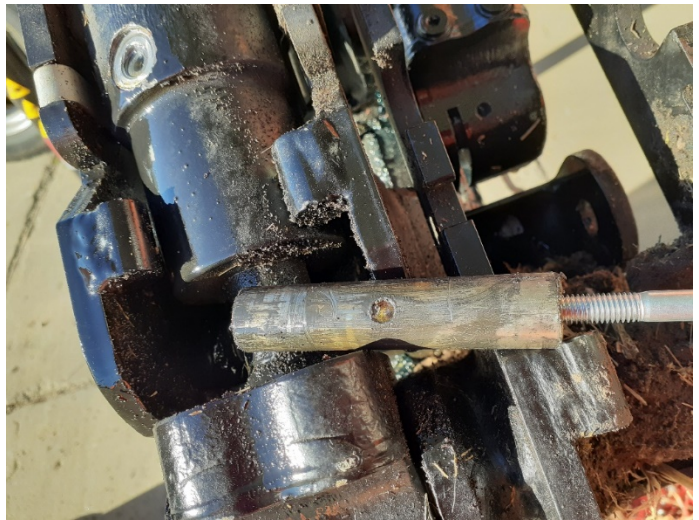
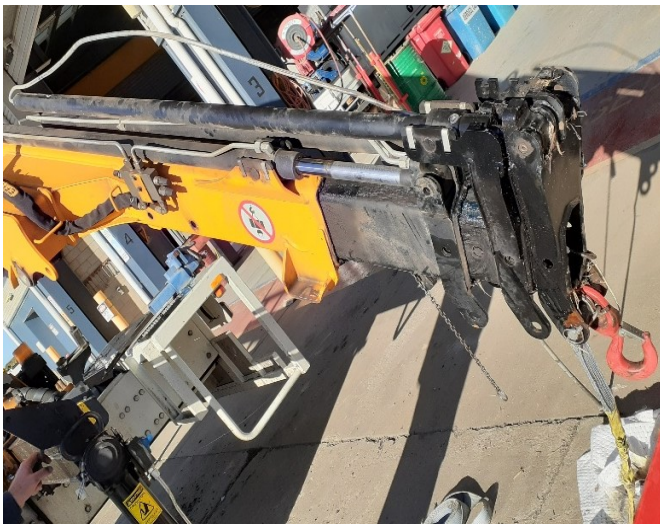
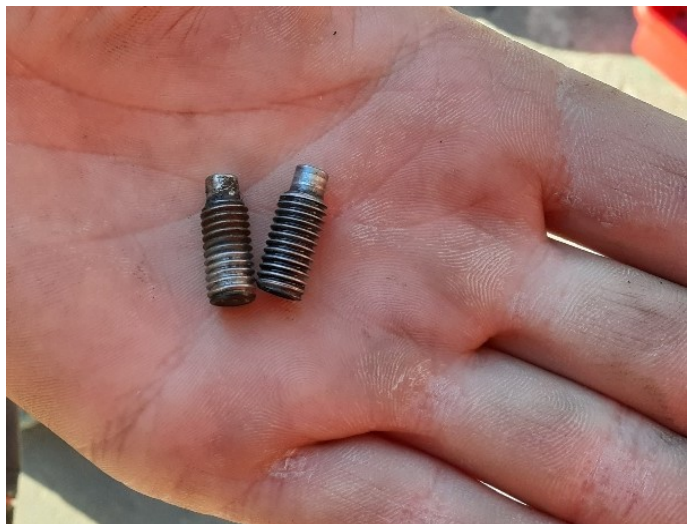
A loose grub screw has allowed a pin to fall out which has then allowed the extension to drop out when crane was deployed for use. The dropping extension has then broken off a hydraulic fitting.

- The incident was apparently caused by a loose grub screw used to lock the pin in place.
- Closer inspection has found several more grub screws that were not sufficiently tight.

- All EFFER Cranes need to be inspected by a RoadTek Workshop Technician before continued use.
- All boom extension segment retainer pins need to have the grub screws fastened & locked in place.
- Maxilift Aust. (Australian distributors of EFFER VLCs) will issue a Bulletin to address this in due course.
- Distribute this information IMMEDIATELY to all staff and discuss at your next safety meeting
- Use Stop-Think-Go at all times.
- Consider this Safety Alert in all future relevant risk assessments
