NZ Safety Alert

11 December 2020

Excavator uncovers misfire

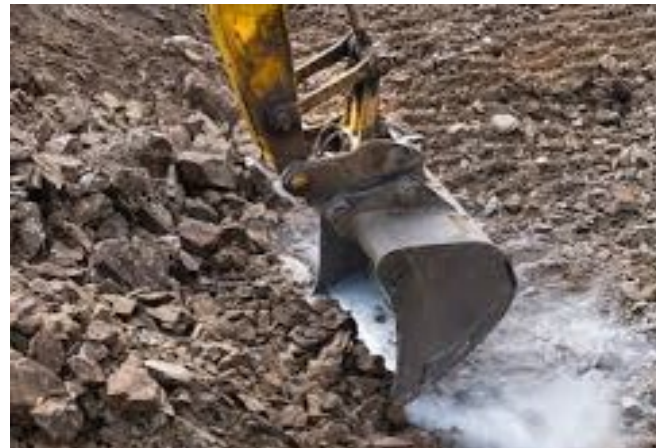
A digger was moving rock from the quarry pit when the operator saw a detonator and booster in the digger bucket. The operator stopped and advised the quarry manager who then advised the current blasting contractor and requested them to check the explosive.

The detonator and booster were from a previous shot and were subsequently placed in a safe area, this area was then isolated off. The blasting contractor gave advice and removed the explosive from the site to be stored in a safe location prior to disposal.

1. A misfire procedure is developed and explained to all workers.
2. Workers treat any explosive components found while quarrying (after blasting) as live, and immediately isolate the area and implement the misfire procedure.
3. Ensure pre-ignition tie-in inspections are conducted so all tie-ins are checked by at least the shotfirer and one other person.
4. Ensure post-blast inspections are properly conducted to identify areas of potential misfires.
