Falls from walkways and platforms

Issued by Resources Safety & Health Queensland

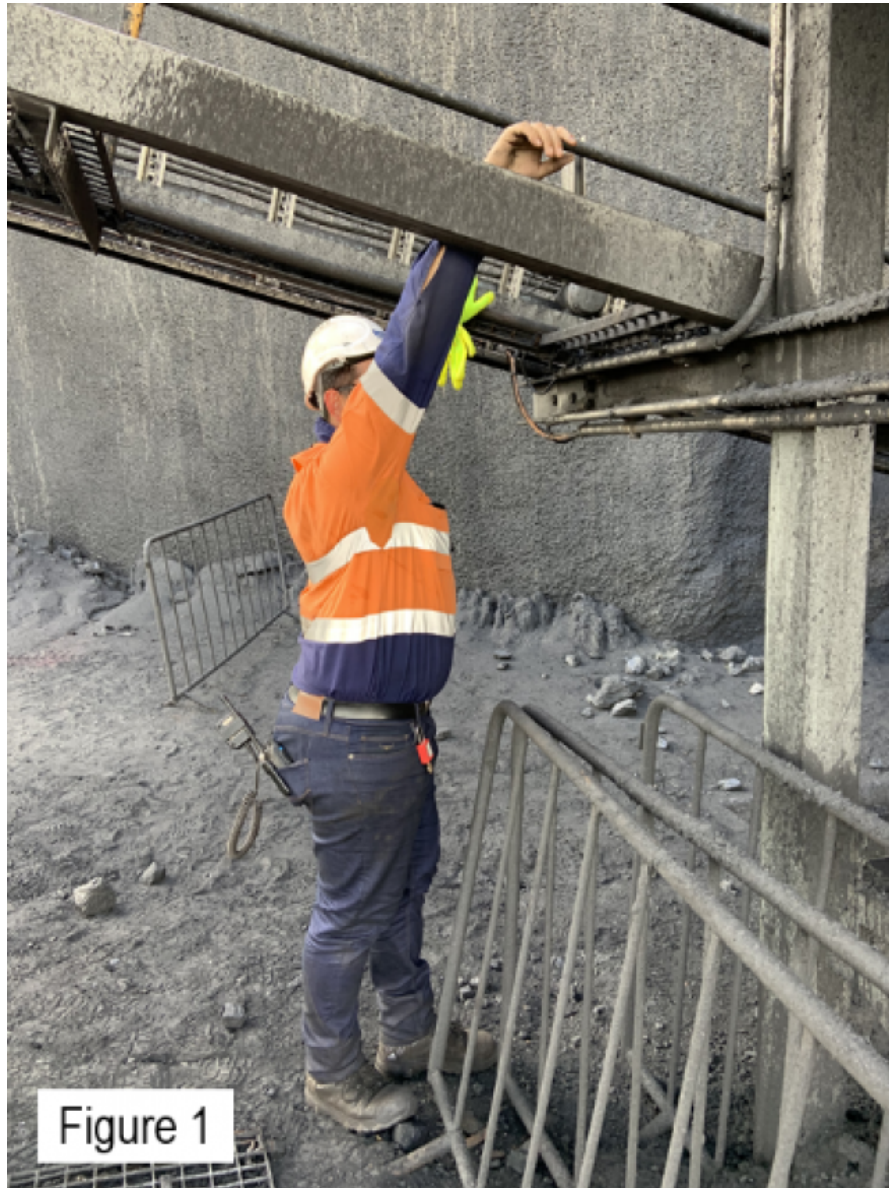
On 27 January 2021, a CMW was walking on a coal handling and preparation plant (CHPP) conveyor walkway. The section of steel mesh walkway the CMW was on failed and the CMW fell through. The CMW was able to lower himself to the ground through the open section of flooring using the handrails and adjacent steel structure for support. The worker was exposed to a potential fall of approximately two metres. The failed walkway and potential fall height are evident in the re-enactment shown in Figure 1.

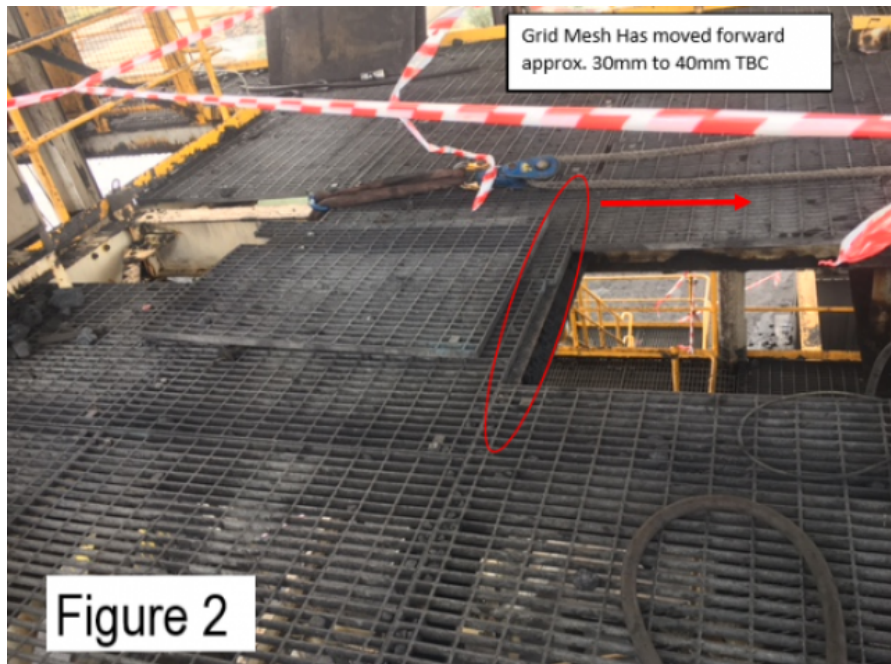
On 4 February 2021, a CMW fell through a section of steel mesh floor. At the time of the incident a roller screen in a CHPP tertiary crushing station was being pulled back into position. The CMW walked behind the work area and fell through a section of floor mesh that wasn't secured. The displaced mesh floor is shown in Figure 2. The CMW was able to stop the fall with his arms, however he potentially could have fallen 8.6 metres as depicted in Figure 3.

- In the first incident the dislodged mesh panel was found to be heavily rusted (refer Figure 4) and the panel failed when the CMW stood on it.
- In the second incident rigging being used to pull the roller screen appears to have dislodged one panel which then dislodged a second panel due to side loading imposed on the panels (refer Figure 2).
