FATALITY - Mudslide and Engulfment of Excavator

Incident Description

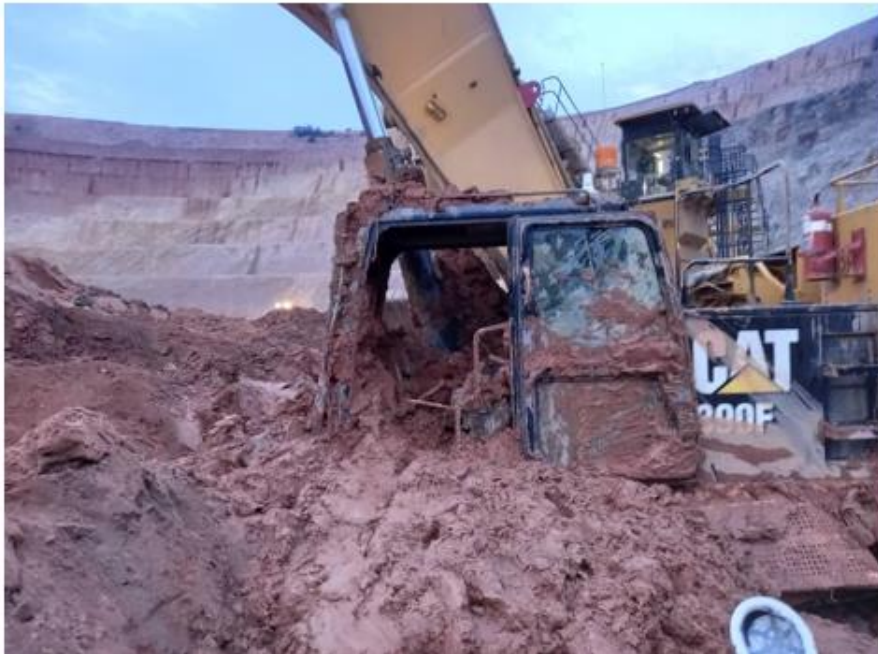
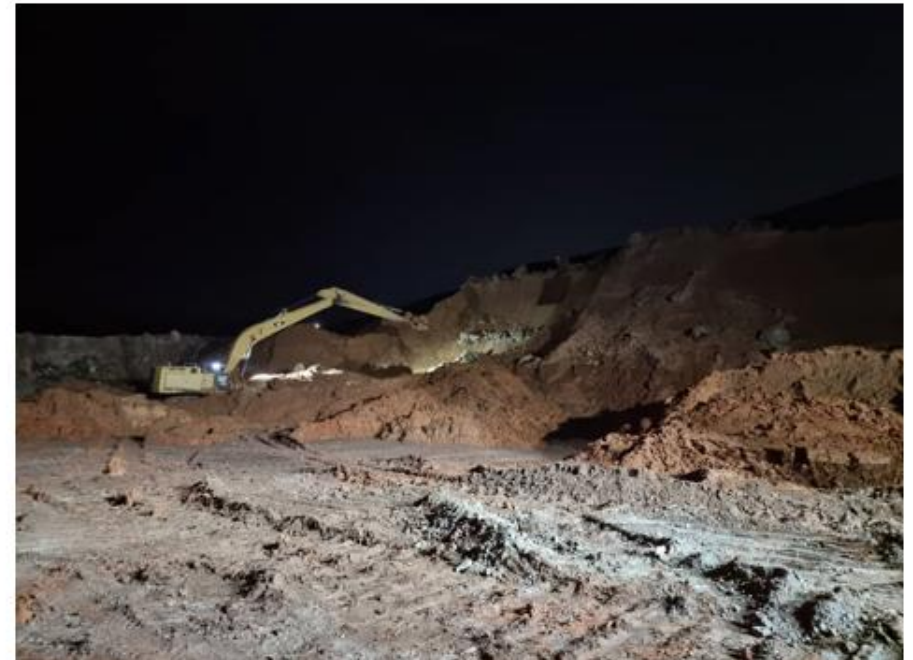
At approximately 16:50 on 26 October 2021 at our Kamoto Copper Company (KCC) Copper Africa operation, Mr Albert Mwaku Mapasa an excavator operator, was performing excavation activities in the Mashamba pit when a mud slide from the dig face he was working on occurred. The mudslide engulfed the excavator cabin causing fatal injuries.

Photos of incident scene post event

1. Review current Ground Strata Management and Inrush Management Plans to ensure all inrush and potential inrush sources are identified
2. Conduct a review of the TARPs in place for Adverse Weather and Inrush to confirm, they are up to date, accountabilities for each trigger point are clear and personnel are aware of content and where they can be located
3. Monitor adverse weather conditions and ensure controls are appropriate for the tasks being undertaken
4. Schedule verification activities in preparation for wet weather events to confirm critical controls are in place and effective
