**REPORT OF INVESTIGATION**

**Surface  
Construction Sand and Gravel**

**Fatal Fall of Person Accident  
May 13, 2014**

**Desert Construction Inc.  
Hualapai Pit  
Kingman, Mohave County, Arizona  
Mine ID No. 02-01062**

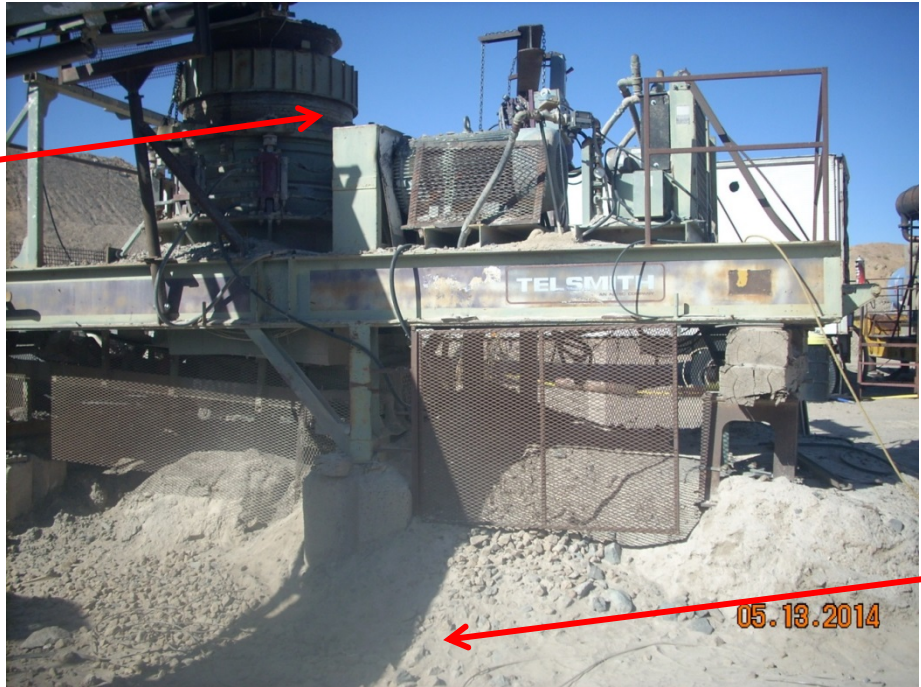
Victim was standing on top of the drive belt guard signaling the excavator operator when he was hit with the excavator bucket.

The victim impacted the ground here.

Schmidt was standing with one foot on the crusher drive belt guard and the other on the cone. As the bucket swung, it struck Schmidt in the side, causing him to fall forward off of the crusher. He fell approximately 11 feet to the ground, landing on his head and shoulder. Shaffer and Scroggins saw Schmidt fall and immediately went to his aid. An ambulance was summoned and Schmidt was transported to the hospital.

Root Cause: The victim was not wearing any type of fall protection to prevent him from falling from the top of the cone crusher.

Corrective Action: Miners were retrained in the proper use of fall protection.

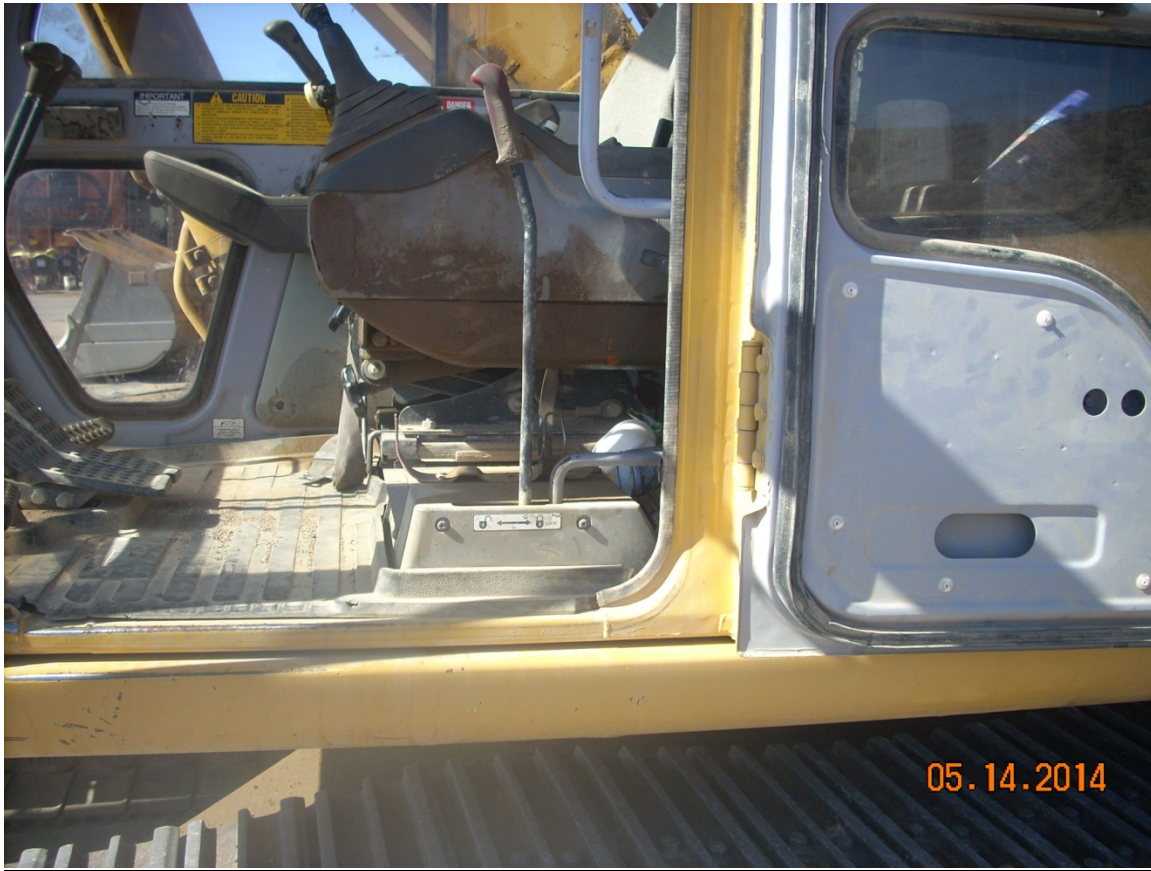
The 790 ELC John Deere excavator involved in the accident uses a series of pedals and levers in the cab to control the machine's movement and the operation of the excavator arm and bucket. This unit is equipped with a hydraulic lock-out lever to the left of the operator's seat that disengages the hydraulics so that the unit and implements will not move. The lever has two positions. When the handle is in a 90 degree vertical position, the hydraulics are isolated and the machine controls are not operable. When the lever is pushed forward, from a vertical position down to approximately 45 degrees, the machine will move and the arm and bucket will operate. While in the 45 degree (operation) position, the lever partially blocks the exit from the excavator. The lock-out lever and hydraulic controls were tested and functioned properly.

Photo shows lever in upright 90 degree position, deactivating the excavator's hydraulic system, making it easy to enter and exit the operator's seat.

Corrective Action: The operator retrained miners to shut down the unit before exiting the cab.

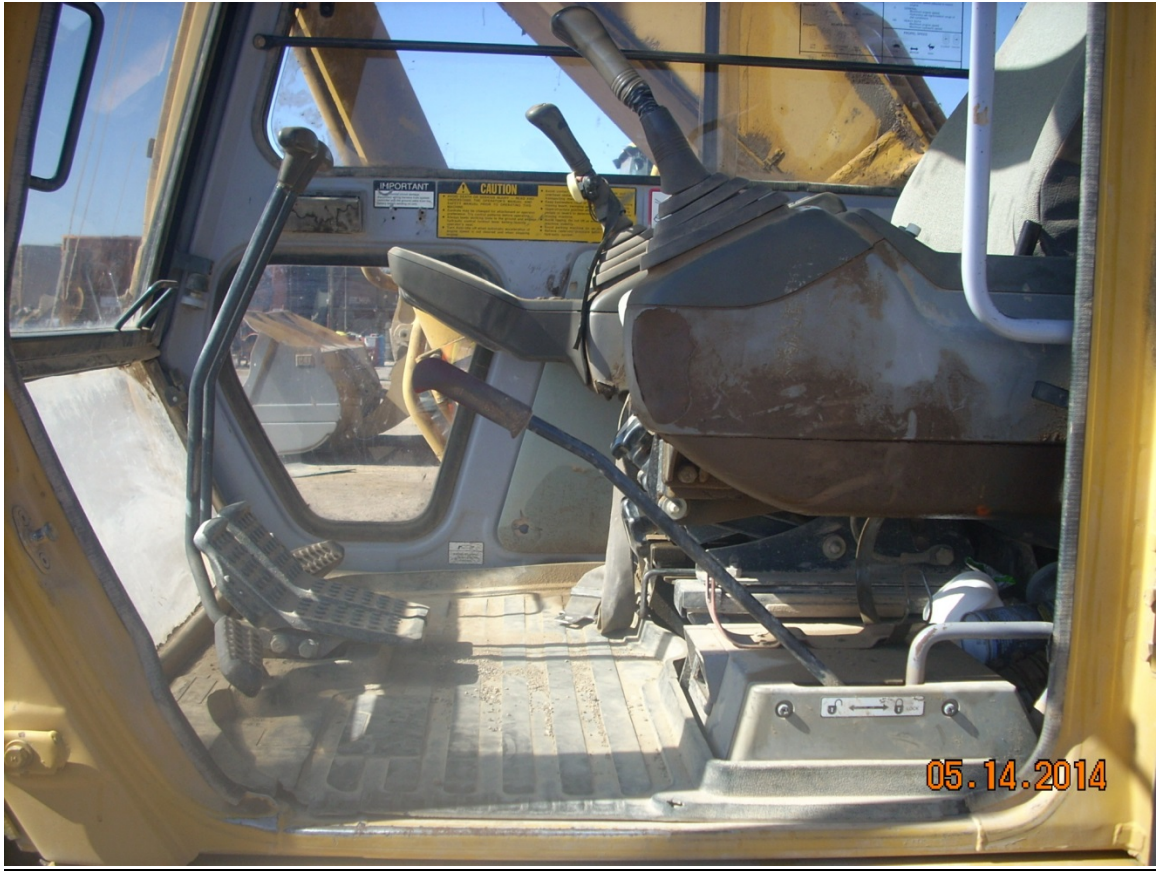
Root Cause: The excavator operator was unable to effectively maintain control of the excavator while exiting the cab of the unit, resulting in the excavator bucket striking the victim.

Photo shows the lever in the forward 45 degree position, engaging the excavator's hydraulic system, and making it difficult to exit and enter the operator seat.
