# MINE SAFETY INVESTIGATION UNIT

INFORMATION RELEASE

## Fatality

<b>Incident date</b>	4 November 2016
<b>Event</b>	Fatality in underground opal mine
<b>Location</b>	Mulga Rush Opal Fields (near Lightning Ridge) NSW

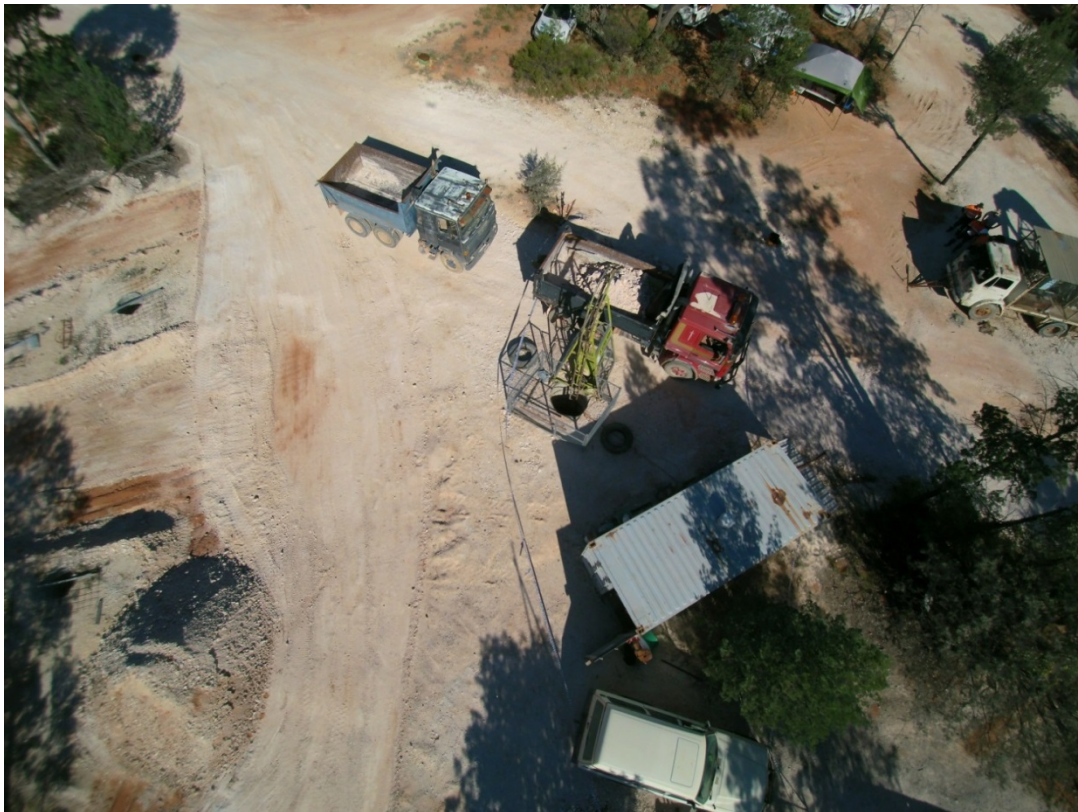
Photograph 1: Surface of the opal mine and shaft hoist system.

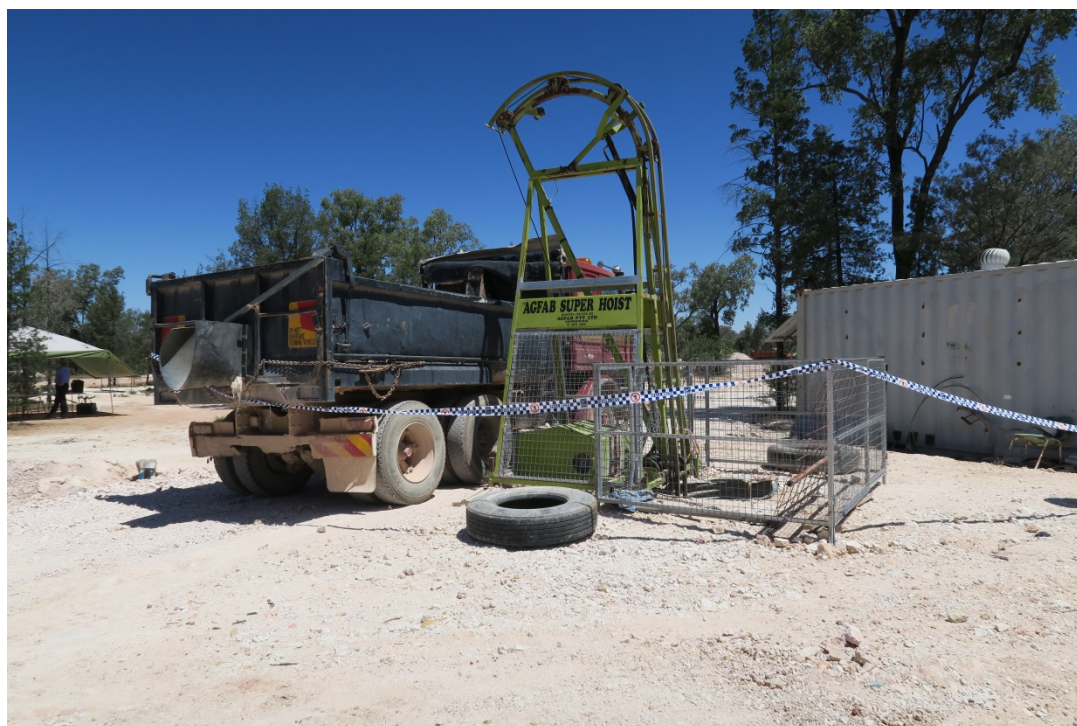
Photograph 2: Headframe and material hoist system at the top of the shaft.

When the bucket returned to the lower limit, investigators suspect the bucket failed to activate the lower level limit switch, which is in the sump at the bottom of the shaft and designed to stop the operation of the hoist.

The hoist continued to operate and all the steel cable unspooled from the hoist winder drum. The steel cable then wound onto the hoist's winder drum in the wrong direction and the bucket raised unintentionally to the surface.

When the bucket reached the surface the hoist hydraulic system prevented the bucket from reaching the tipping point, causing it to remain in a static suspended position above the shaft. In this position, the hoist hydraulic and electrical system continued to operate and the hydraulic drive motor prevented the bucket from falling.

During the task, investigators suspect the worker bumped the lower limit switch, which deactivated the hoist's electrical and hydraulic power, causing the bucket to free-fall down the shaft at speed without hydraulic drive motor control (as the steel cable was wound onto the winder drum in the wrong direction).

If work is to be undertaken in a shaft, the material hoist bucket must be secured, either at the bottom of the shaft or at the surface, with the hoist system isolated and protective guarding installed to prevent the bucket or other items from falling down the shaft.

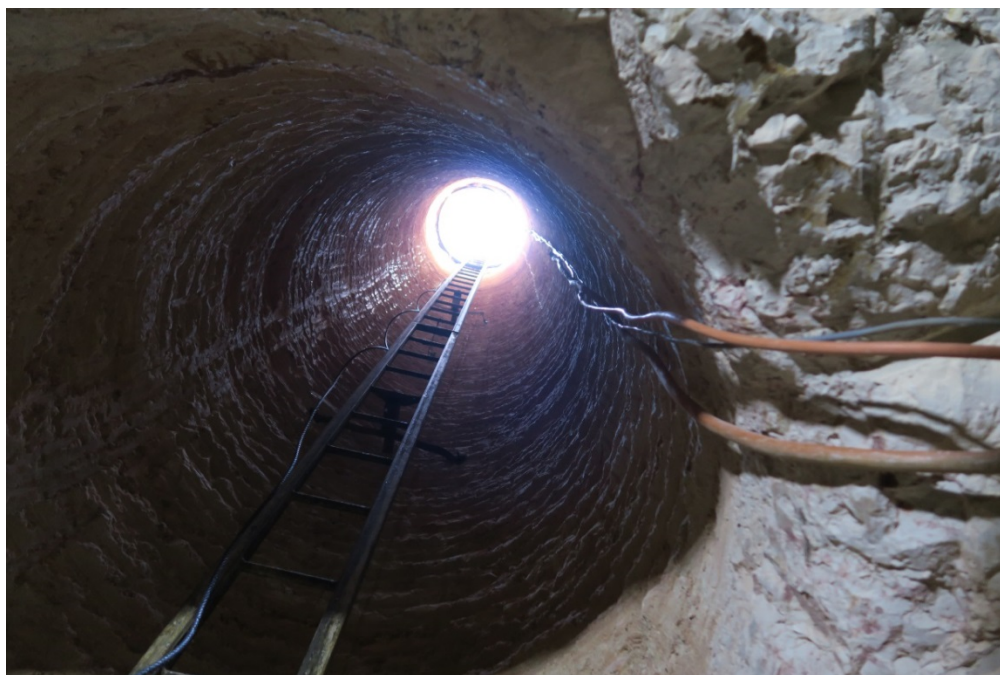
Photograph 3: The shaft, guide rail system, steel cable and electrical cable (taken from the base of the shaft).
