NZ Safety Alert

3 March 2023

Finger injured during maintenance

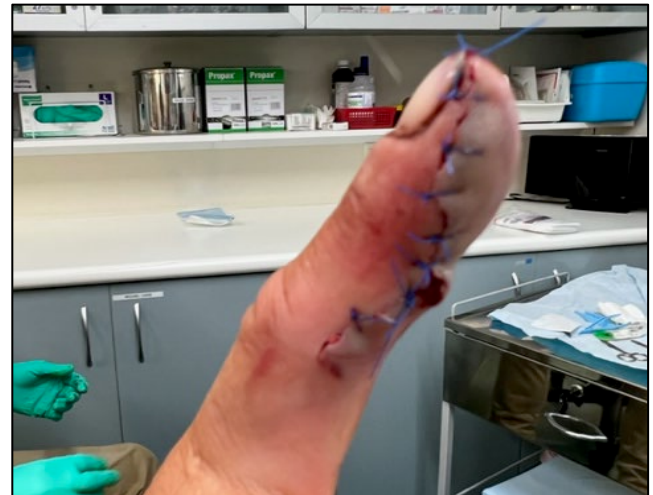
A worker and a contractor were removing the track of a D8 dozer. After removing the master pin from above the rear sprocket, and while the worker was packing down the tools from on top of the track, the track started moving.

Fearing the track may hit the ute parked in front of it, the worker tried to stop the track running and caught his right index finger between the cleats.

The worker sustained serious injury to his finger which required medical attention and some time off work.

1. Where practical, that maintenance activities are conducted from the ground. In this case the master pin could have been removed from a point closer to the ground.
2. All plant is fundamentally stable before commencing maintenance work. Chocks, chains etc. should be used to stabilise the plant.
3. Maintenance areas are clear of mobile plant and equipment before conducting maintenance tasks.
