**NSW  
Resources  
Regulator**

# **Workers trapped in shaft winder**

Causal investigation

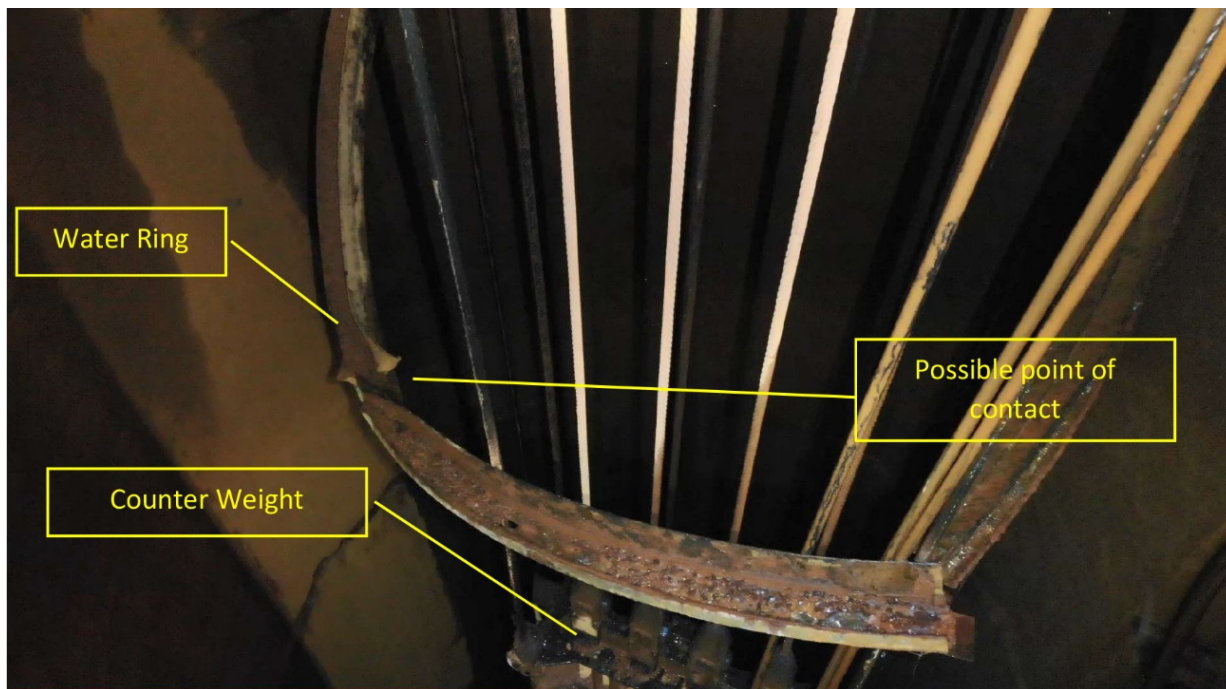
Figure 7: Shaft water ring wrapped around counterweight head ropes and shaft services.

- Sent camera down to assess situation (found water ring dislodged at counterweight location).
- Installed object fall barrier (beams) at bottom of shaft.
- Removed water ring in four sections from shaft using camera directed slings and winches.
- Brought conveyance to surface for examination using auxiliary hydraulic drive.
- Non-destructive testing (NDT) of cage head rope attachments and associated structure on conveyance.
- Removed object fall barrier (beams) from the bottom of shaft.
- Measured and reset rope insert groove depths on winder drum.
- Adjusted winder encoder parameters following insert groove depth adjustment.
- Adjusted mechanical hunting tooth parameters following insert groove depth adjustment.
- NDT of head ropes.
- Inspected counterweight when brought to the surface.

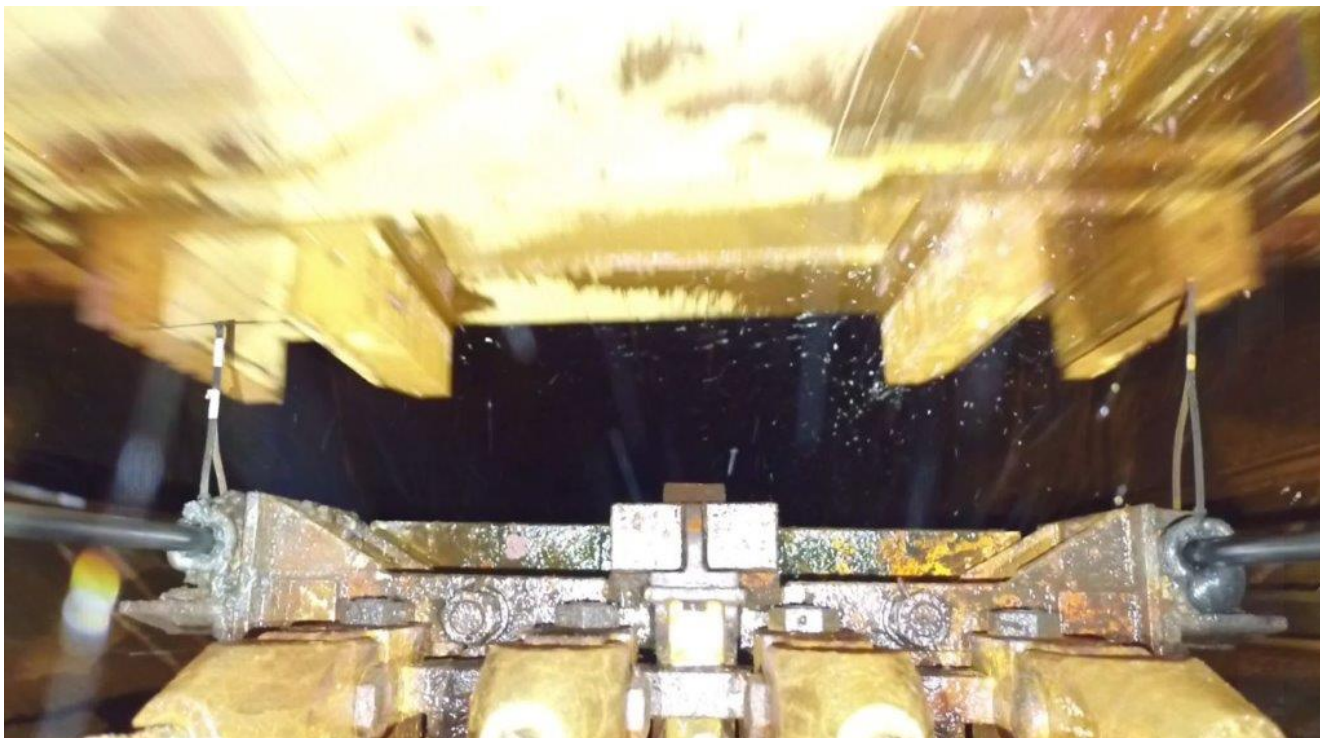
Once whisker tests showed acceptable clearances physical measurements between counterweight and cage were undertaken to verify clearances.

**Figure 9: Counterweight to cage clearance.**

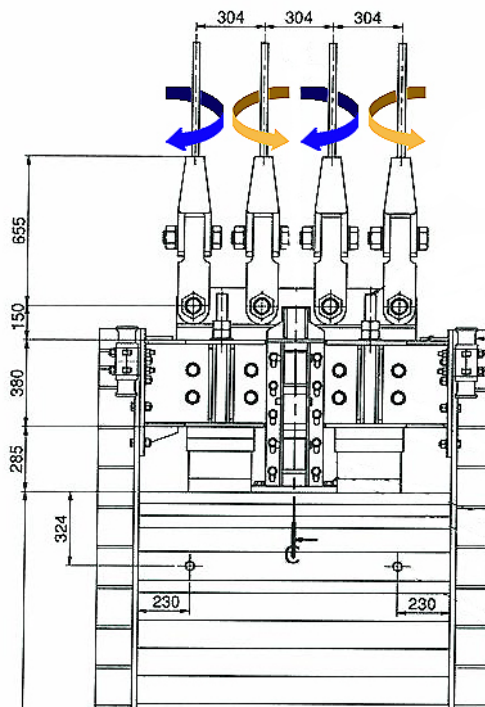
Witness evidence provided by the dayshift deputy indicated that the counterweight had rotated outside of its usual axis. The most reasonable explanation for this rotation was uneven head rope tensions. The four head ropes used on the No. 3 shaft winder were 30 millimetre diameter, 1960 megapascals, galvanised 790 kilonewton ropes. Ropes 1 and 3 were right hand langs lay and ropes 2 and 4 were left hand langs lay. Langs lay ropes have a known rotational torque when a vertical load is applied. This is demonstrated in figure 10 below.

Figure 10: The Tahmoor No. 3 shaft counterweight depicting rotational torque applied to the capels from the head ropes.

Theoretically, when all four ropes are of equal tension, the net torque on the counterweight is zero. However, each rope will have minor variances in rope rotational torque for any given load. When head rope tensions are out of balance (i.e. do not have the same load applied) a net rotational torque will be applied to the counterweight. This torque will influence the axis on which the counterweight sits and possibly rotate outside of its operating profile.

The investigation process determined that a significant cause of the incident was uneven head rope tensions, combined with drum liner wear, which allowed the counterweight to rotate outside of its normal operating profile. The rotation of the counterweight meant that it was possible for the counterweight to make contact with the number four water ring as the cage conveyance transported two workers to the surface of the mine.
