Week ending 11 January 2019

This incident summary provides information on reportable incidents and safety advice for the NSW mining industry. To report an incident to the NSW Resources Regulator: phone 1300 814 609 24 hours a day, 7 days a week.

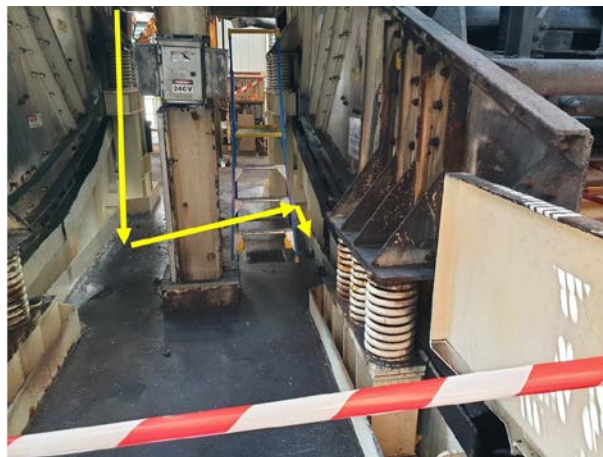
Incident type	Summary	Recommendations to industry
Dangerous incident IncNot0033593	A section of pipe was being removed for maintenance work. When it was cut, it dropped 4.4 metres to the floor below, bounced into a gap between the floor and vibrating screen, and landed on the level below.	When conducting maintenance activities where objects are removed, controls must be put in place to manage the risk of falling objects. When establishing a no-go zone as a control for falling objects, bouncing or ricocheting must be considered.

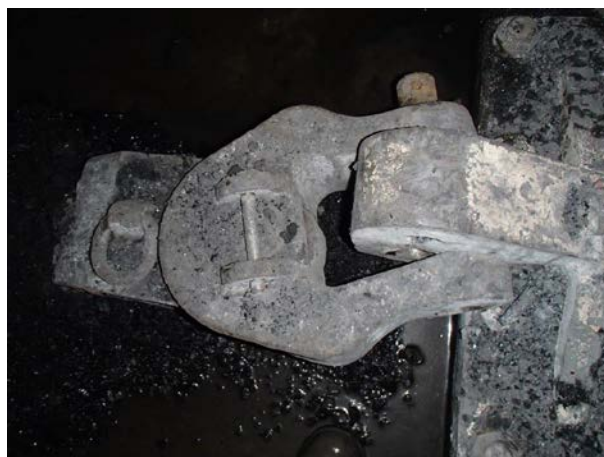
Dangerous incident
IncNot0033573

A metal fastener hit a worker in an underground coal mine. A horizontal clevis pin failed, hit an electrical enclosure and then ricocheted, striking the worker's hand. The worker underwent surgery the following day.

Clevises and pins should be included as part of life cycle management plans. Dimension checks should be routinely conducted to confirm wear in the clevises and pins. Uneven wear can induce abnormal loading.

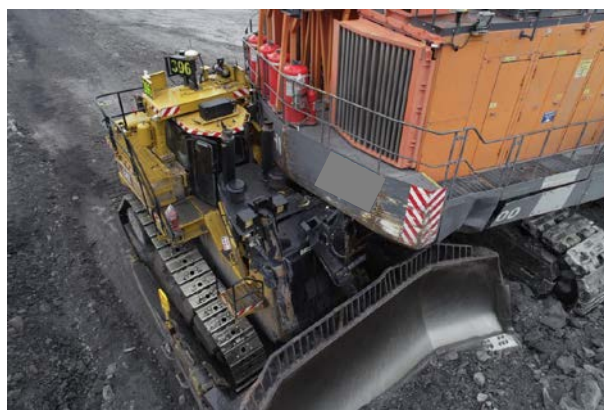
Dangerous incident
IncNot0033526

A collision occurred when an excavator slewed, striking a dozer with the counterweight. The dozer operator called up the excavator operator who confirmed the message. The dozer came up beside the excavator and as it was reversing, the excavator started to slew. The counterweight made contact with the dozer, damaging the ladder and door. The door was damaged and required additional force to open it. No injuries were sustained.

Details of positive communications requirements such as equipment number, message content and confirmation should be detailed in mine procedures and training. All operators must follow the correct positive communications even when working with the same workers over a long period of time. Experience does not remove the need for positive communications.
