First Alert – Arc Flash Injury to

Incident		Description	
Event Date: 27/06/2019	Time: 10:00	Location:	
Investigation Status:	On-going	NP Reference: INV3963	
Event Description:		<p>An employee was repositioning a cable from one MCCB to another. He moved an in-service cable back, out of the way, to create room for the cable migration and in doing so has caused a flashover. At this point we know the flashover occurred on the white phase of the in-service cable to the earthed switchboard frame.</p> <p>No further information is available at this point and the incident is under investigation.</p> <p>This alert serves as a reminder to follow safe low voltage work practices, including:</p> <ul style="list-style-type: none"> • First, determine if the equipment can be isolated. • Check for back feeds and adjacent services. • Complete a risk assessment, identify controls and plan a work methodology. • Use a safety observer if appropriate for the risk. • Ensure everyone understands the work methodology and controls. • Use insulating barriers. • Use PPE including insulating gloves and visors where appropriate. • Prove Test Prove • Use insulating tools.

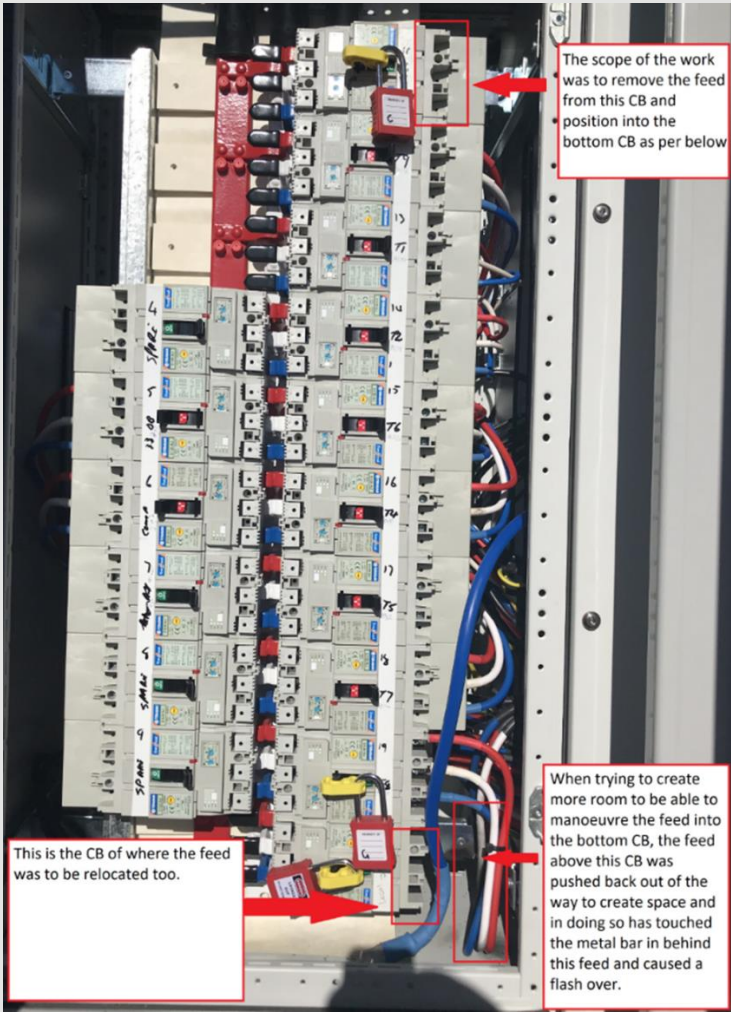
<p>The scope of the work was to remove the feed from this CB and position into the bottom CB as per below</p> <p>This is the CB of where the feed was to be relocated too.</p> <p>When trying to create more room to be able to manoeuvre the feed into the bottom CB, the feed above this CB was pushed back out of the way to create space and in doing so has touched the metal bar in behind this feed and caused a flash over.</p>			
Actual Outcome:		Employee has sustained a burn to his left hand middle finger.	
Actions Required / Messages:		Under investigation	
Contact Person:
