REPORT OF INVESTIGATION

Open Pit Non Metal Mine
(Limestone)

Fall of Person
March 7, 2019

Robben's Fabrication and Mechanical, LLC
Contractor ID (B6573)
at
CEMEX Construction Materials South, LLC
Balcones Quarry
San Antonio, Texas
ID No. 41-00994

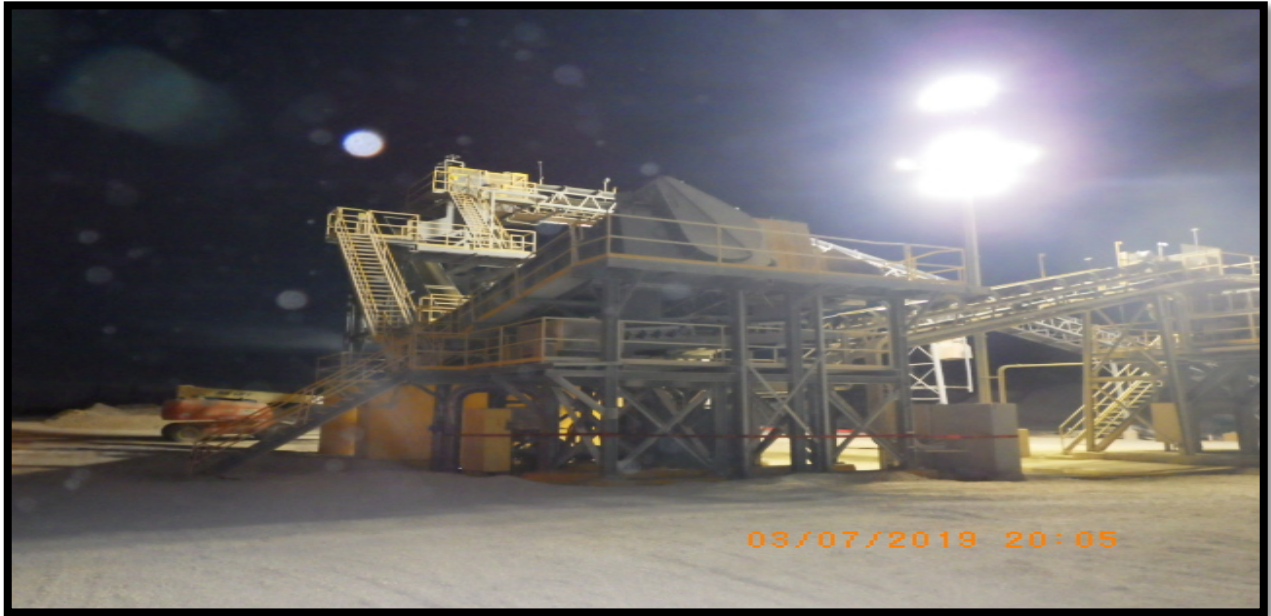
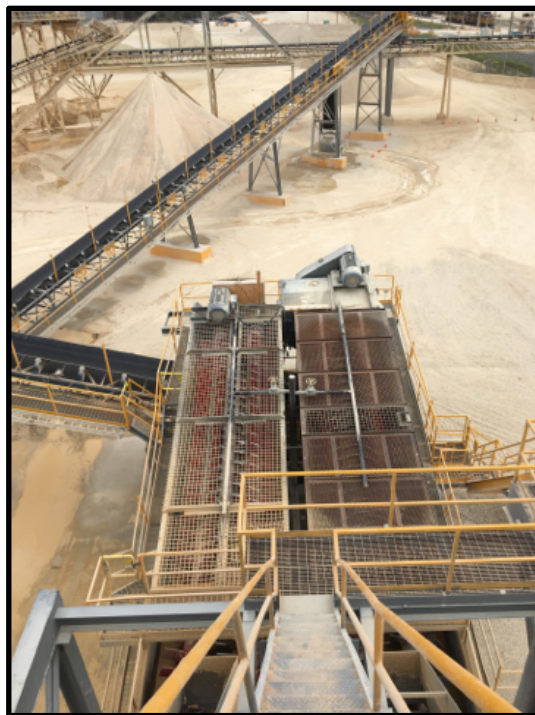
APPENDIX B
Log Washer Photos

The accident occurred at the wash plant where two log washers are side by side. The north log washer is a McLanhan Super Mudmaster 46' x 35' and the south log washer is a 44' x 35' unit. The gap between the log washers ranges from 15 ¾-inches at the motor drive end to 16-inches on the opposite end and is approximately 35 feet long. (See Appendix B)

The miners were replacing the drive belts on the motor of the north log washer when the accident occurred. They stood on top of the north log washer, which was covered by a metal screen. There were catwalks on all sides of the north and south log washers except for the gap between them.

While tightening the front bolt, Dominguez stood while he was bending over and pulled the wrench toward himself. His wrench slipped, causing him to lose balance and fall backward. He stumbled when his left foot hit the electrical power cable and he fell through the narrow gap between the log washers.

Corrective Action: The operator retrained miners and contract employees on the requirement of wearing fall protection and their “working at heights” policy. The operator also provided additional guarding at the log washers for working on top of the log washers.
