Coal Inspectorate | Alert | No.392 V 1 | 09 June 2021

Sudden tyre failure ejects rock shrapnel through a dozer's cabin

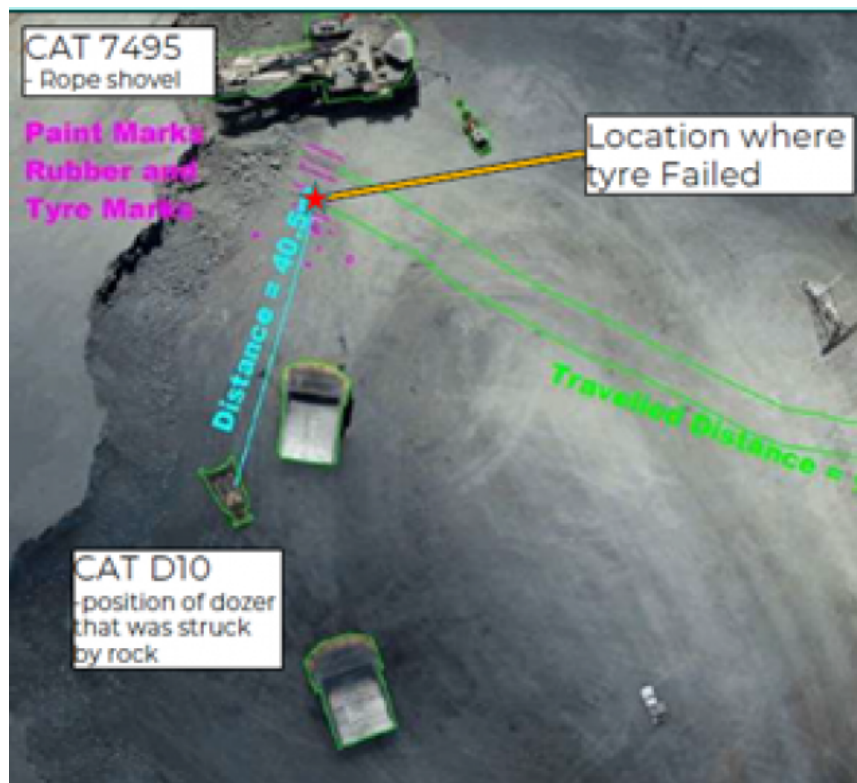
A Cat 795F rear dump was being loaded by a rope shovel when a basalt rock approximately 400mm in diameter has fallen on the offside and rolled beneath the truck unnoticed. Once loaded the truck has driven forward over the rock causing Position 6 tyre to immediately fail (figure 2). This sudden eruption caused numerous pieces of basalt rock shrapnel to eject from the floor, with one rock weighing 950 grams striking a manned Cat D10T dozer parked 40.5 metres away. This rock penetrated the dozer cabin's right-side window (figure 3) before passing through the cabin and exiting by shattering and pushing out the rear window (figure 4). The rock was later found on the catwalk behind the cabin. The dozer's operator stated that he was crouched / leaning forward in the dozer's seat at the time of the impact. The dozer at the time was waiting to conduct floor clean-up and had Impact Rated XIR Glass fitted. Position 6 tyre which was 512 hours old had been inspected earlier in the day as part of preventative tyre maintenance, and no issues were identified.

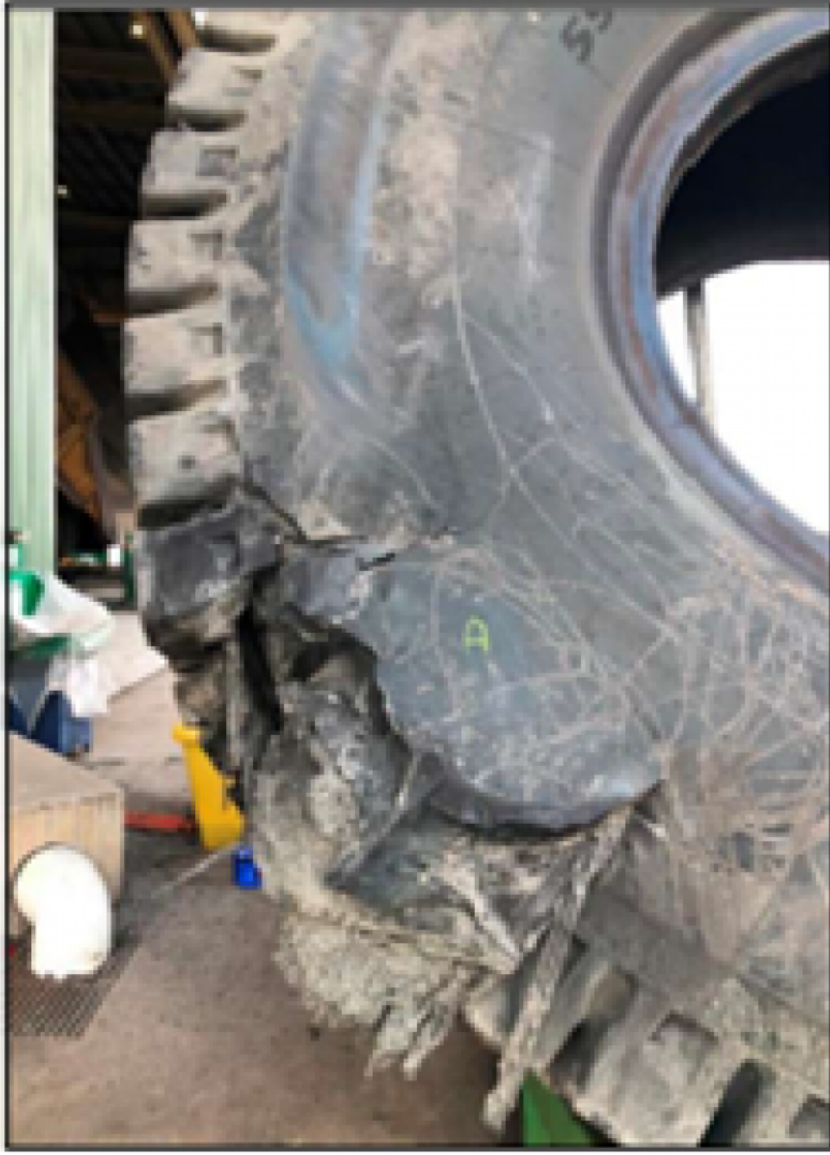
As a truck has pulled away from the excavation face a large rock, run over by Tyre Position 6, has immediately caused the failure of the tyre, causing rock shrapnel to eject from the floor.

- Basalt can have an unconfined compressive strength of 100-300 MPa.
- High strength strata can cause severe damage to tyres.
- Mining equipment parked in a potential "line of fire".

- Identify restricted work areas near excavation faces.

- Designate safe parking areas for equipment near excavated faces.
- Ensure effective risk management for excavation of high strength material (e.g., basalt).
- Ensure loading techniques minimise spillage.
- Review mining equipment to ensure Impact Rated Glass is fitted where required.
