Incident periodical

High Potential Incidents summary
Queensland Mineral Mines & Quarries Inspectorate
September 2020

Mineral Mines & Quarries Inspectorate

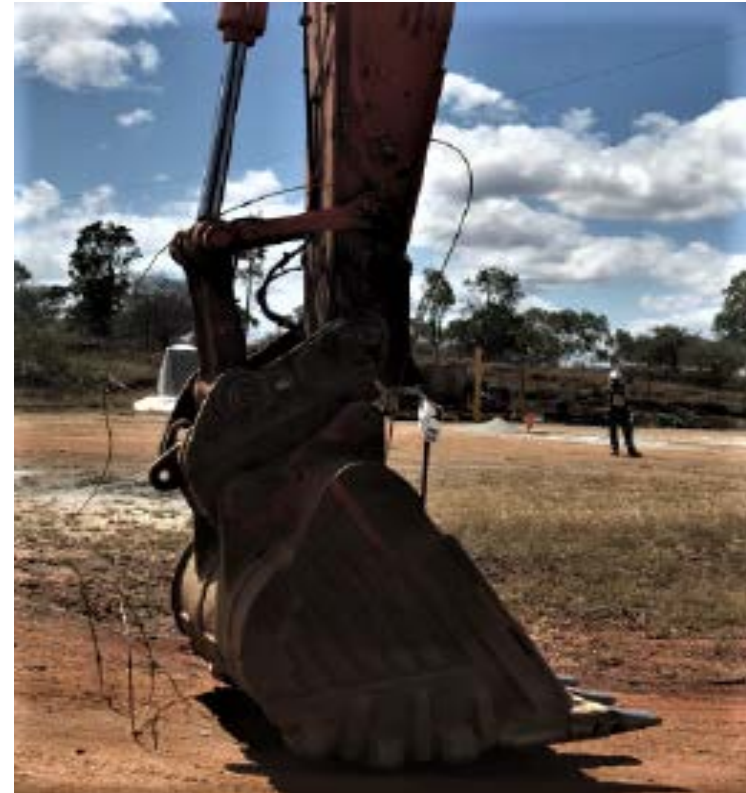
On 7 September 2020, an Excavator was travelling towards the exploration core shed area when it struck and severed the 11 kV overhead power line (OHL). The operator knew to stay in the cab which had been part of his training. The electrician also advised the operator to stay in the cab until Ergon confirmed that the power was isolated.

Conductor entangled around excavator boom

The excavator was being trammed with the boom in a raised position resulting in a maximum height of approximately 8.5 metres from ground level.

The clearance under the OHL was 6.5 metres. Even if the excavator was being trammed in its travel position the height would be approximately 4.5 metres and would still encroach the exclusion zone of the OHL.

The excavator operator was familiar with the travel route and knew the power line was there. On this occasion the operator simply forgot about it.

No warning signs were in place on the approach to the OHL.

Redesign travel ways or restrict travel to ensure alternate travel route is taken so that mobile plant does not have to travel under the OHL. [Elimination]

Preventing mobile plant from travelling under the OHL by bunding it off along its entire length as the mine have now done. [Separation]

A process to monitor control effectiveness to prevent inadvertent contact with OHLs must be implemented that includes how the monitoring is undertaken and who is responsible. [Administration]

Create an emergency response plan specifically for plant contacting an OHL [Administration]

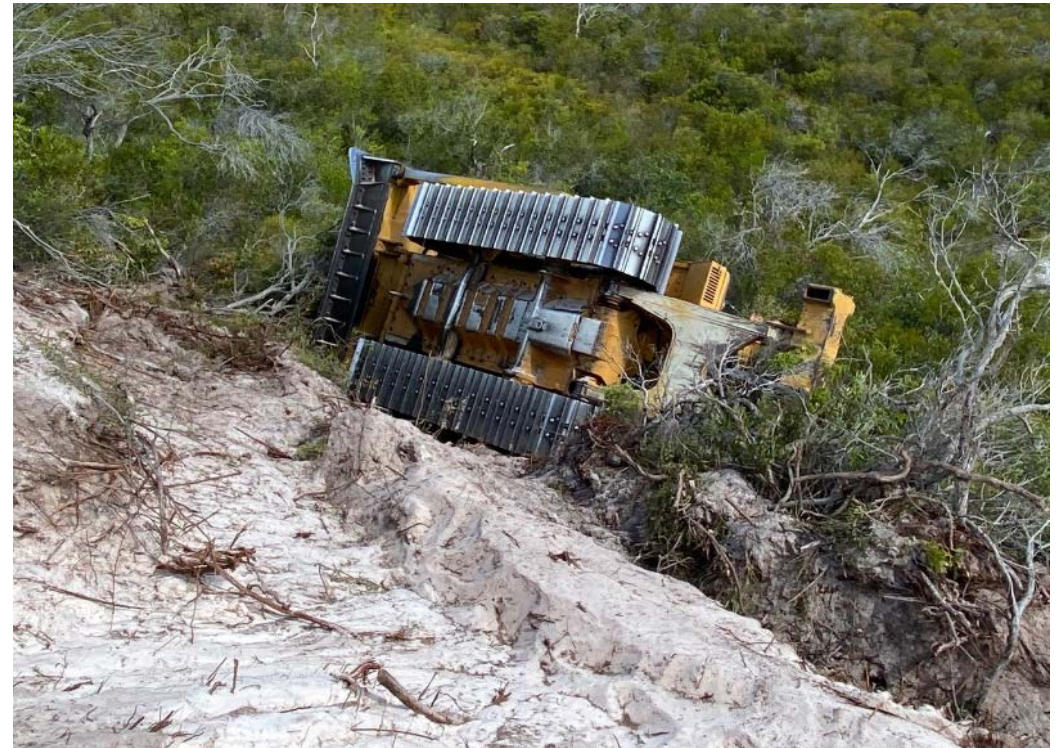
On 15 September 2020, a dozer operator was creating a track on a the ridge of a sand dune when the dozer slid sideways and veered to the right hand side. The dozer was still stable at this point and only rolled over when the operator tried to reverse back up onto the ridge. The operator was wearing the seat belt and was not injured.

The blade was raised too high, consequently no windrow was being created on the right hand side and there was no material to support the track on this side.

After the dozer slid sideways and was stable at that point, the operator did not use the radio to ask for advice from their supervisor.

The operator had not created a track by straddling a sand dune ridge before.

The workers carrying out the job safety analysis should include an operator familiar with the task. [Administration]

Effective controls must be in place to prevent uncontrolled movements associated with operating mobile plant on steep gradients. [Administration]

Operator training should be reviewed to ensure they understand that when faced with a difficult situation they should contact their supervisors for advice. [Administration]

The supervisor should check and record that operators are competent and confident they can implement the agreed controls. [Administration]

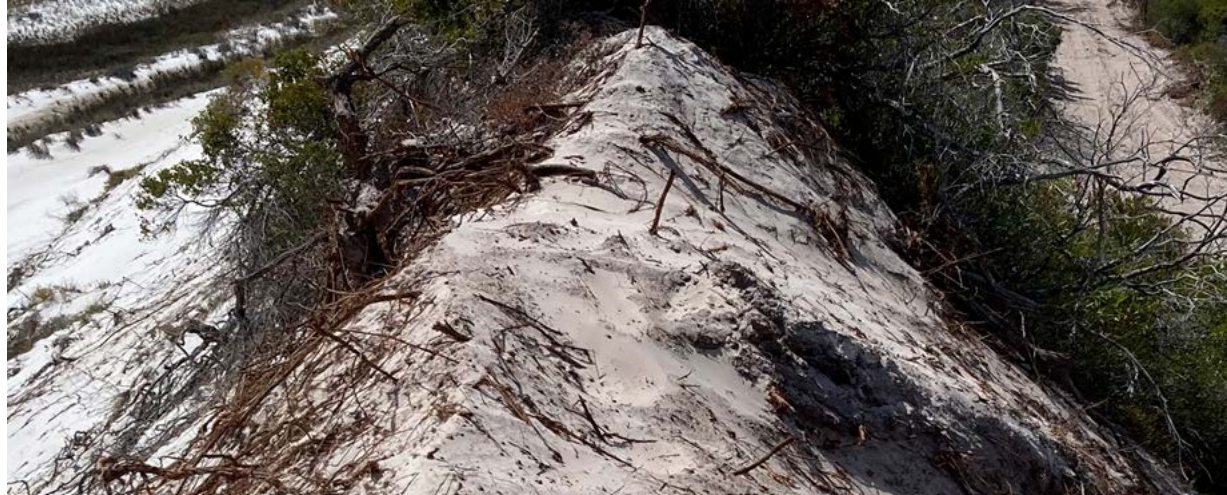
Ridge of sand dune

The technique for creating a track is to staddle the ridge and keep the blade height so that sufficient material comes around both ends of the blade to form a window on either side. This will ensure that there is a sound bed for the tracks to run on.

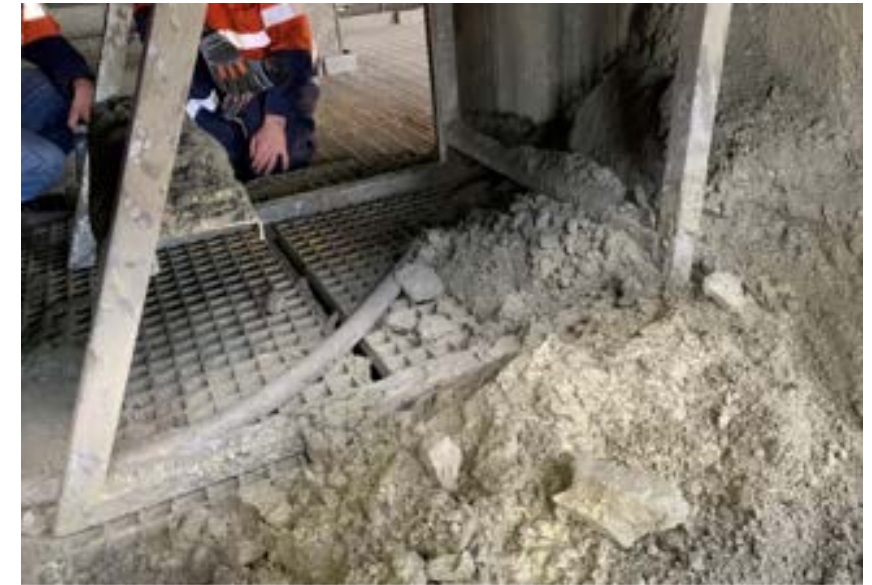
Every scheduled 24 hours the hung up product was cleaned off the inside of the chamber from the top prior to entering the chamber at the bottom. However It had become accepted practice not clean down the chamber from the top prior to entering the chamber at the bottom during breakdowns because it was assumed that the product build up would be minimal.

The Standard Work Instruction (SWI) related to cleaning the chamber from the top before entering the chamber at the bottom and was not followed. The SWI required a SLAM (Stop, Look, Analyze, and Manage) to be completed but was not found after the incident.

Inside the chamber after the incident

As proposed by the mine, eliminate the hazard by installing: [Elimination]

- Non-stick lining at the top
- An automated system to clean the chamber which will minimise the occasions that workers have to enter it.
- Review all routine tasks or practices that have evolved over time and become accepted without being risk assessed.
[Administration]
- Explain to workers why it is necessary to use on-the-job risk assessment tools even when carrying out repetitive tasks.
Consider doing risk assessment with workers not familiar with the task to identify accepted risks. [Administration]
