NZ Safety Alert

11 March 2022

Worker struck while fixing pump

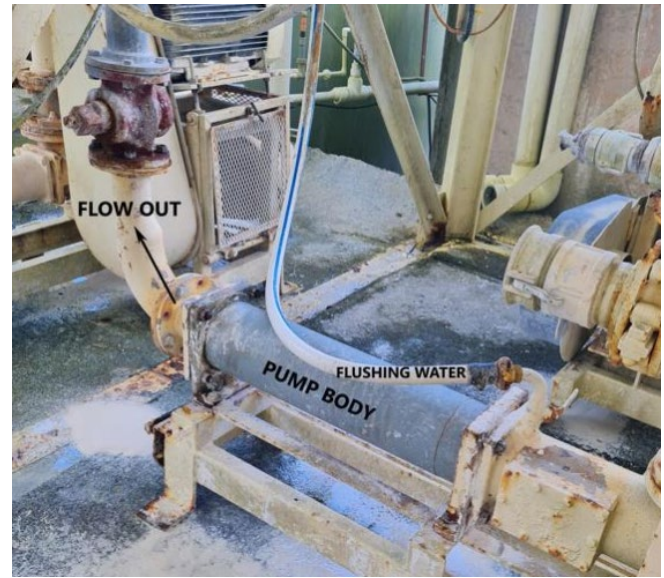
A maintenance crew were investigating over temperature in an electric motor driving a filter press pump.

The electric motor, drive belts and plumbing were removed from the pump and the pump flushed with water to try to dislodge what was jamming it. This did not clear the blockage.

While one fitter tried to free the pump by spinning the drive shaft with a spanner, the second fitter turned the flushing water back on, energising the pump. The spanner flew from the fitter's hand striking him on the elbow.

The fitter suffered a contusion and graze to his right elbow.

1. All energy sources are isolated prior to commencing any maintenance activities.
2. Ensure no-one is working on or near plant that is to be energised, without appropriate guarding or separation distance.
3. Pressure release hazards, including water pressure, are identified and appropriate controls are implemented.
