# Mine ERZ Controller sustains injuries trapped by an airlock door

Mines safety bulletin no. 180 | 14 March 2019 | Version 1

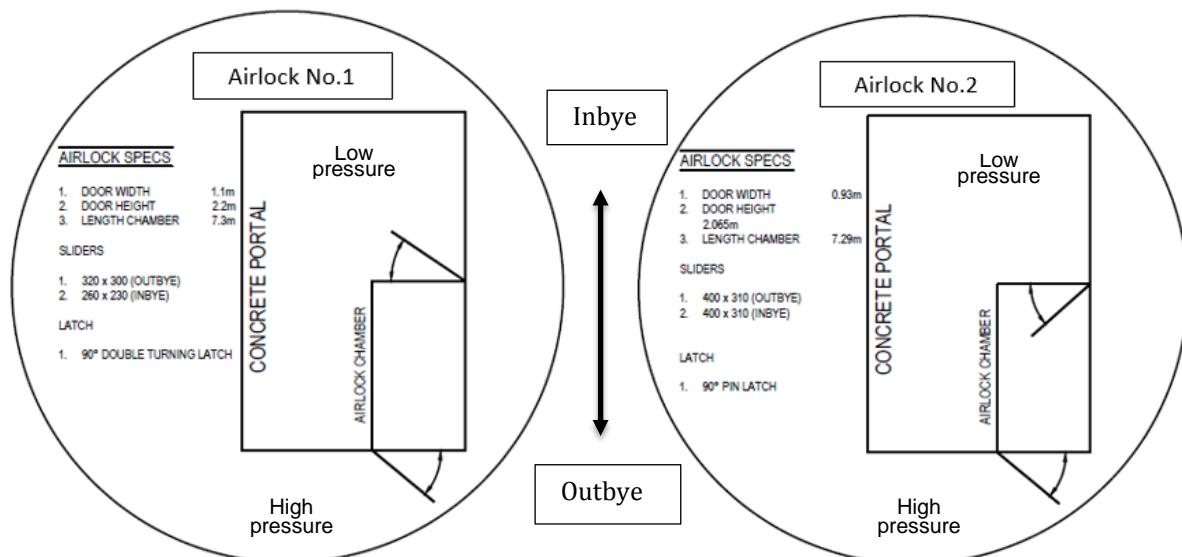
Airlock 1 (see image 1) is the design of the airlock the ERZ Controller was trapped in at the outbye door.

Airlock 2 is a common airlock design normally used for access at points with high pressure differentials.

At the time of the serious accident, up to 1981pa pressure differential appeared across the airlock where the serious injury occurred, calculated to produce 426.4kg force against the ERZ Controller's leg.

When the ERZ controller began to open the outbye door he stepped into the doorway of the airlock to push the door further open. As this occurred the inbye door of the airlock swung open, short circuiting the ventilation and causing the outbye door to slam closed, trapping the ERZ controller by the leg.

The investigation identified the mechanism for the inbye door opening was the brattice covering the inbye door shifting, as the change in pressure against it increased, and that the inbye door handle had been modified during a repair and could no longer fully latch closed.

It is plausible that the brattice shifting rapidly, the lesser area of the handle contacting the door frame and the high pressure differential, all contributed to the uncontrolled opening of the inbye door.

- There was a failure to maintain an acceptable level of risk in the workplace.
- Design of the airlock itself was fundamentally incorrect for the purpose of providing safe access from intake to return airways with a high pressure differential.

8. It is recommended Ventilation Officers establish standards for airlock design for their mine. S341(d), S350 CMSHR 2017. S30, S38, S44 CMSHA 1999.
9. Audit compliance to procedures, forms and processes for changing gas monitoring equipment locations or changing / disabling alarms. S223 & S224 CMSHR 2017.
