INCIDENT ALERT

LOCATION: CONCRETE PRODUCTS
ACTIVITY: MAINTENANCE & HOUSEKEEPING
SUB ACTIVITY: N/A

ALERT STATUS: High Potential
DATE ISSUED: 19/03/2018 14:32:28
INCIDENT No: 01486

Fatality whilst inflating a tyre on loading shovel

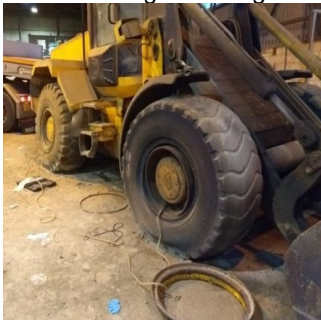
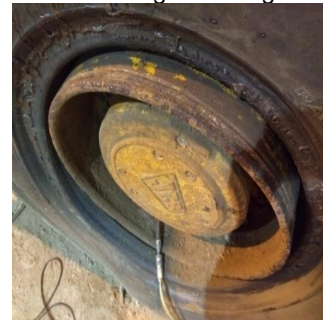
Having inflated the rear offside tyre, the IP started inflating the front offside tyre. As pressure in the tyre increased, it was forced off the wheel hub and the sealing/locking ring was projected off the wheel hub, striking the IP.

- Tyre was being inflated using the tractor unit on-board compressor and an airline that did not have any gauge, remote operating controls or any way of regulating pressure.
- Tyres were being inflated from flat whilst still attached to the machine and no restraints used.
- The IP had positioned himself in an area of danger.

- Only competent staff must undertake work on tyres.
- Any maintenance on tyres and wheels must be subject to a risk assessment and must be conducted in accordance with a documented safe working procedure.

- Safe working procedures must ensure at all times during inflation that only authorised persons are permitted in the work area and the individual conducting the inflation remains a minimum of 3m to the side of the tyre area to ensure they are clear of the trajectory zone should the tyre explode or a fault occur.

- Inflation equipment should be fitted with a gauge, remote controls and/or some way of regulating pressure
- Some organisations require that if the tyre has lost 10% or more of the recommended pressure a specialist contractor must be engaged to inspect, repair and inflate the tyre as required.
