REPORT OF INVESTIGATION

Surface Coal Mine

Fatal Machinery Accident
October 17, 2018

No. 1 Surface Mine
Princess Polly Anna Coal, Inc.
Rupert, Greenbrier County, West Virginia
ID No. 46-09473

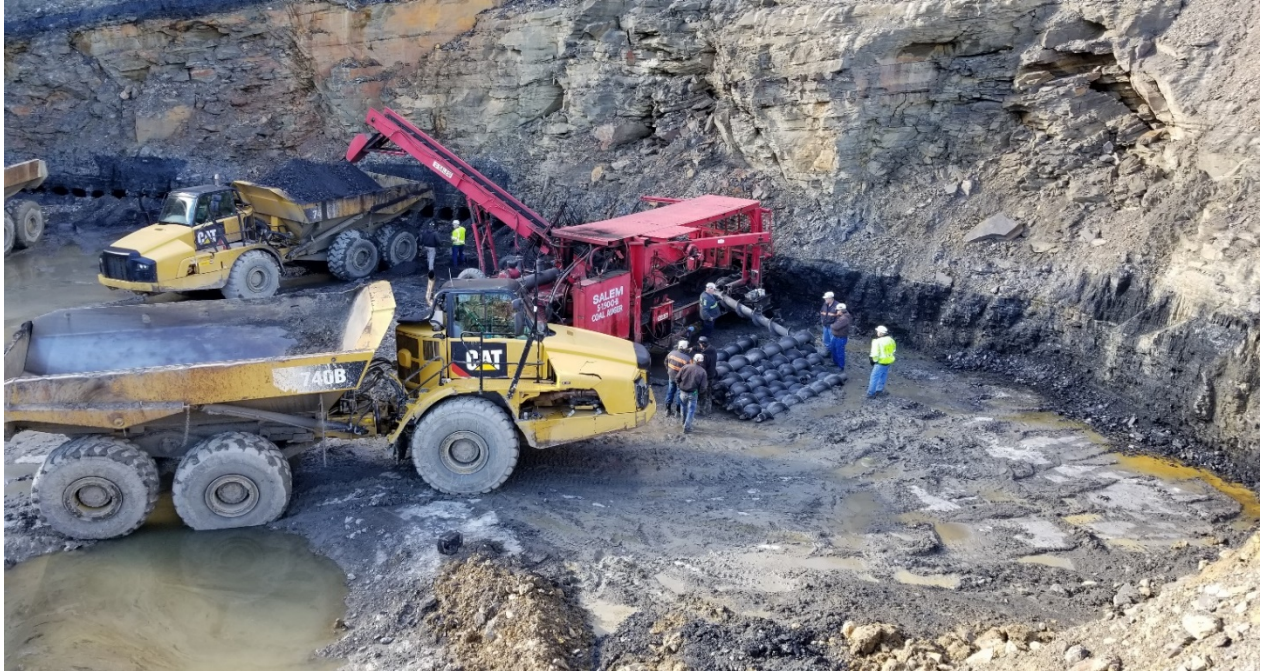
Photograph of Accident Scene

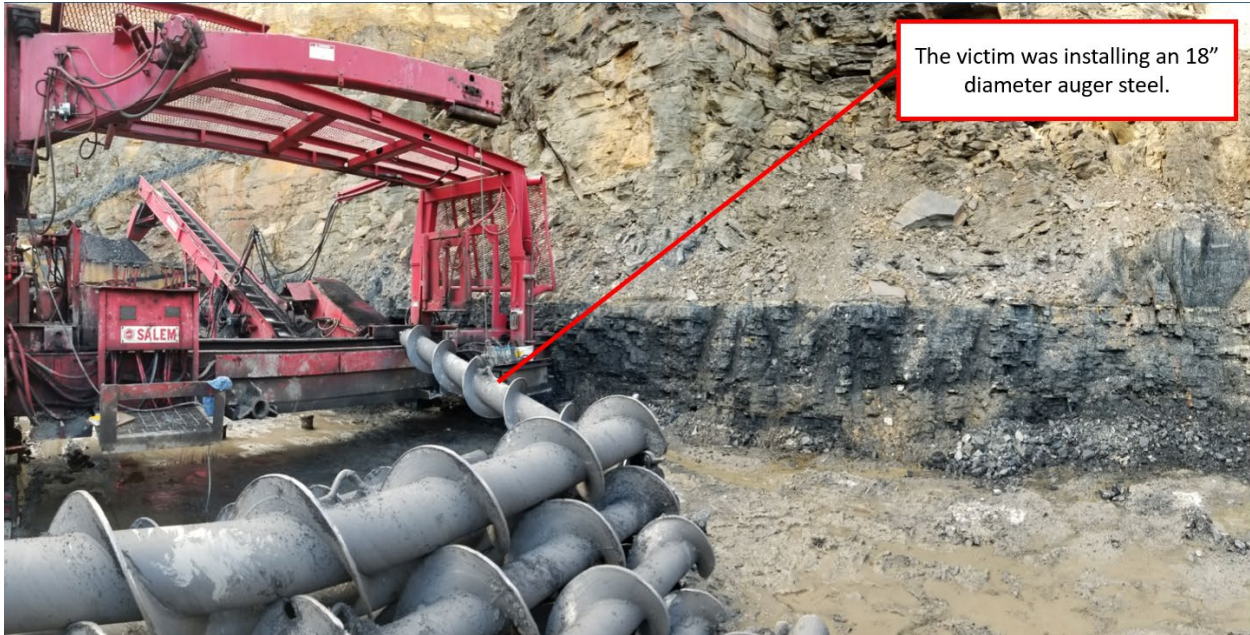
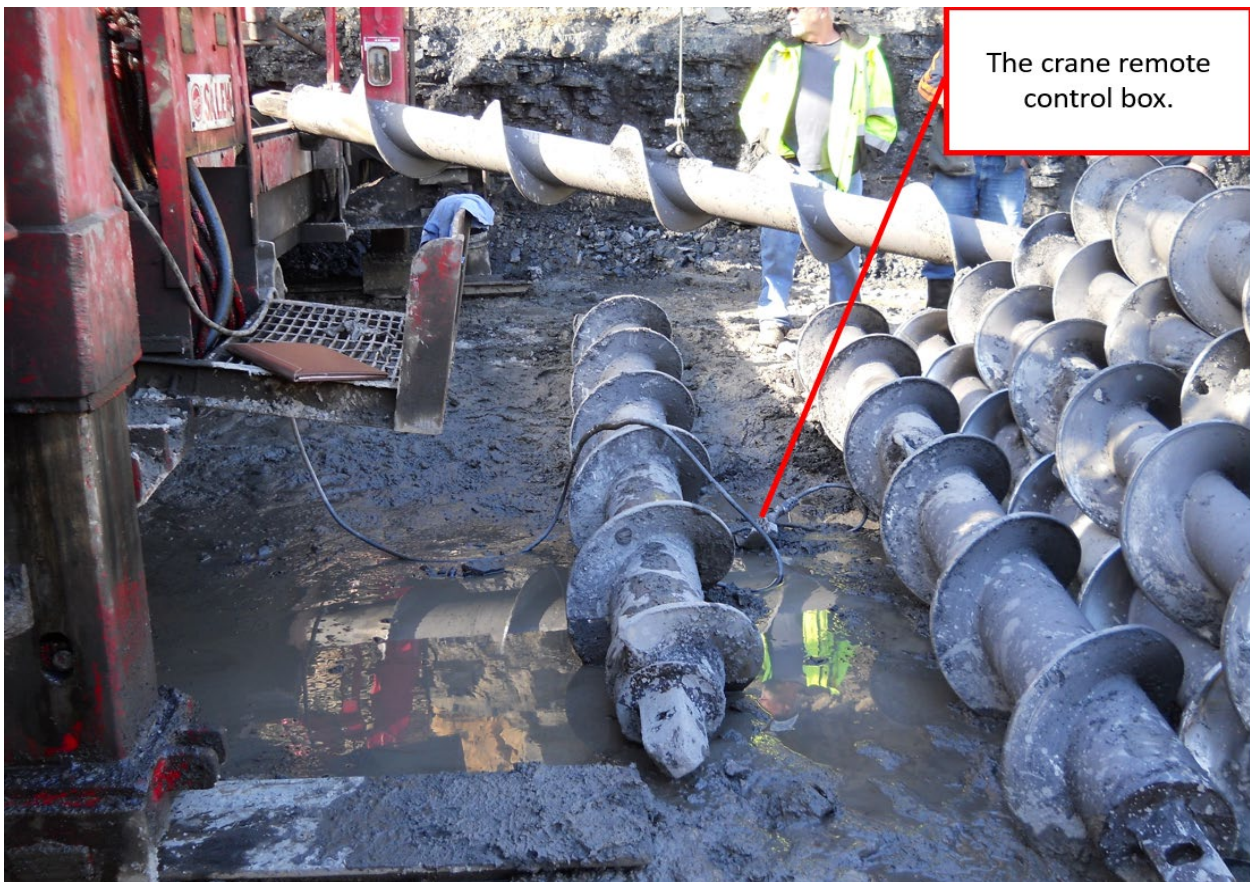
Photos of the accident scene

The auger crane boom was found to be extended out away from the auger machine with a piece of auger steel suspended on the crane rope hook. The remote crane boom controls were found on the ground near the operator deck (Appendix B). The weather was clear and 57 degrees. The ground around the auger was muddy and a stack of auger steel was stored next to the auger machine.

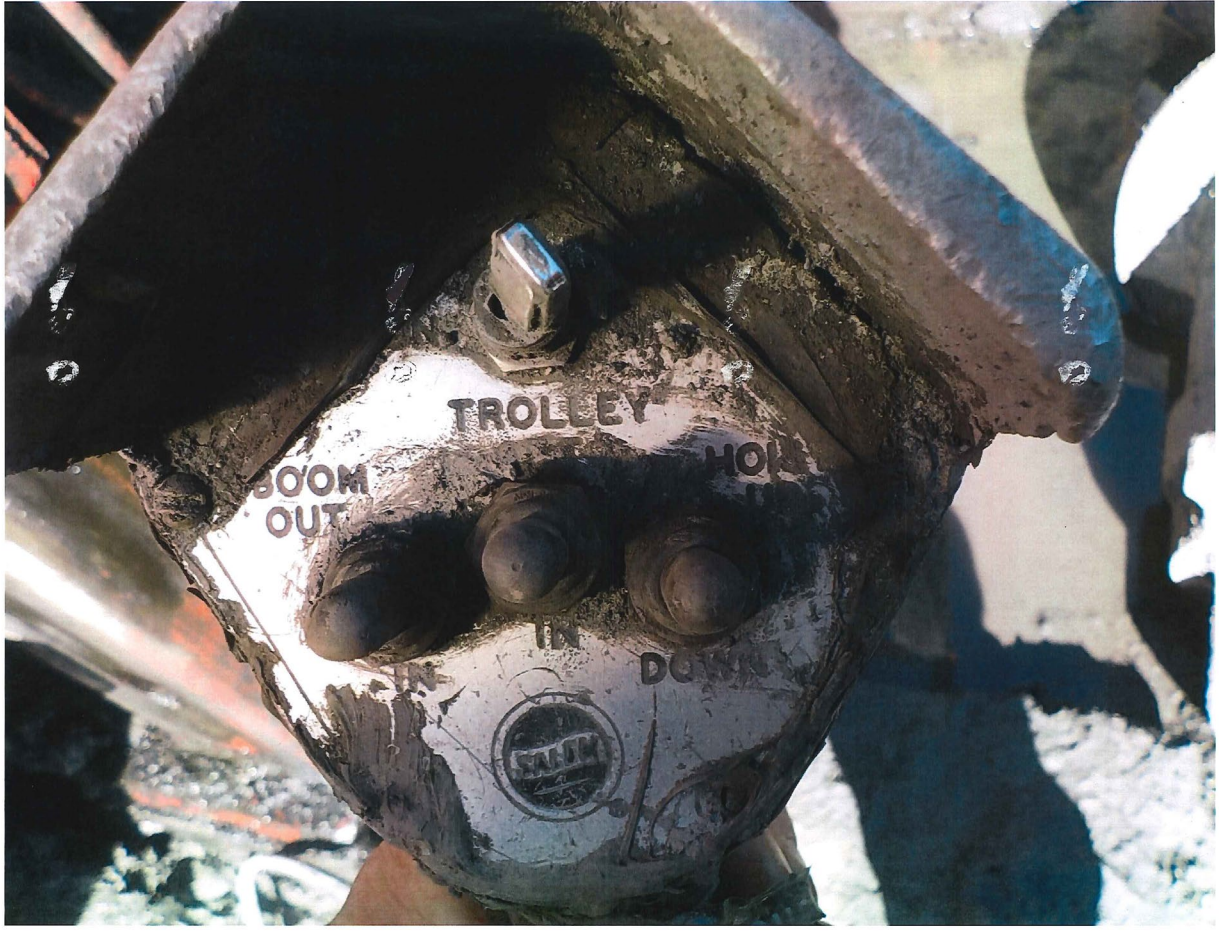
Crane Boom Hand Held Control Picture

Investigators determined there was a defect in the crane boom swing toggle switch on the crane control handset. See "boom out" and "in" in Appendix C. When tested, in several instances this switch was placed in the swing out position, but the crane boom did not swing. For it to work, the switch had to be moved back and forth a few times.

Investigators found a brass alloy water-oil-gas gate valve, not a part of the original design, on the crane boom jack that was not rated for the operating pressure of the machine. Also, an extra, unused switch marked "Trolley" was installed on the crane control (see Appendix C). This "Trolley" control served no purpose since this machine did not have an extendable boom.

Investigators determined that the remote was equipped with a crane boom in-out "Trolley" switch that was not connected because the boom did not have this capability to extend and retract the length of the boom. The investigation team inspected the controls of the auger machine and conducted tests on the auger's crane boom hydraulic functions. Investigators determined that the on/off switch on the remote control was reversed (see Appendix D). When the switch was in the "off" position, the system was actually on. Also, the crane boom would slowly swing outward without operator input. Testing showed that when the crane boom toggle switch was placed in the neutral (stopped) position, the crane boom would swing out slowly away from the machine instead of staying still. The drift rate was 70 degrees per minute when there was no load on the crane boom and 45 degrees per minute when the crane boom was carrying an auger steel.
