# SAFETY BULLETIN

## Rocks breach catch bund

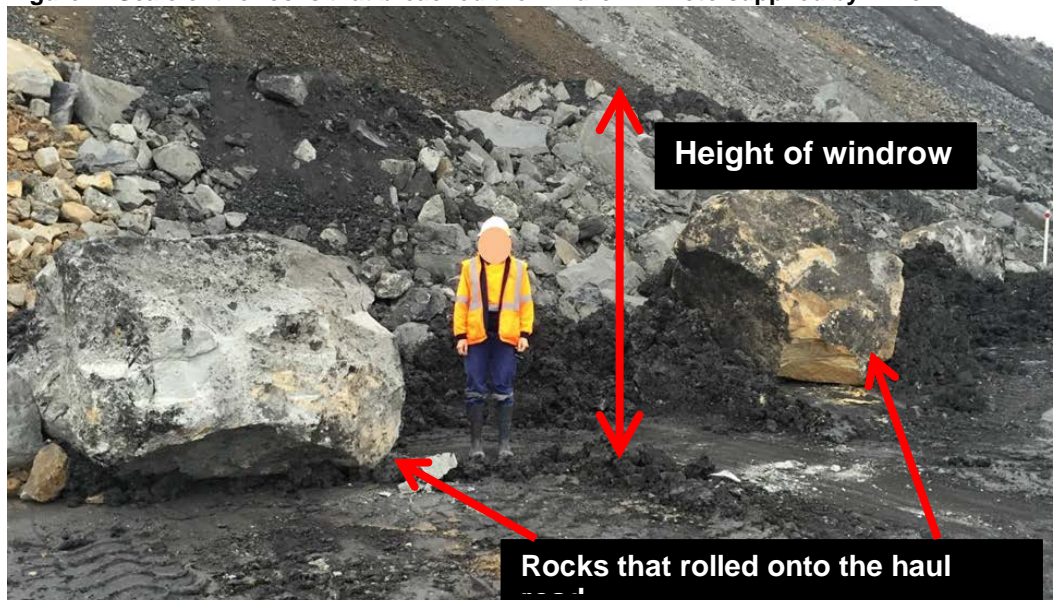
Figure 1: Scale of the rocks that breached the windrow. Photo supplied by mine.

Another truck was observed dumping their load just prior to the breach. Rocks from this load have rolled out of the tray and continued down the dump slope. They have reached the bund and, with a combination of a partially filled bund and excess momentum, they have breached the bund and come to rest near the stopped truck.

- It is poor practice to have any operations occurring below an active dump. Operations below an active dump should be avoided where possible.
- If it is unavoidable to exclude operations from below an active dump, an appropriate risk assessment of the hazard should be completed. The risk assessment should have input from those potentially at risk from the hazard.
- Additional controls must also be implemented to minimise the risk to those operating below a dump. These controls should include:
  - dumping in daylight only
  - dumping at a different location when traffic is below the dump
  - managing the size of the material so that oversized material is placed separately on the dump
  - increasing the size of the catch bund, both in terms of height and thickness

- reducing traffic, equipment and exposure levels in the work area below
- increasing inspection frequency based on the increased risk
- increasing supervision of the work being undertaken at both locations
- stopping access during the time of dumping a load.

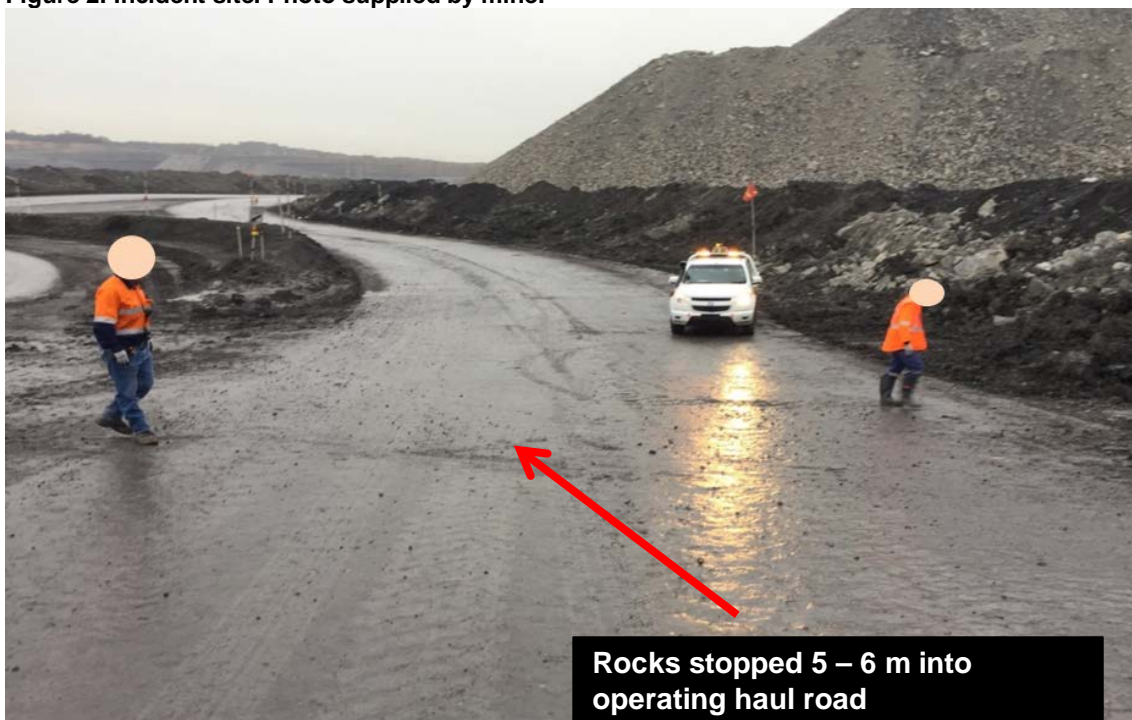
The investigation conducted by the Resources Regulator established that the dozer operator did not identify that the catch bund was filling up. The dozer operator had only inspected the dump from the top of the dump, about 40 m from the breach point. Up until the breach, no supervisor inspections of the dump had been conducted during the shift.

Figure 2: Incident site. Photo supplied by mine.
