SAFETY ALERT

INCIDENT	A0-P4 Near Miss
SUBJECT	Damaged loose tow ball.
INCIDENT DATE	13/04/21
BUSINESS UNIT	Higgins Christchurch
RADAR NUMBER	INCID-044264

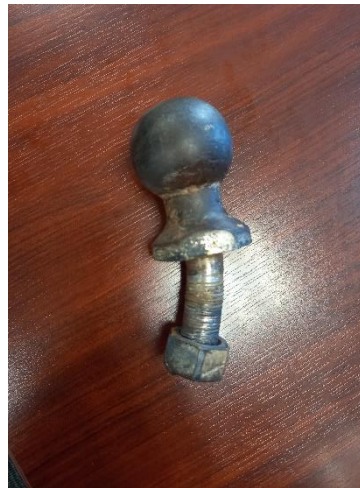
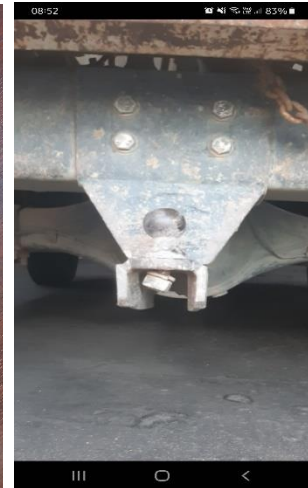
It is unclear how the nut became loose, there are signs that it has been hit which could have caused it to loosen. The main concern is that it is evident that the tow ball has been used whilst it is loose causing it to bend. The nut was only hanging on by a few threads.

There was the potential for the tow ball to come off whilst towing a trailer on the open road causing serious injury, damage or fatality.

- The tow ball was replaced
- Toolbox talk held on site to discuss

- Tow balls should be checked as part of the prestart and defects reported immediately to the workshop and a warning tag should be attached to the tow ball.
- Ensure you check the weight rating of the tow ball in conjunction draw beam certification plate and ensure you don't exceed those maximum weights.
