REPORT OF INVESTIGATION

**Fatal Machinery Accident
February 1, 2008**

**Thompson Tractor Company, Inc. (DL2)
Birmingham, Jefferson County, Alabama**

**Reed Minerals, Inc.
Jap Creek Mine
Walker County, Alabama
I.D. No. 01-02996**

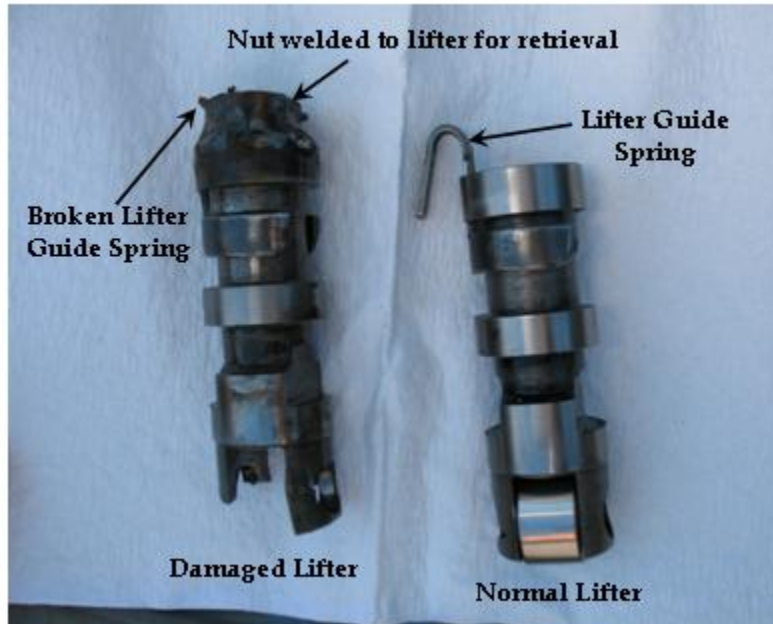
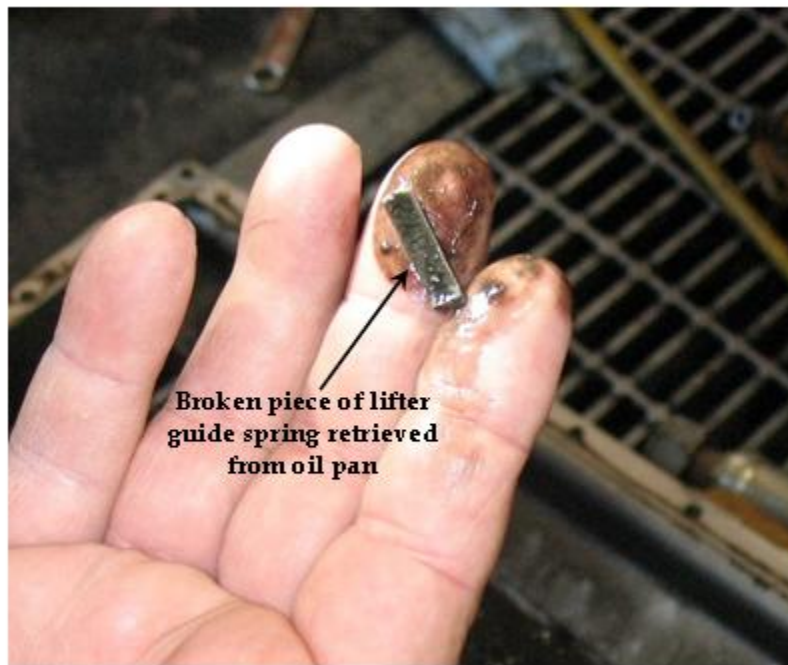
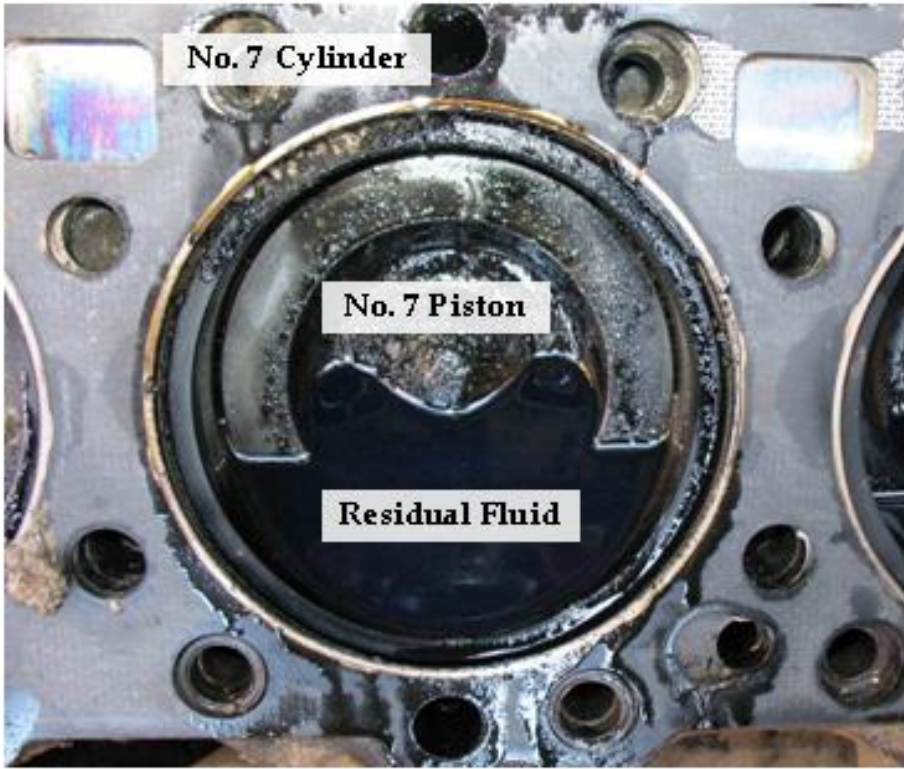
Additional Photographs

On February 6, 2008, investigators and representatives from the mine and Thompson witnessed the removal of the cylinder heads by Frost and Peterman. Residual fluid was observed in the number 7 cylinder (see Appendix B). Nothing internal to the piston cylinder or combustion chamber was observed to be broken. Engine components were examined for damage. All previously removed hardware was identified and counted and nothing was missing. It was observed, however, that a lifter guide spring was broken, indicating a possible failed lifter or camshaft lobe. The lifter was removed and observed to be damaged (see Appendix B). The lifter and guide spring are external to the piston cylinder and any broken pieces would have fallen into the engine oil pan through the oil drains. The engine was subsequently removed from the dozer and taken to the Thompson facility near Birmingham, Alabama, for further inspection.

On February 11, 2008, investigators traveled to the Thompson facility to observe additional dismantlement of the engine. The oil filters contained small metal shavings that, according to shop mechanics, appeared to be lifter fragments. The broken piece of the guide spring was found in the oil pan (see Appendix B) along with additional metal from the damaged lifter.

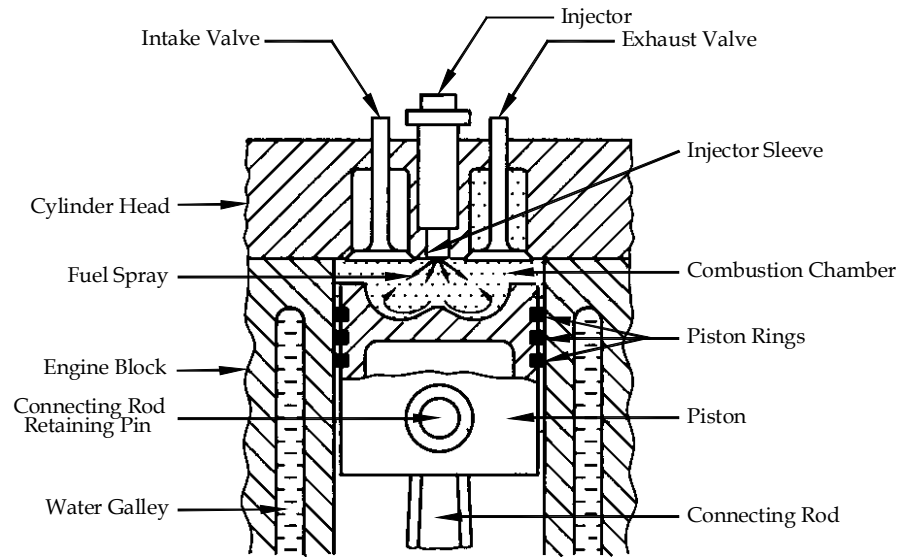
SKETCH 1

Typical sketch showing injector in place

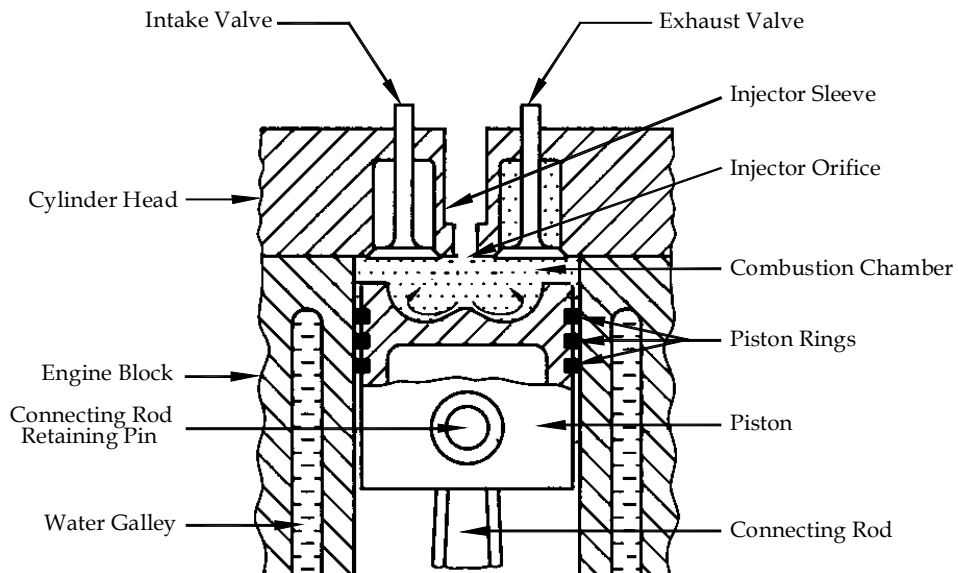
SKETCH 2

Next, the valve cover, valve rocker arms, and injector at the number 7 cylinder were removed. With the rocker arms removed from the engine head, all 4 valves (2 intake valves and 2 exhaust valves) of the number 7 cylinder were held in the closed position by the valve springs. Stratton apparently made the determination that there was nothing wrong with the injector and turned his attention to the lifters. According to Thompson officials, the determination that there was a more significant problem with the engine was most likely made after observing a broken lifter guide spring and realizing that the lifter was probably damaged. Stratton tried to retrieve the questionable lifter but was unable to do so. In an attempt to observe movement of the lifter and to place it into a better position for retrieval, he requested that Frost “bump” the engine. Stratton was leaning over the open injector sleeve opening when Frost “bumped” the engine. Stratton had not removed residual fluid from the number 7 cylinder and diesel fuel was ejected from the open 0.33-inch diameter injector sleeve orifice, which was the only opening to the atmosphere, under pressure at a high velocity and struck Stratton in the left eye. Stratton was not wearing eye protection. (See Appendix C for illustrative cylinder sketches.)

Typical sketch showing injector removed
