Week ending 23 May 2018

This incident summary provides information on reportable incidents and safety advice for the NSW mining industry. To report an incident to the NSW Resources Regulator: phone 1300 814 609 24 hours a day, 7 days a week.

Summarised incidents

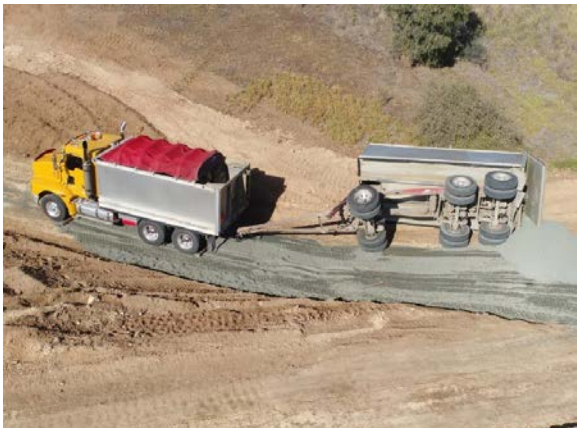
Incident type	Summary	Recommendations to industry
Dangerous incident SinNot- 2018/00801	<p>A dog trailer rolled over while tipping gravel on site. As the truck moved forward, the trailer wheels went over soft ground and the trailer rolled onto its right-hand side.</p>

<p>Areas where vehicles are raising a load should be monitored for hazards such as cross grades, uneven ground, soft points and foreign materials.</p>

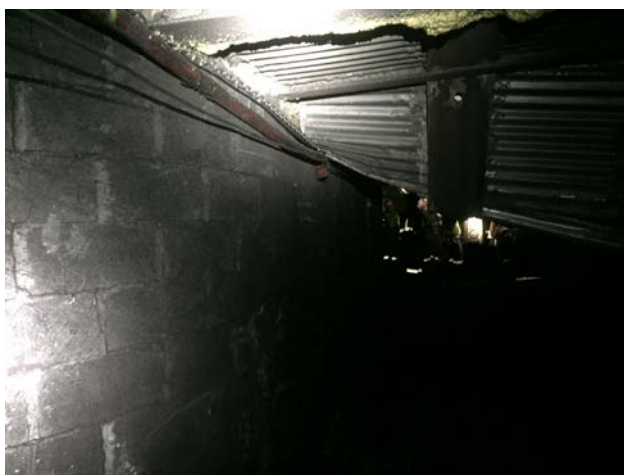
Dangerous incident
SinNot- 2018/00796

A ventilation overcast and compressed air line were damaged when they were contacted by a shuttle car being towed by a LHD. The overcast was pulled down as a result of the contact.

The overcast was part of ventilation circuit to waste areas, and ventilation to working parts of the mine were not impacted.

Before relocating large equipment in underground mines, a profile run should be undertaken to protect mine infrastructure from damage during the task.

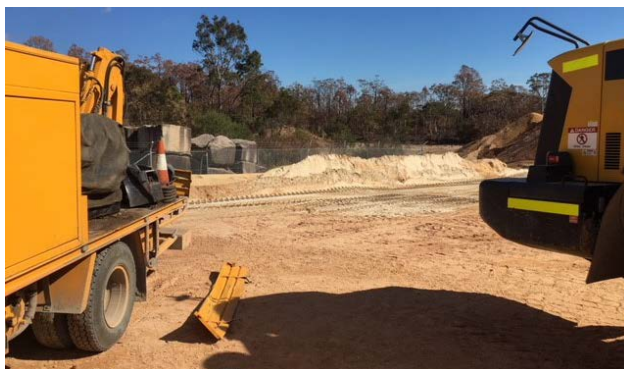
Dangerous incident
SinNot- 2018/00793

A service truck and front-end loader collided. The truck entered the loader's work area and incorrectly anticipated the loader movements. No positive communication was conducted.

Safety bulletin [SB18-06 Lack of positive communications](#) was published in April 2018. This alert addresses this incident. Positive communication systems need to include all workers on site including contractors.

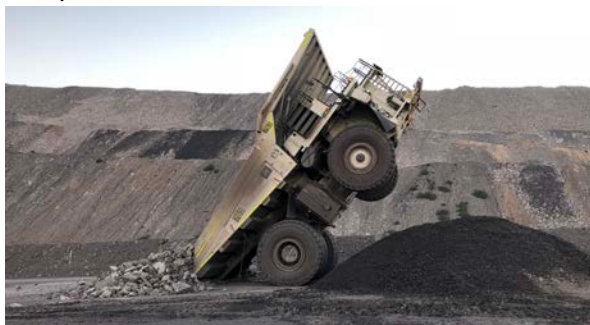
Dangerous incident
SinNot- 2018/00789

A operator was unable to safely exit from the cab of their loaded haul truck for three hours after inadvertently hitting the brake or accelerator pedal, causing the truck to tip up and sit on the rear of its tray. The truck was queued on a ramp and started to roll backwards. The operator initially failed to detect this movement and reacted suddenly. The operator reported they may have had a micro-sleep.

Schedule 2 of the Work Health and Safety (Mines and Petroleum Sites) Regulation 2014 includes the requirement that the health control plan must address fitness for work, which includes fatigue.

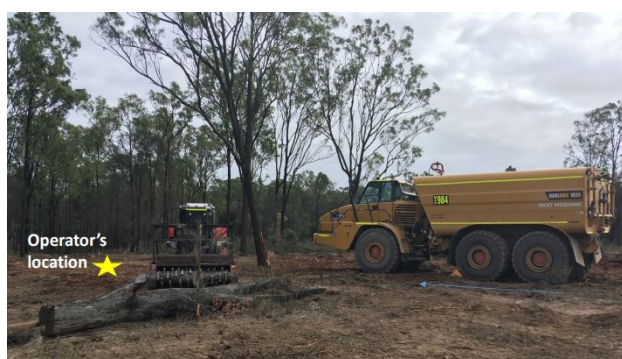
Dangerous incident
SinNot- 2018/00781

An articulated water cart hit a tree. The operator exited the machine, it then rolled forward 10 metres into the tree.

The principal hazard management plan for roads or other vehicle operating areas should include procedures detailing the requirement that mobile equipment is parked fundamentally stable.

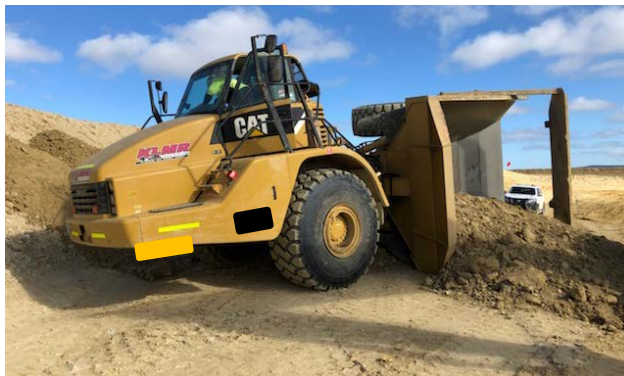
Dangerous incident
SinNot- 2018/00779

An articulated dump truck has rolled. The truck was tipping its load when the incident occurred.

This is the 22nd reported roll-over of articulated dump truck

in the past 12 months, and has been the subject of recent safety alerts.

Areas where vehicles are raising a load should be monitored for hazards such as cross grades, uneven ground, soft points and foreign materials.

The Resources Regulator considers this trend is intolerable and will be undertaking a focused compliance campaign on the operation of all terrain dump trucks over the coming weeks, with a zero-tolerance approach to less-than-adequate operating procedures and potentially defective plant.

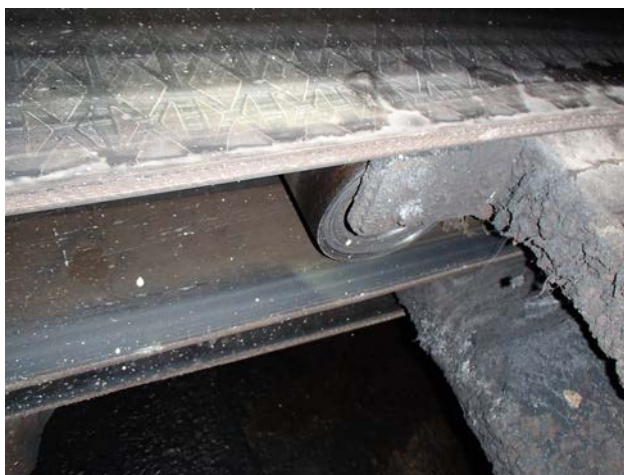
Dangerous incident
SinNot- 2018/00775

A fire occurred in the loop take-up of a trunk conveyor. The cause of the fire was identified as a collapsed return roller.

Failure of conveyor idlers is a known risk. Controls should include:

1. routine belt inspections where the focus is on thoroughly completing the task
2. condition monitoring
3. CO detectors in a designated location.

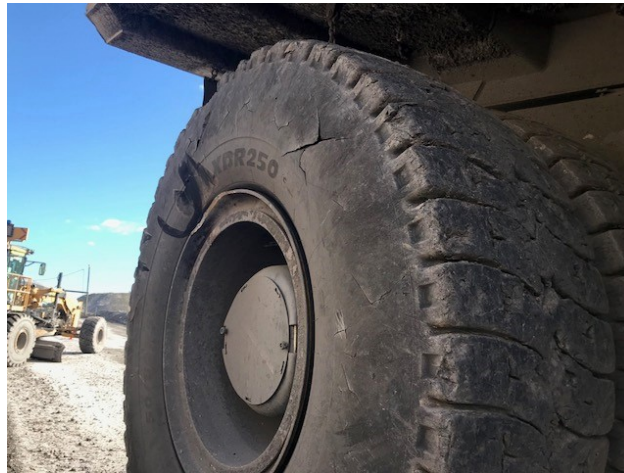
Dangerous incident
SinNot- 2018/00773

A collision occurred between a grader and haul truck. The grader was travelling down a ramp when the operator reported to have had a micro sleep and travelled toward the haul truck travelling up the ramp. The front of the grader made contact with the sidewall of the truck tyres.

Schedule 2 of the Work Health and Safety (Mines and Petroleum Sites) Regulation 2014 includes the requirement that the health control plan must address fitness for work, which includes fatigue.

Segregation between vehicles travelling in opposite directions should be

considered when developing the principal hazard management plan for roads or other vehicle operating areas.
