Dangerous incident | IncNot0041771

Open cut coal Roads or other vehicle operating areas

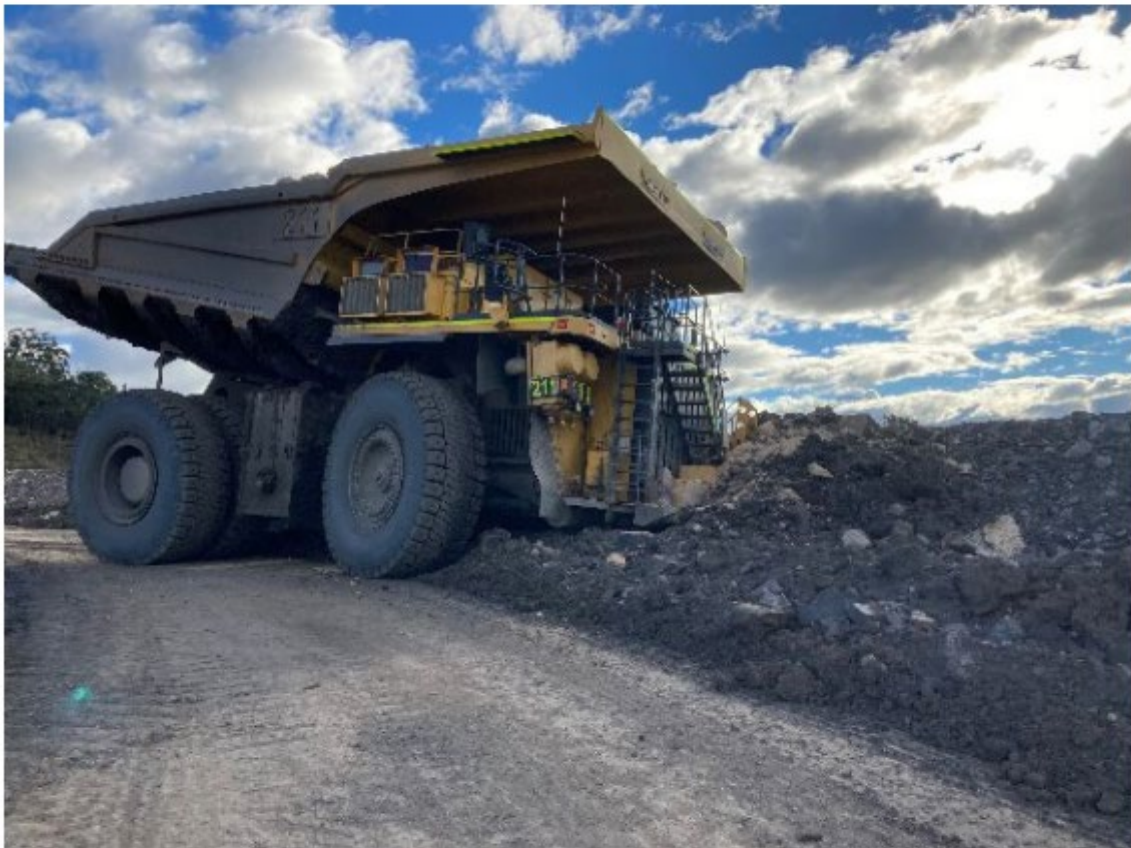
Summary: While descending a ramp, a haul truck gained speed and exceeded the operating range of the retard system. The operator failed to apply the service brake in time and was unable to safely negotiate a 90 degree corner at the base of the ramp. The truck hit the left side windrow.

Comments to industry: Workers must operate vehicles at a speed that is appropriate to the prevailing conditions. Engineering controls that minimise the risk of loss of control should be considered, including the use of speed-limiting devices, speed monitoring, and alarms. Mobile plant operating characteristics, including stopping distances, maneuverability and speeds must be considered when developing control measures to manage the risks of operating vehicles. This should consider both loaded and unloaded vehicles.
