# WEEKLY INCIDENT SUMMARY

Week ending Friday 13 December 2019

**Mine safety reference** ISR19-49

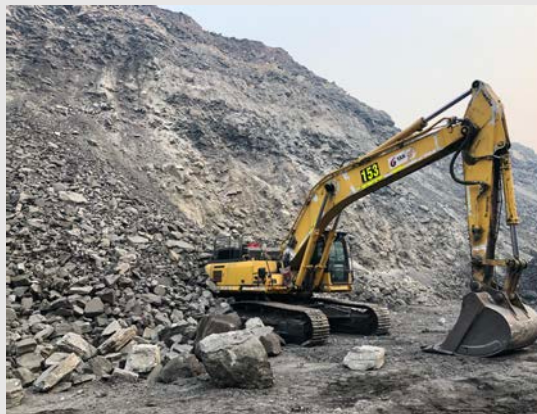
High potential  
incident  
IncNot0036250

A substantial amount of rock fell from a low wall in an open cut mine, hitting an excavator. The excavator was not being operated at the time of the incident and no workers were in the vicinity at the time the fall occurred.

Operators and supervisors should be trained in geological hazard identification and must implement effective controls including, but not limited to, installing catch berms, water management and set-back distances for parking up machines. The minimum controls implemented must be defined in the principal hazard management plan (PHMP) - taking into account the level of risk.

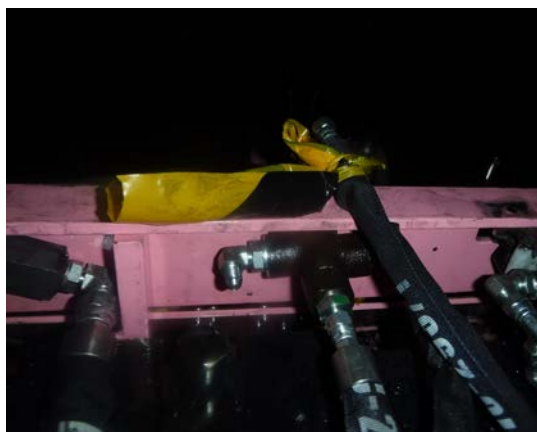
Dangerous  
incident  
IncNot0036275

Operators were fault finding on an Airtrack hydraulic circuit. Upon repressurisation of the load sense circuit (about 25 Bar standby pressure), an operator was hit in the neck by a quarter inch hydraulic hose and was covered in hydraulic oil. The operator was cleared of any fluid injection injuries.

Mine operators are reminded that when equipment is being tested after maintenance and repairs, effective no standing zones are to be put in place that remove workers from the line of fire if a failure occurs.

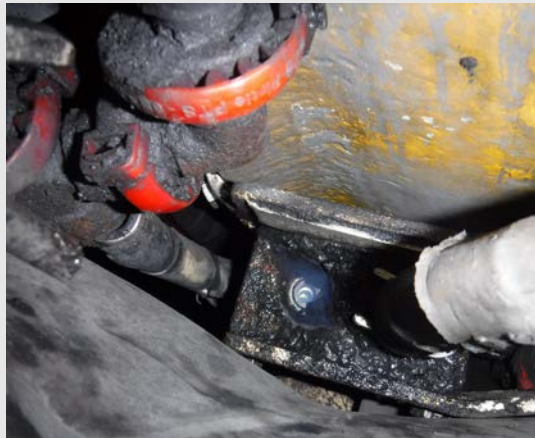
Dangerous  
incident  
IncNot0036300

While installing a roof support on the longwall installation face, a fitting failed on the power take off (PTO) manifold block resulted in the fitter being sprayed with Solcenic oil. The fitter was standing about 50 centimetres away at the time of the fluid release. The procedure identified controls that would remove people from the area, however these were not implemented

When tasks cannot be completed in line with the procedures provided, workers must stop the task and, in consultation with their supervisor, implement additional controls to maintain an equivalent level of safety. The recommendations from IncNot0036275 (above) must also be considered.

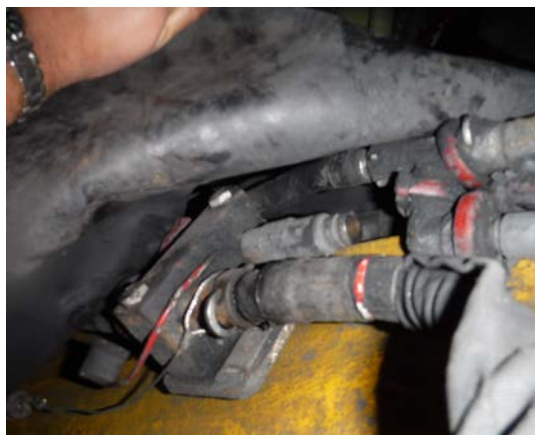
Dangerous  
incident  
IncNot0036240

A PTO supply hose failed during a longwall installation. The hose was installed and pressurised for about five minutes before it failed. The failure occurred at the ferrule and was a clean break. No-one was hit by the release of fluid. The hose was sent for testing to determine the cause of failure.

With any equipment failure, the mine has an obligation to determine the cause to ensure a reoccurrence does not happen. The use of metallurgical specialist to assist mine personnel to determine causes is one method mines have of ensuring this is done thoroughly.
