# NZ Safety Alert

18 September 2020

## Near Miss - Failure to lockout

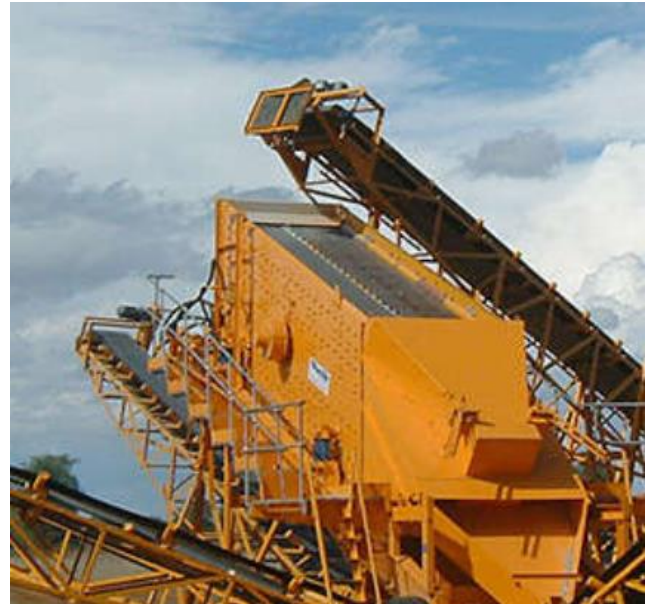
The workshop supervisor went to assist a fitter in diagnosing a bearing failure on a conveyor head drum over a screen. The problem was on the head drum side of the gearbox and could not be seen clearly from the ground. The fitter had isolated the plant.

The Supervisor told the fitter that when he was up on the screen, he would give hand signals to start and stop the conveyor so he could inspect the bearing assembly while it was running.

The Supervisor had unguarded access to nip points while the plant was running and also did not use any fall protection to secure himself while climbing up to the area.

There was no injury or damage resulting from the incident.

1. All energy sources, including electricity, hydraulic fluid, compressed air, stalled loaded conveyors etc. are isolated prior to commencing any work on plant, and not reenergised until work is completed.
2. Fall hazards such as poor access and areas where workers can fall from height are identified in risk assessments.
3. All workers are trained and regularly assessed as competent in isolation procedures.
