# HPI Alert Part 1

| Incident Title: Combined Alert for Burst Services (Sewer and Water) in Excavations | | | Date of issue: 28 Oct 2019 | |

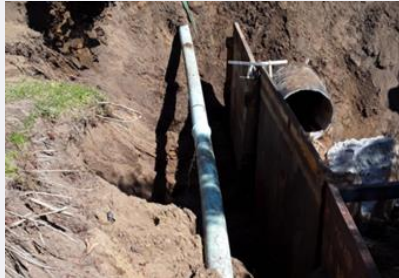
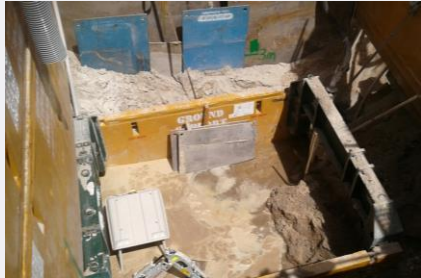
| Incident Title: Combined Alert for Burst Services (Sewer and Water) in Excavations | | | Date of issue: 28 Oct 2019 | |
|--|---|---|---|--|
| | <p><b>Burst Water Main (INC-057338)</b><br/>A pressure main failed causing a significant amount of water to enter an excavation.</p> <p>The workers had previously removed an anchor block which had been supporting the 150 PVC water main. This heavily bowed the water main causing the internal rubber ring to be dislodged and water to start filling the excavation.</p> <p>Workers then shut existing valves to isolate the water main without Water Corporation consent. This resulted in an unplanned outage to approximately 70 customers.</p> | <p><b>Burst Sewer (INC-057347)</b><br/>A worker became trapped when the side of an excavation collapsed.</p> <p>The worker was repairing shoring in the bottom of a deep excavation when the side of the excavation gave way. The workers legs were pinned and he was quickly retrieved and taken for medical examination.</p> <p>Shortly afterwards, the recently installed sewer bypass failed and sewerage began filling the excavation. A 1.5 tonne excavator within the excavation was engulfed.</p> | | |

| Incident Title: Combined Alert for Burst Services (Sewer and Water) in Excavations | | | Date of issue: 28 Oct 2019 | |
|--|---|---|---|--|
| <b>What immediate corrective actions were taken</b> | <ul style="list-style-type: none"> <li>Water Corporation operations were notified and attended site to repair the burst water main and install an alternate sewer bypass.</li> <li>An independent investigation has been established.</li> </ul> | | | |
