NZ Safety Alert

25 November 2022

Tyre & rim detach from dump truck

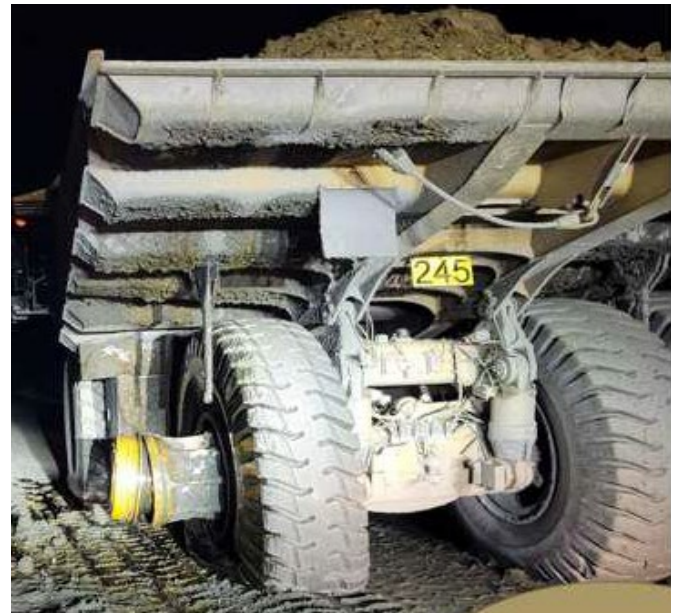
While operating a dump truck on a haul road, the position 3 tyre & rim detached from dump truck. The truck was hauling waste on a flat haul road and was approximately 2.5 hours into night shift. No one was injured.

A post-incident mechanical inspection on the truck confirmed that the replacement tyre rim was not prepared correctly by the tyre fitter/mechanics. Grease left on the rim enabled the 52 nuts to come loose from the bolts, causing the tyre and rim to fall off the truck.

1. Pre-start inspections are conducted on all mobile plant before use on any shift.
2. You review your tyre and rim procedures, including those of contractors, to ensure that all hazards have been identified and controlled.
3. All tyre fitters/mechanics are adequately trained and assessed as competent to work on tyres and rims.
