PLANNED INSPECTION PROGRAM

# Consolidated report – Structural integrity of coal handling and preparation plants

**November 2017**

**Planning &  
Environment**  
Resources Regulator

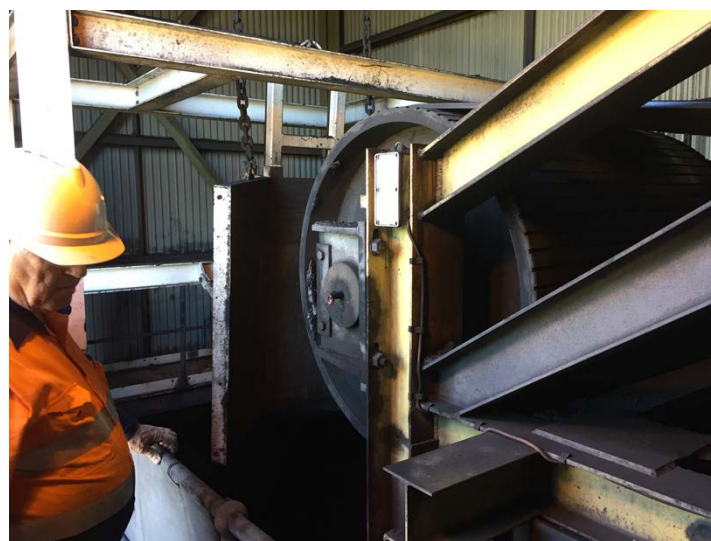
**Figure 5: Drift conveyor jib pulley.**

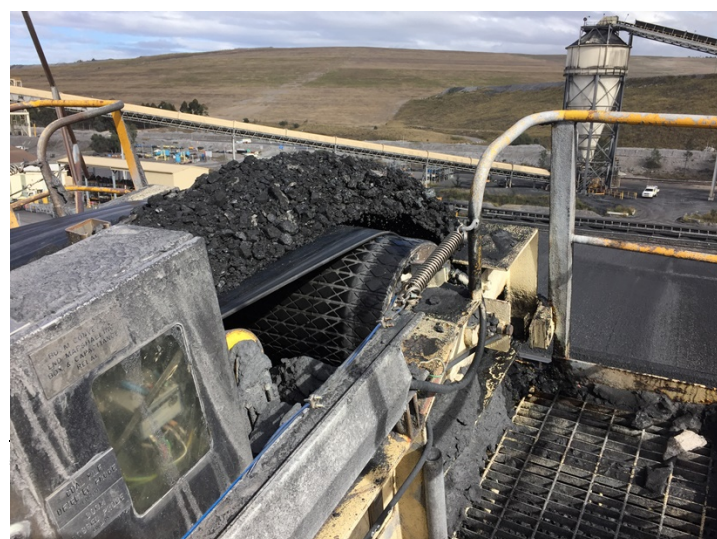
**Figure 7: Luffing stacker jib pulley.**

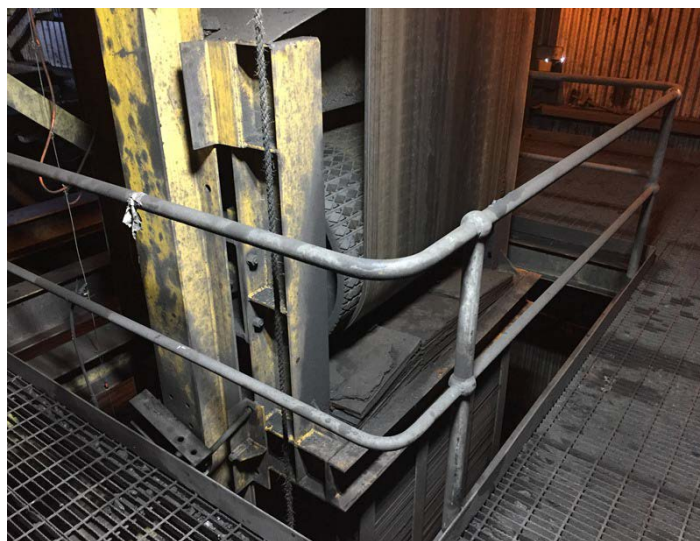
**Figure 6: Drift conveyor LTU pulley.**

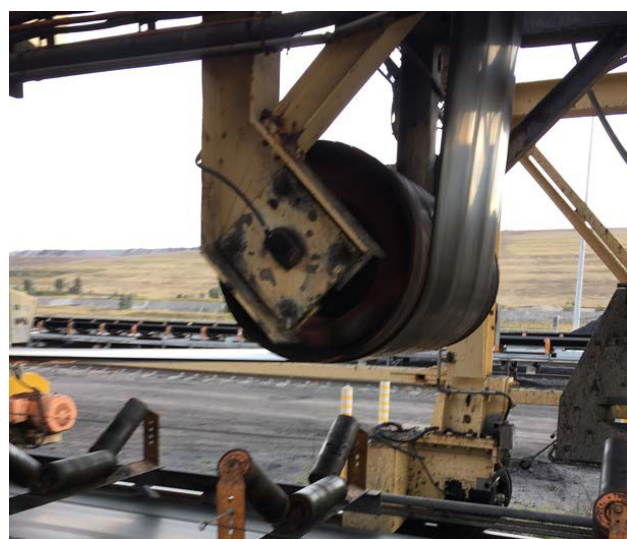
**Figure 8: Luffing stacker bottom bend pulley.**

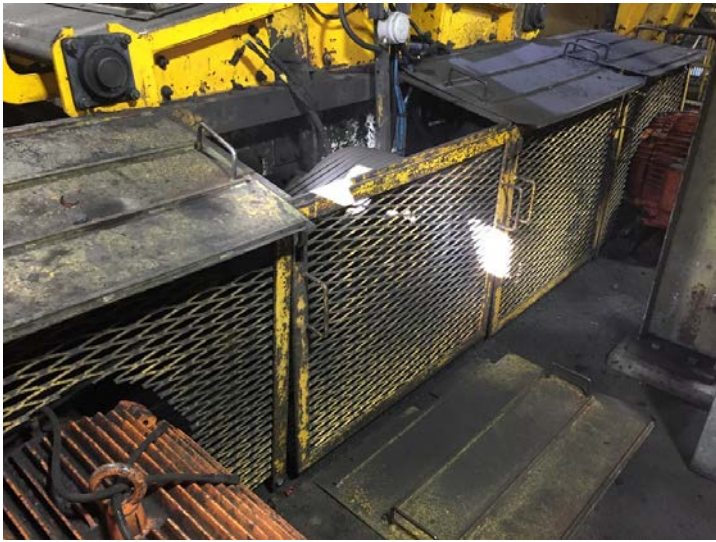
**Figure 9: Crusher vee belt drive cover left off while operating pulley.**

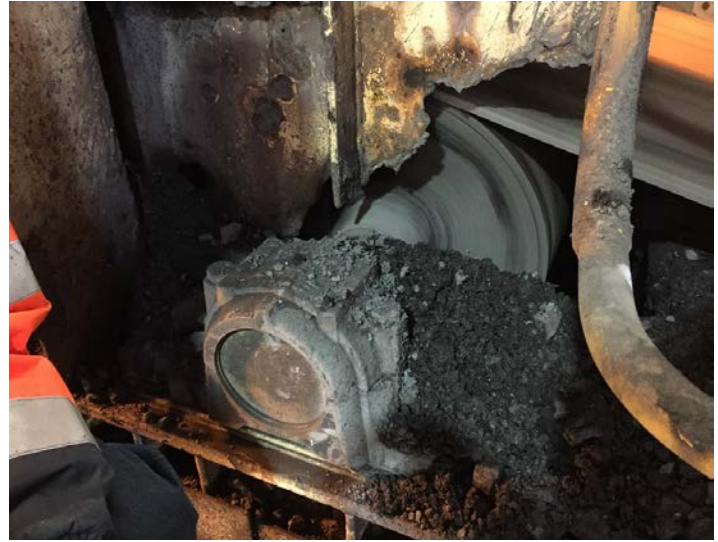
**Figure 10: Corroded head chute allows access to snub pulley.**

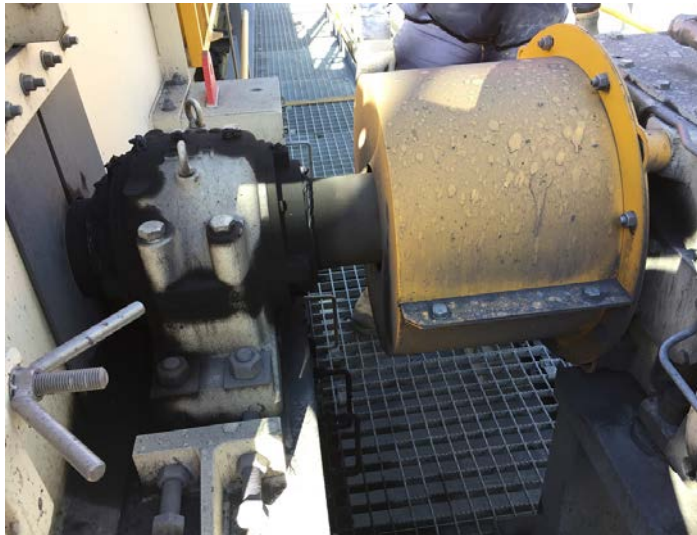
**Figure 11: Exposed rotating shafts on conveyor drive.**

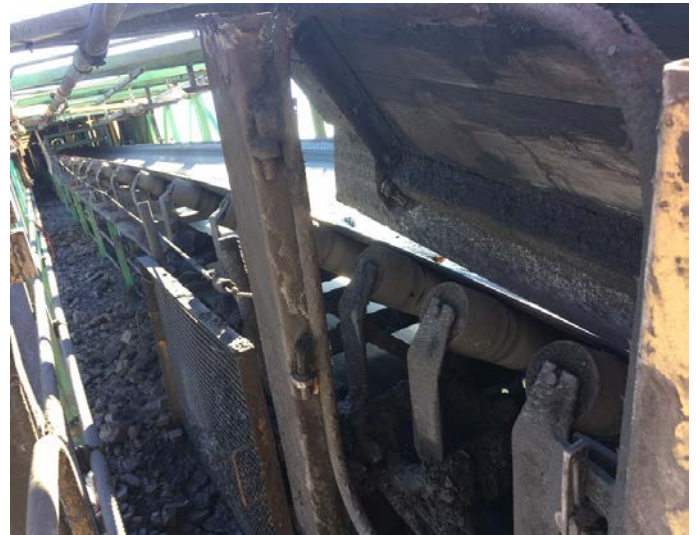
**Figure 12: Guard mesh and part of frame corroded.**

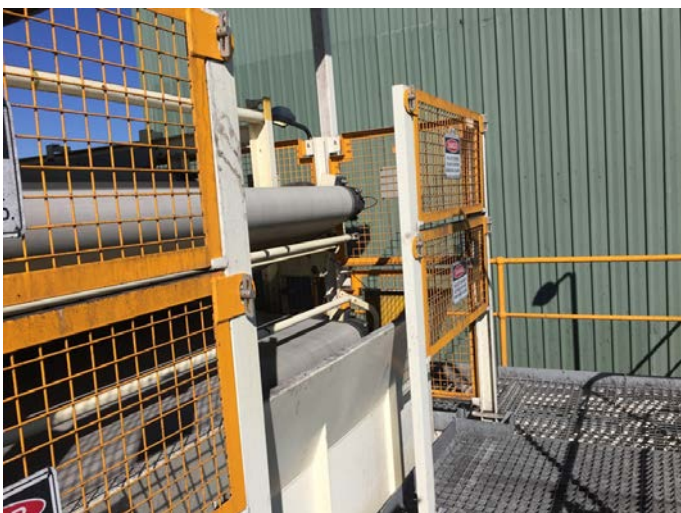
**Figure 13: Toggle retainer does not require tool to remove.**

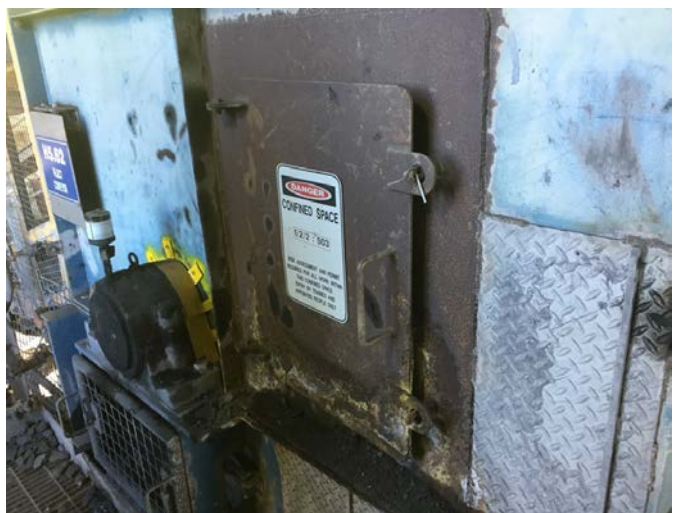
**Figure 14: Access hatch beside pulley nip point not secured.**

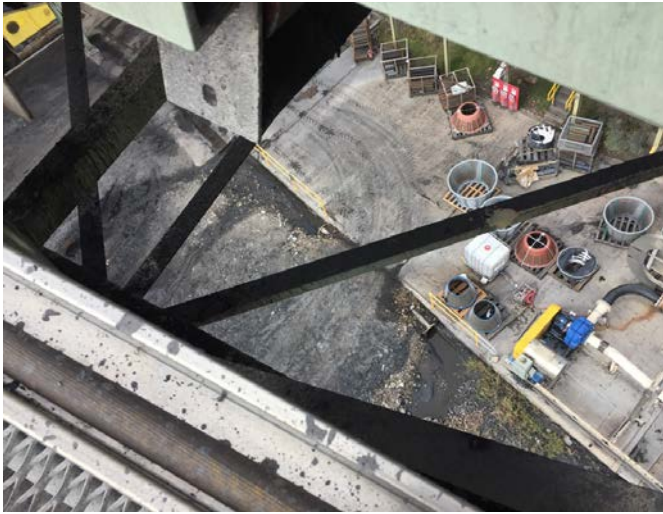
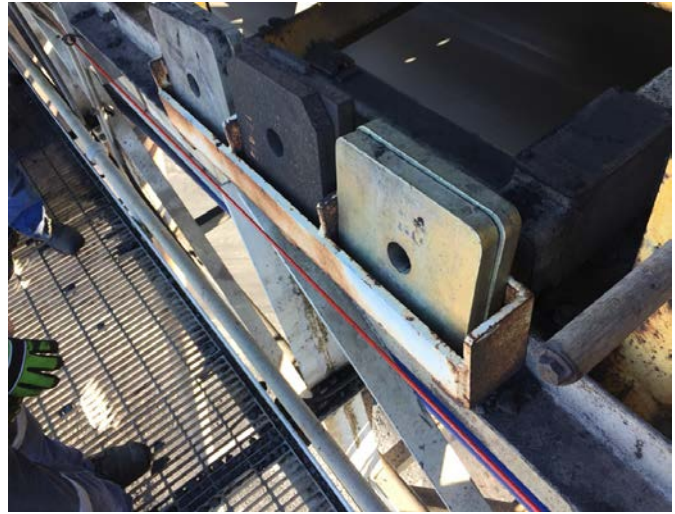
Figure 15: No protection to access road/storage area below. Figure 16: No protection if test weights dropped.

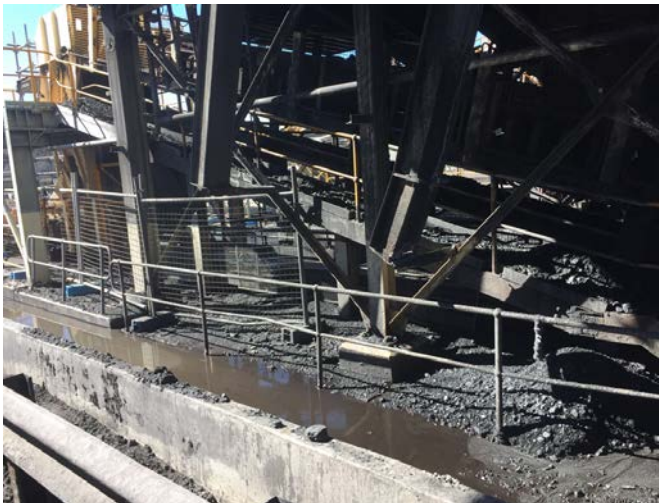
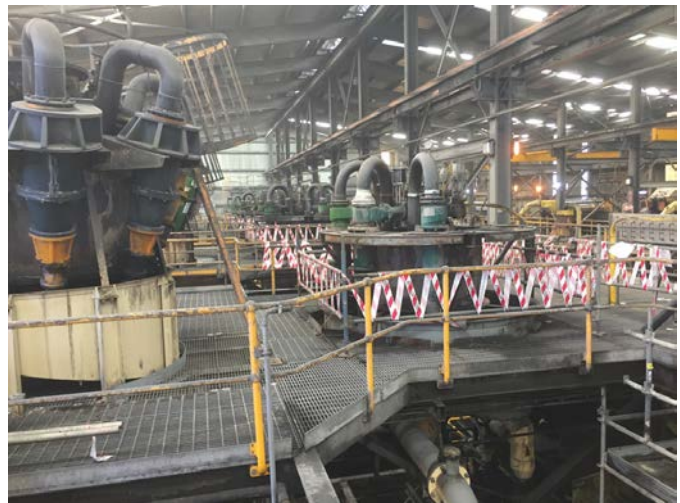
Figure 17: Temporary site fencing restricts cleaning. Figure 18: Tapeused as barrier around low cyclone underpan.

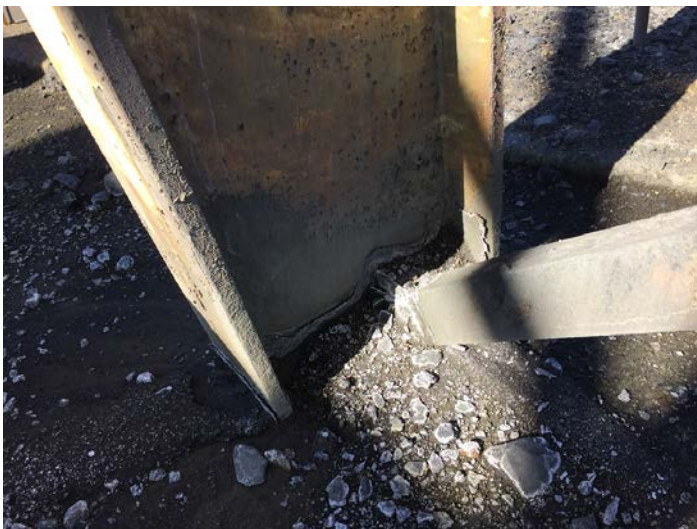
**Figure 19: Bin column base corrosion.**

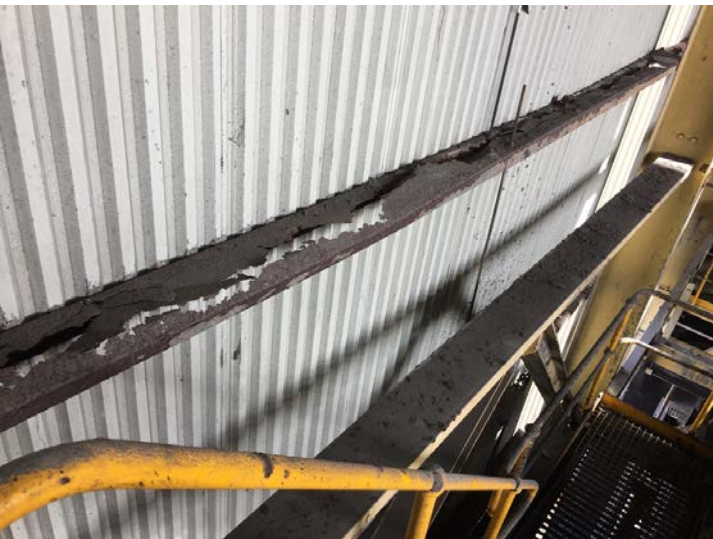
**Figure 21: Corrosion of wall purlins.**

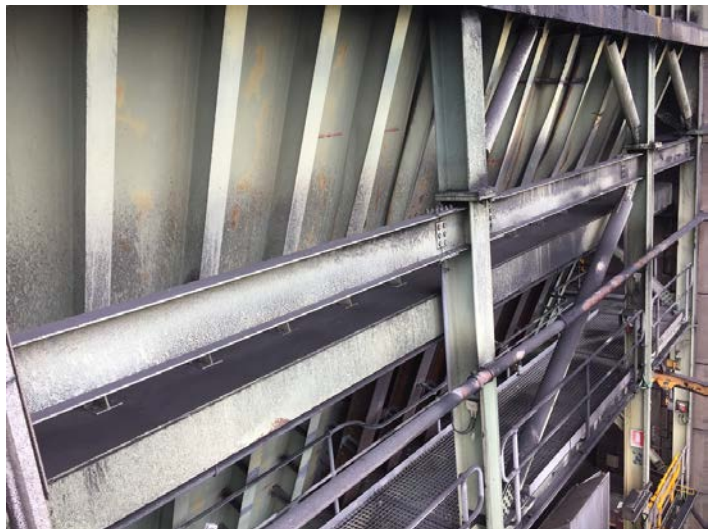
**Figure 20: Hopper beams distorted due to load, some repaired.**

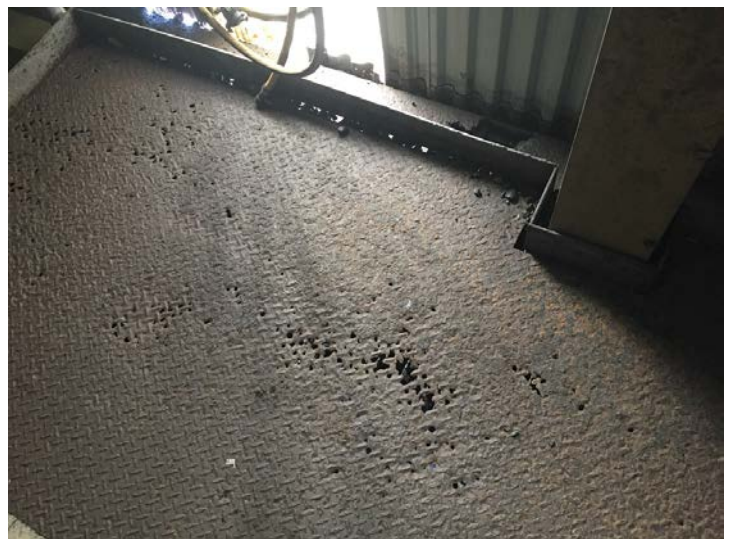
**Figure 22: Full thickness corrosion of platform floor plate.**

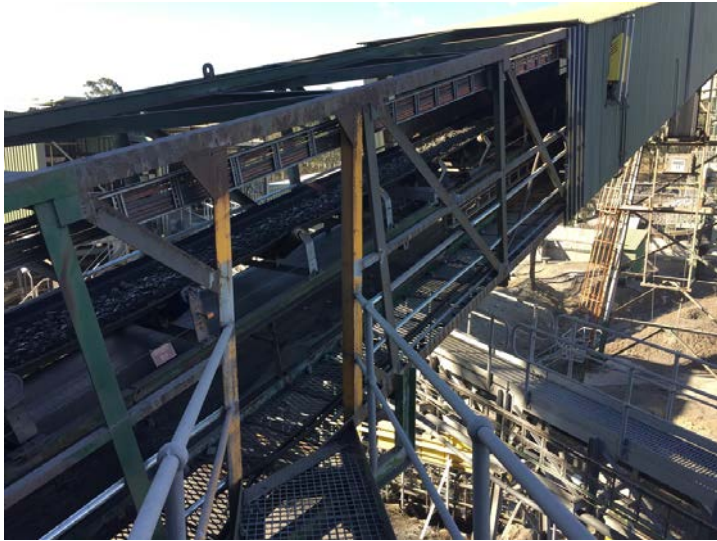
Figure 23: Modification to gantry structure.

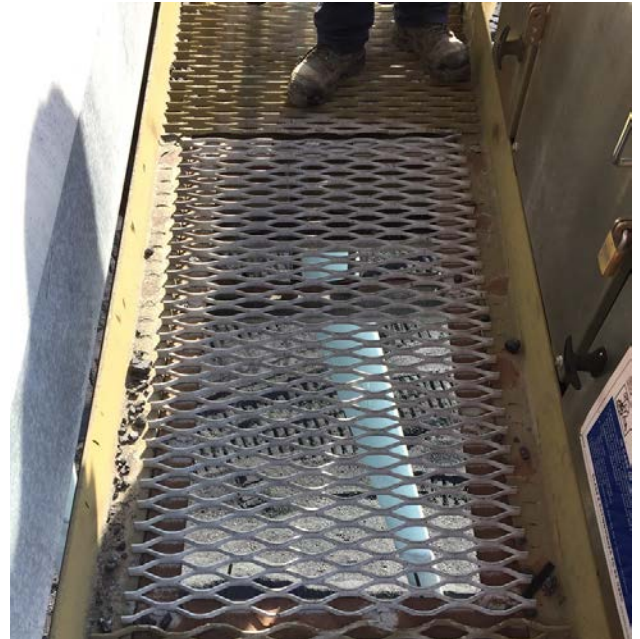
Figure 24: Section removed from walkway not secured.

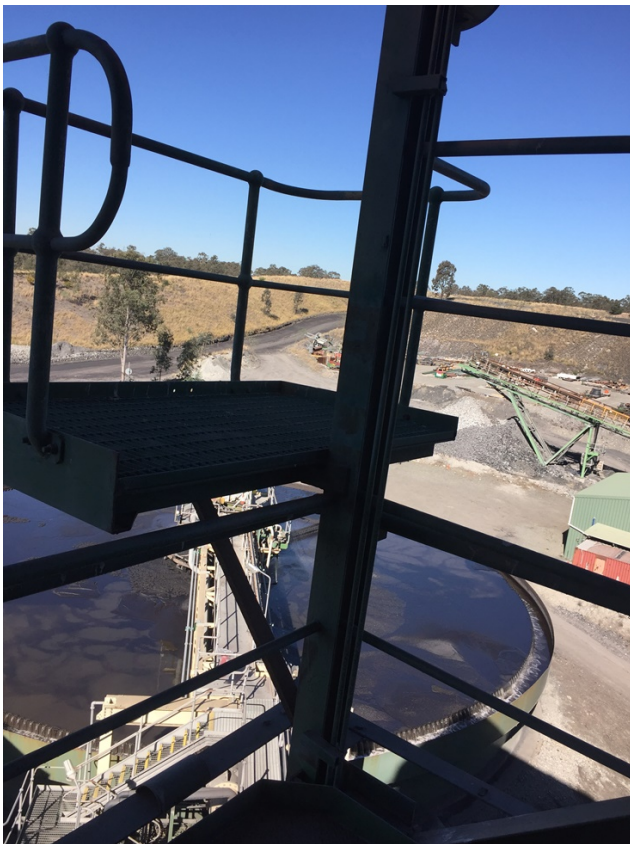
Figure 25: Access platform added without ladder.

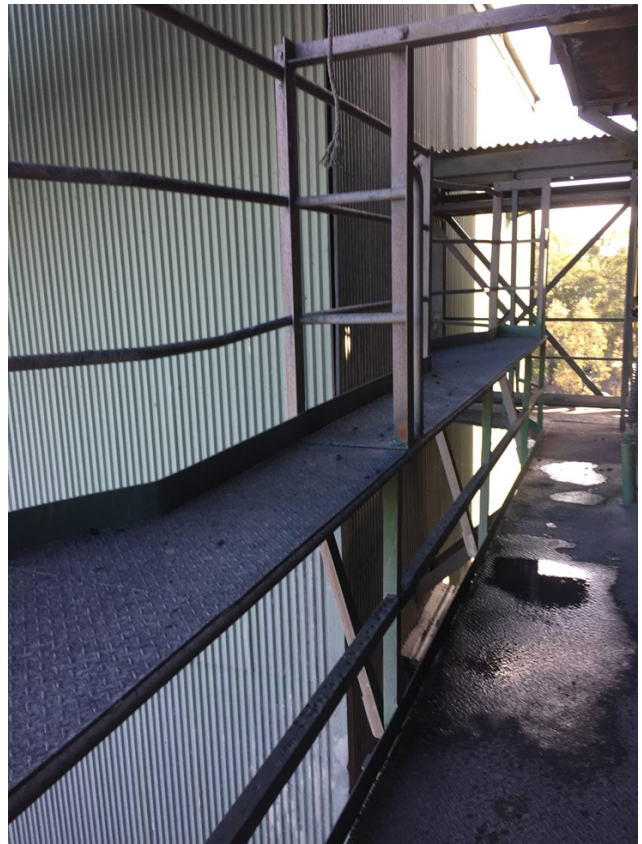
Figure 26: Platform added mounted to handrail.

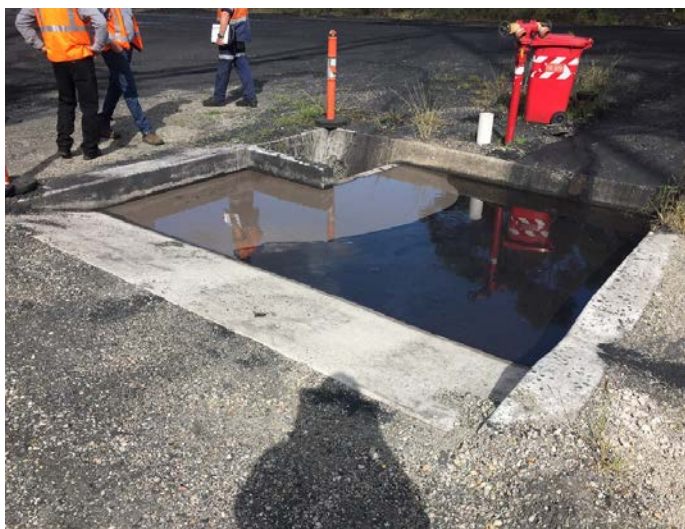
**Figure 27: Sump with no protection or signs.**

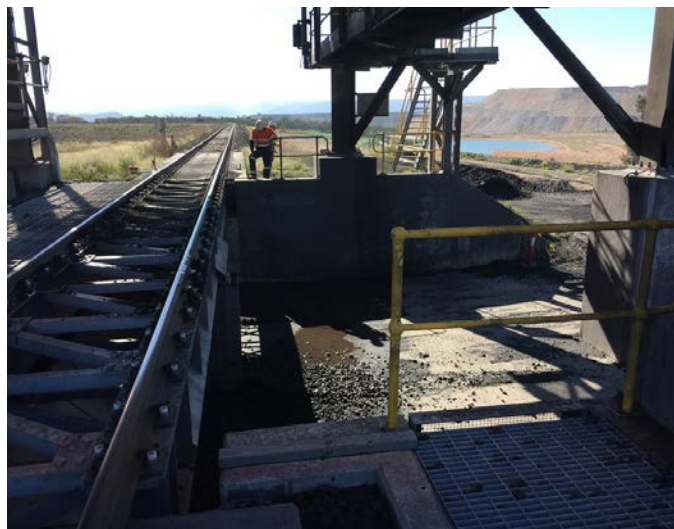
**Figure 28: Handrail does not fully protect against falling**

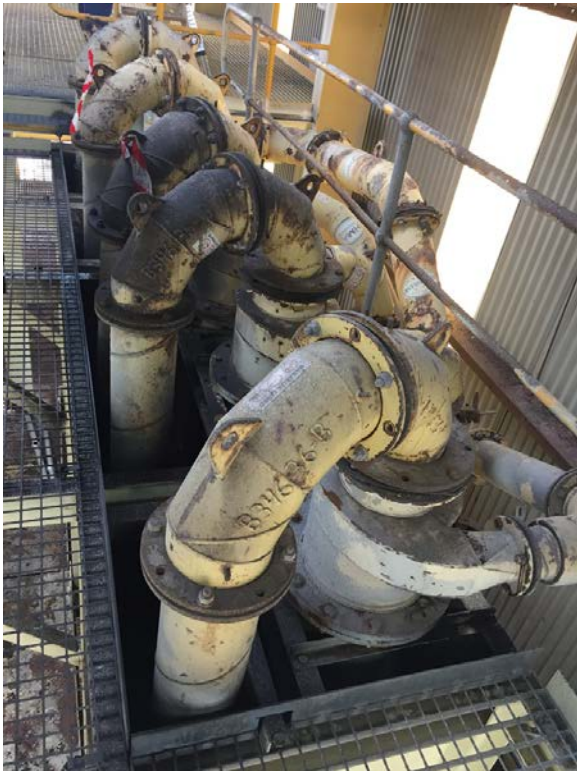
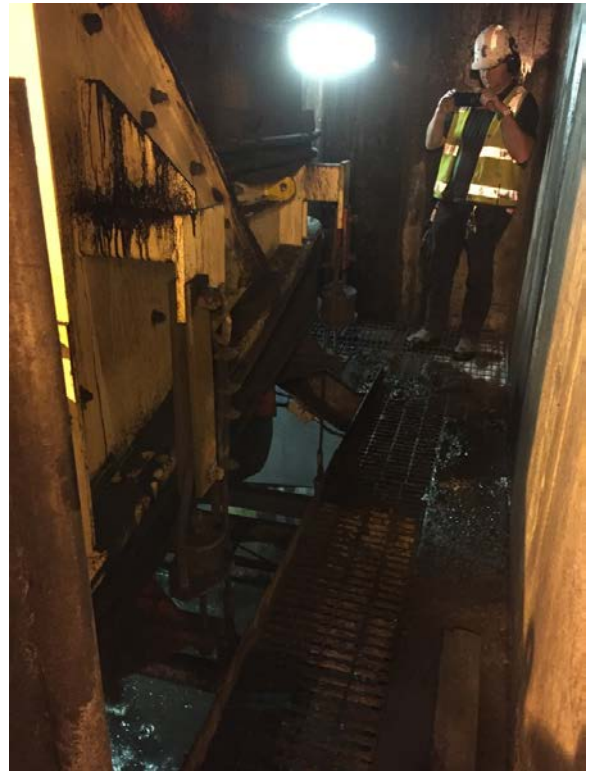
Figures 29 and 30: No protection against falling into cyclone underpan or beside reclaim tunnel vibrating feeder.

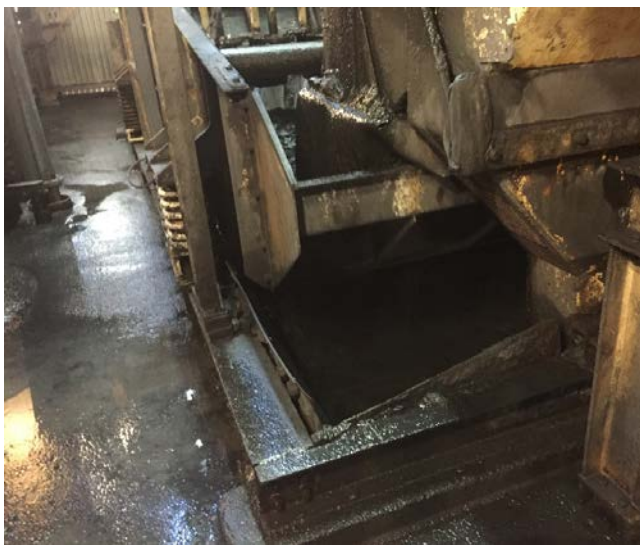
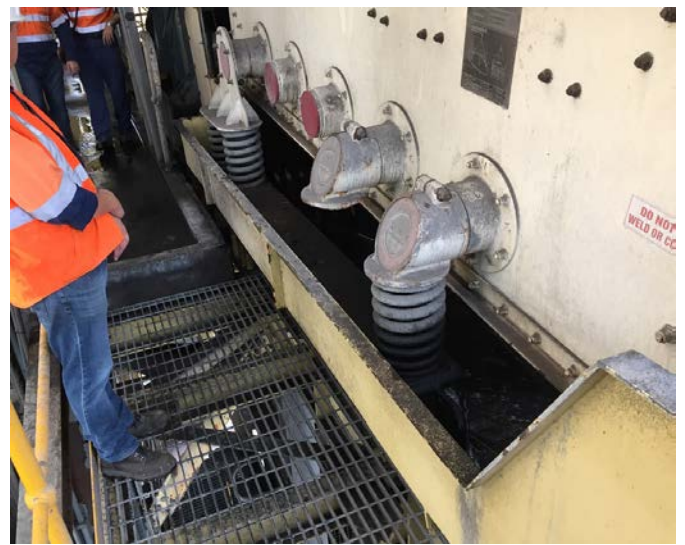
Figure 31 and 32: No protection against falling into screen underpans.

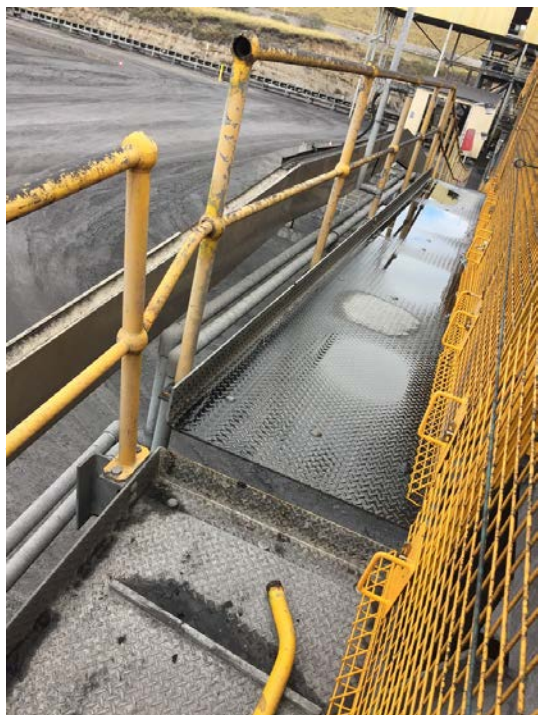
Figure 33: Handrail corroded and fallen off.

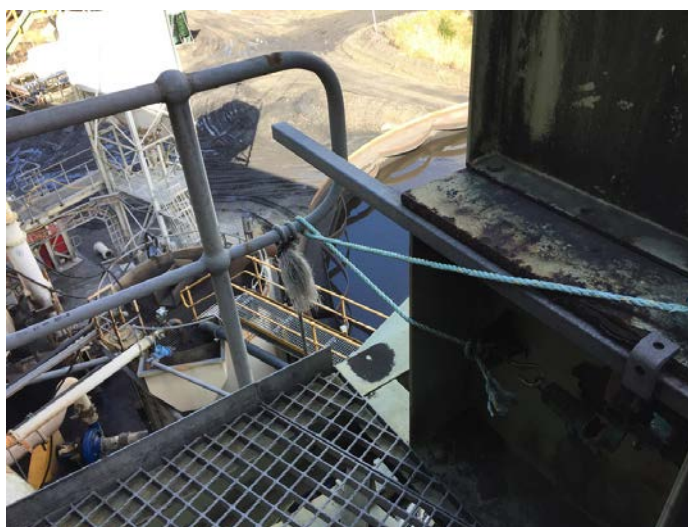
Figure 34: Rope and unistrut are ineffective to prevent falling.

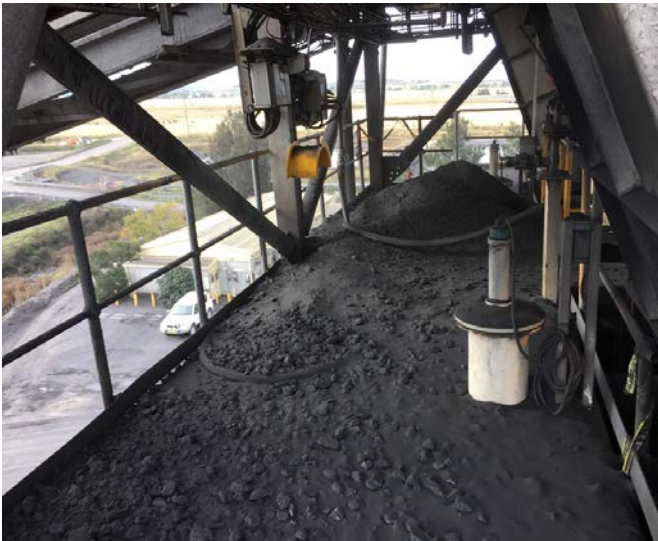
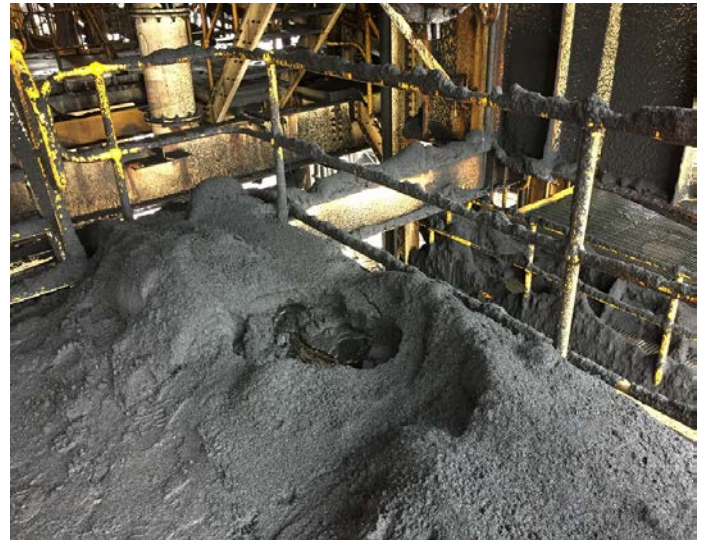
Figures 35 and 36: Spillage makes kickrails ineffective and handrail heights non-compliant, as well as difficult to negotiate.

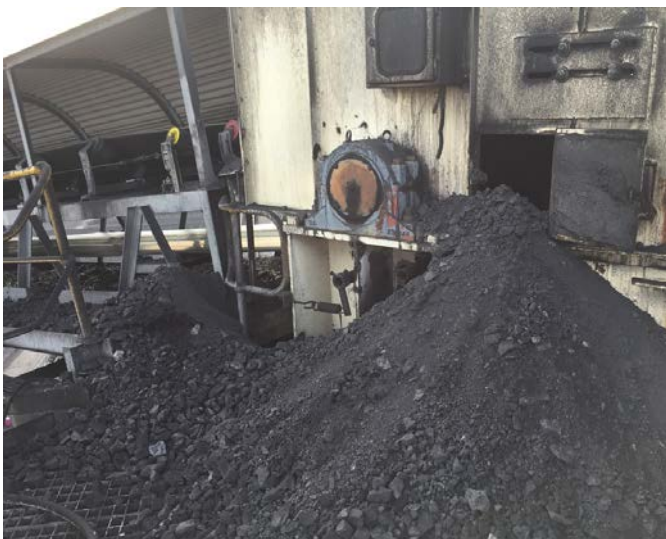
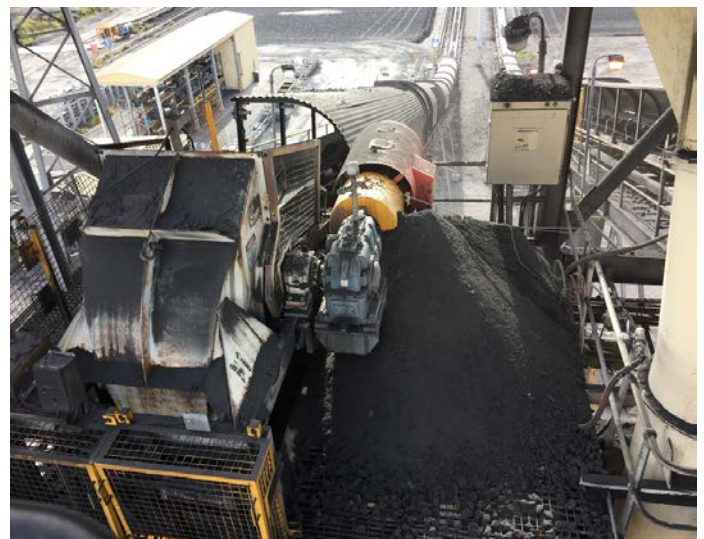
Figures 37 and 38: Conveyors were still operating at time of inspection, but were shut down.

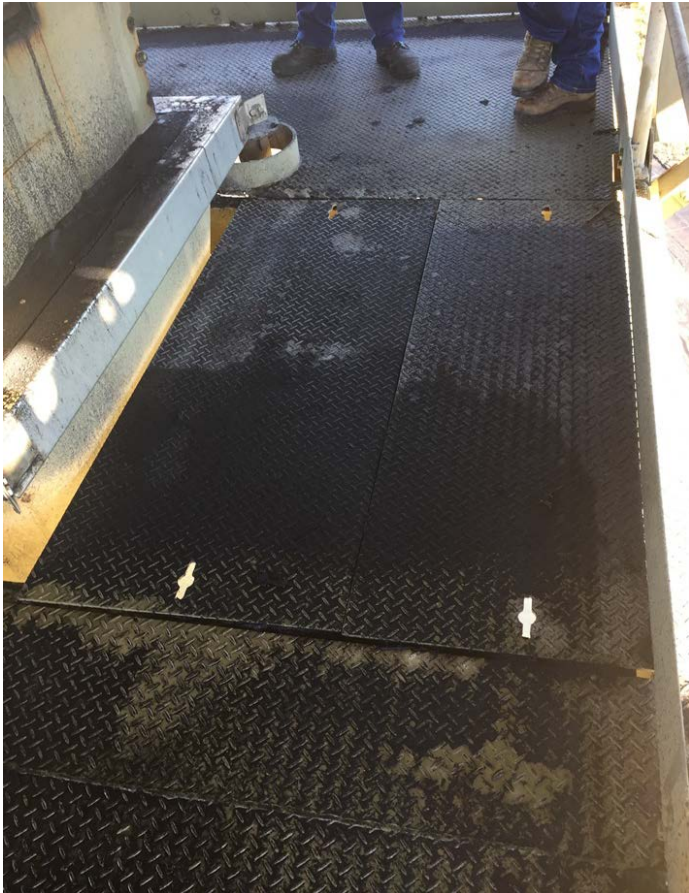
Figure 39: Walkway plates not secured on bin platform.

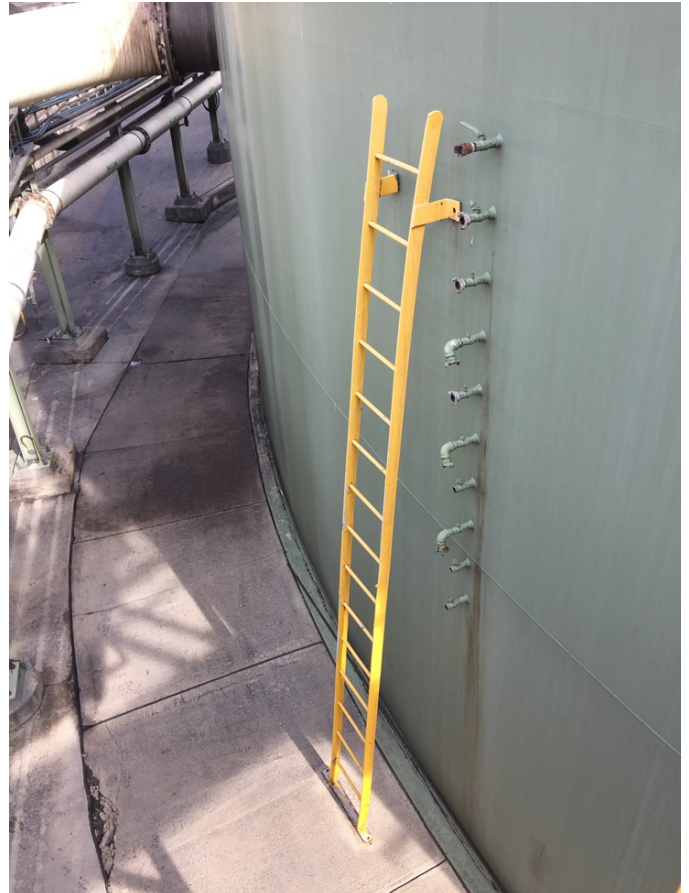
Figure 40: No fall protection on ladder.

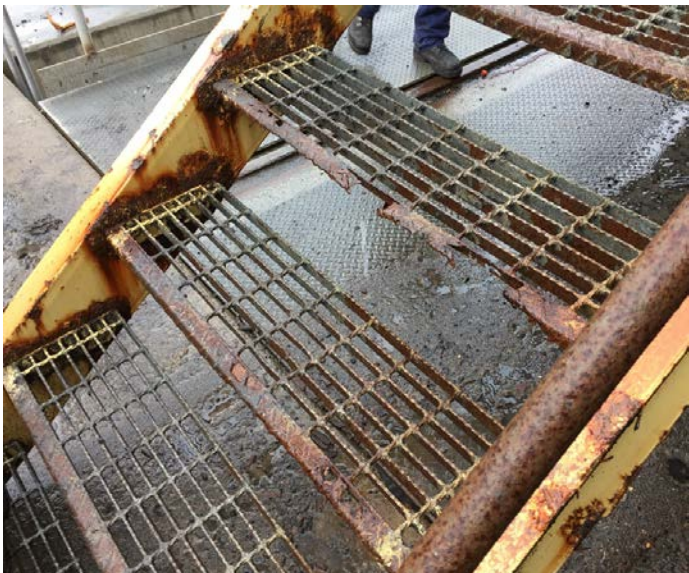
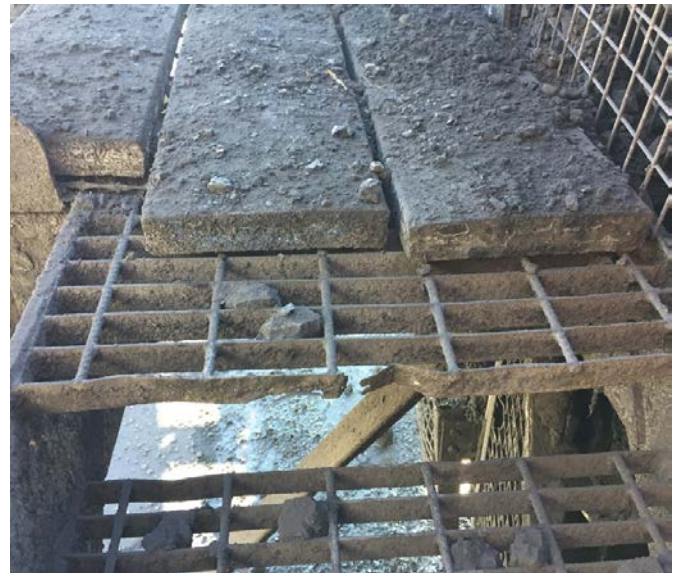
Figures 41 and 42: Significant corrosion of stair treads compromises structural integrity and creates trip hazard.

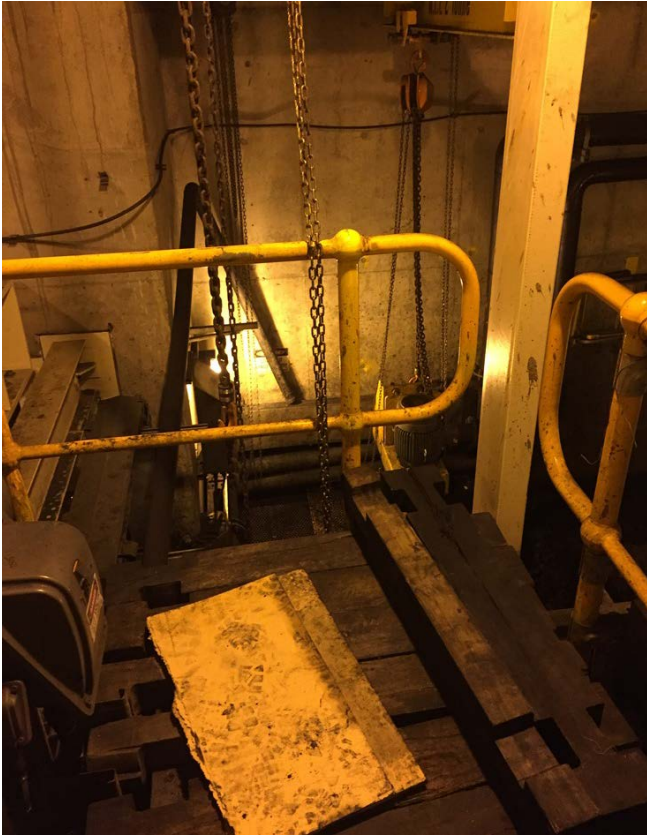
Figure 43: Material and rubbish stored on walkways.

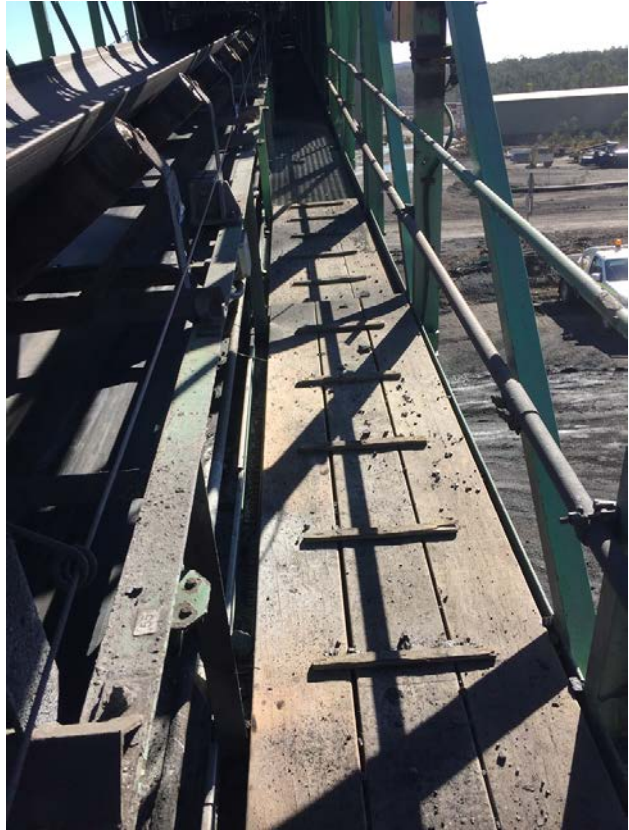
Figure 44: Scaffold knee rail and walkway makes handrails non-compliant height.

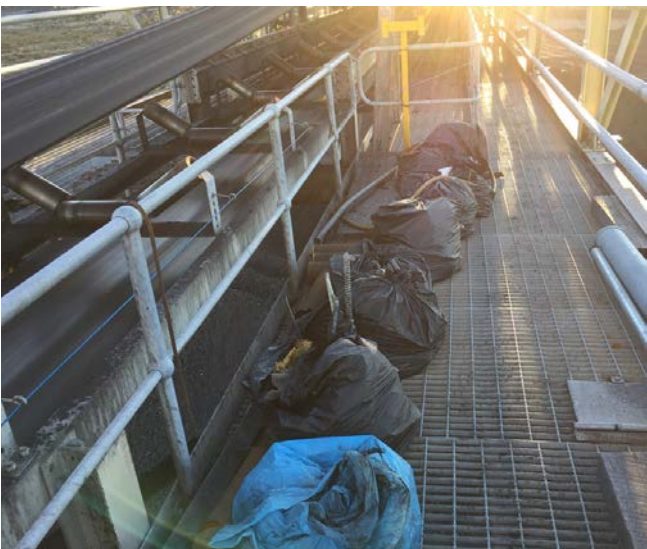
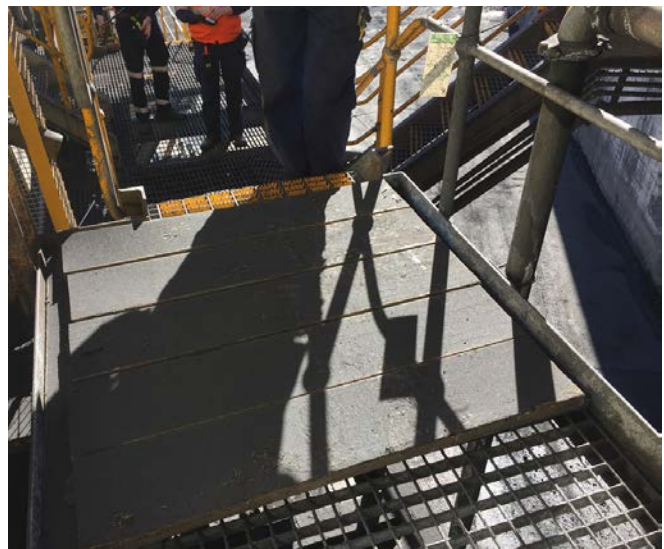
Figures 45 and 46: Rubbish, materials and scaffold boards become trip hazards, especially at the top of stairs

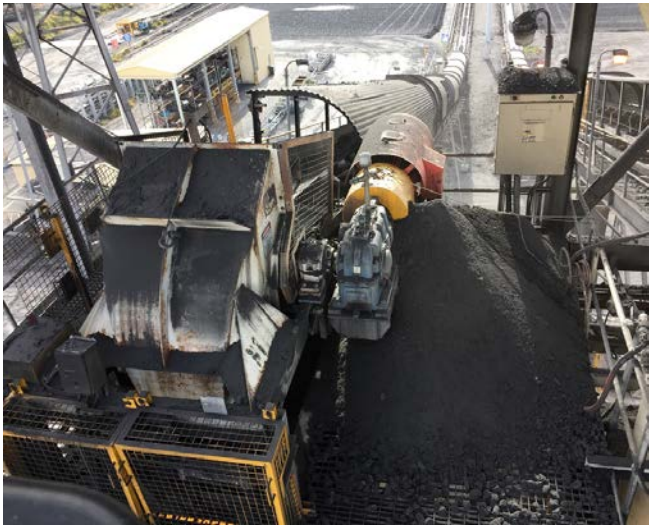
Figures 47 and 48: Conveyor drive was still operating.

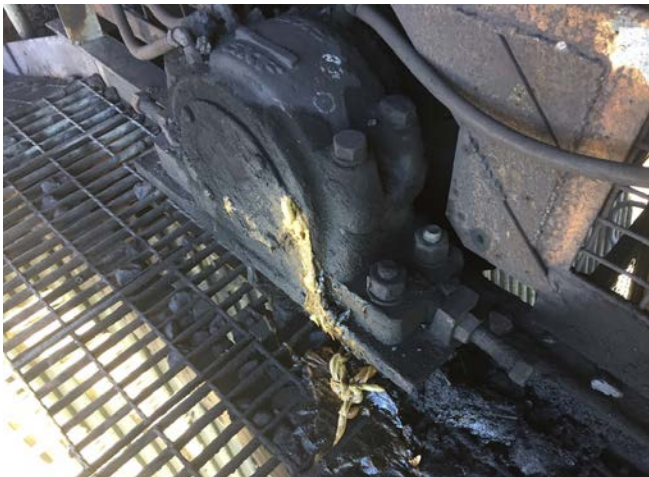
Figure 50: Fine dust build-up on pulley bearing guard.

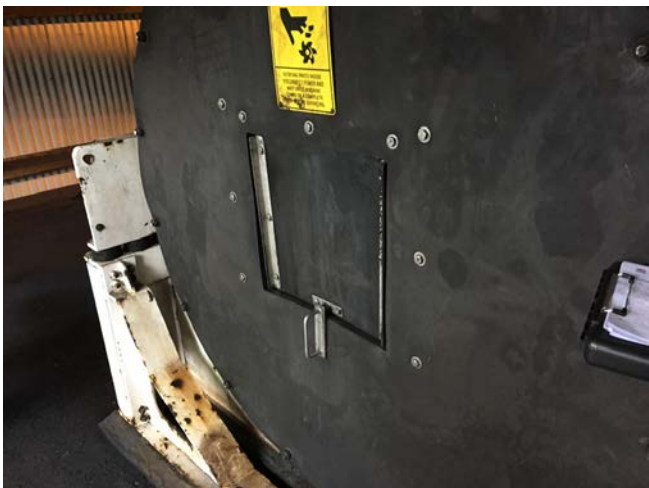
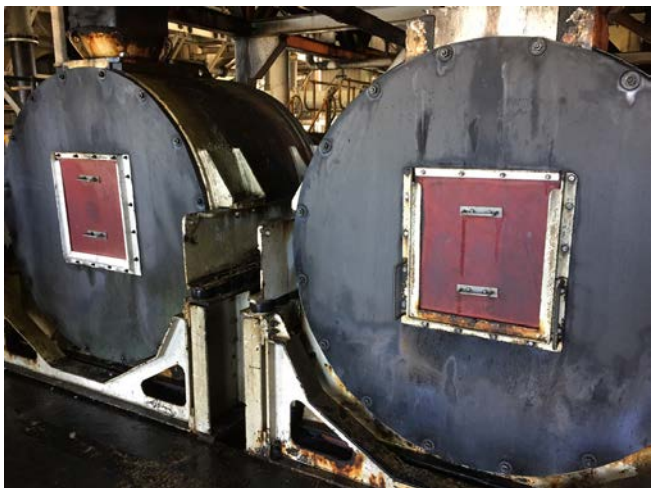
Figure 51 and 52: Centrifuge not identified as confined space and covers not secured against inadvertent access to rotating parts.

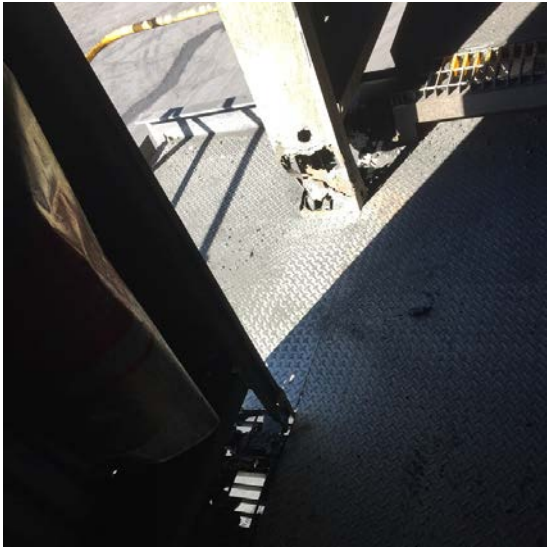
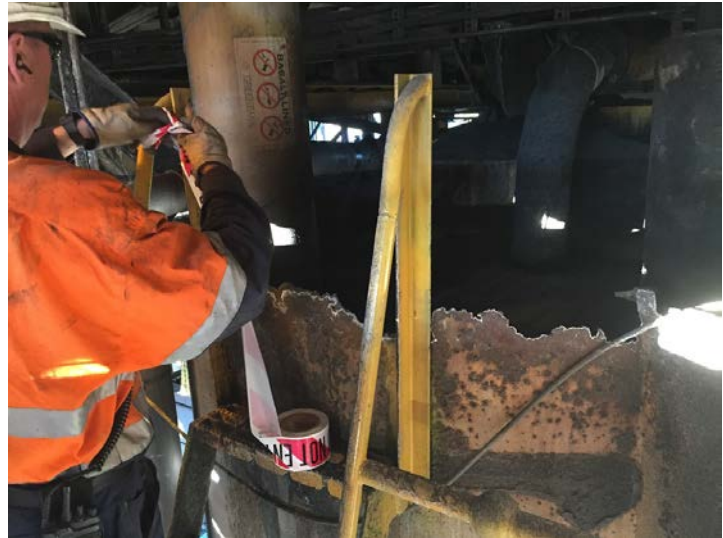
**Figure 53: Door frame rusted through on both sides. Figure 54: Lip of dense medium sump corroded to a knife edge.**

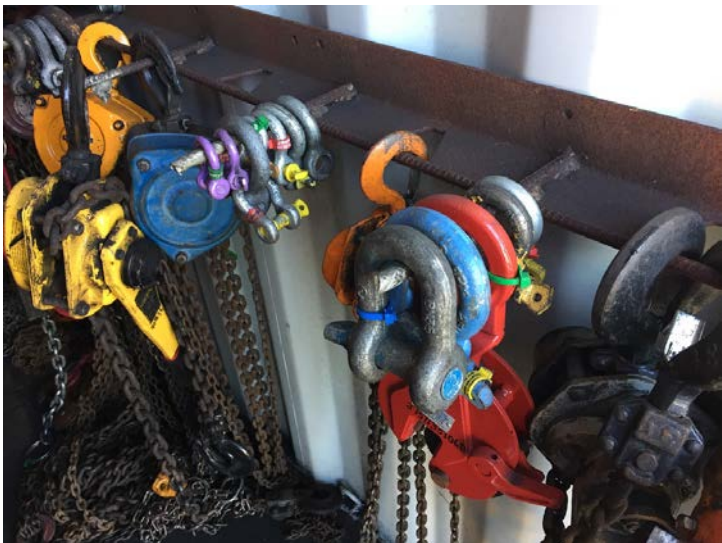
**Figure 55: Lifting gear tags.**

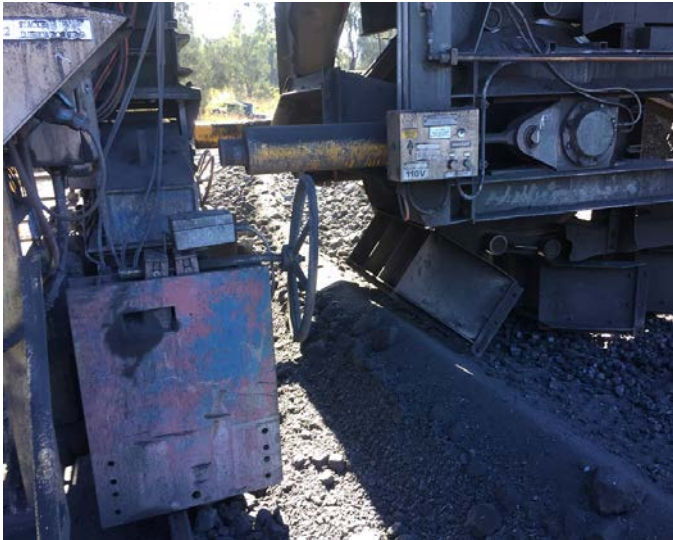
Figure 56: Position of controller relative to moving components

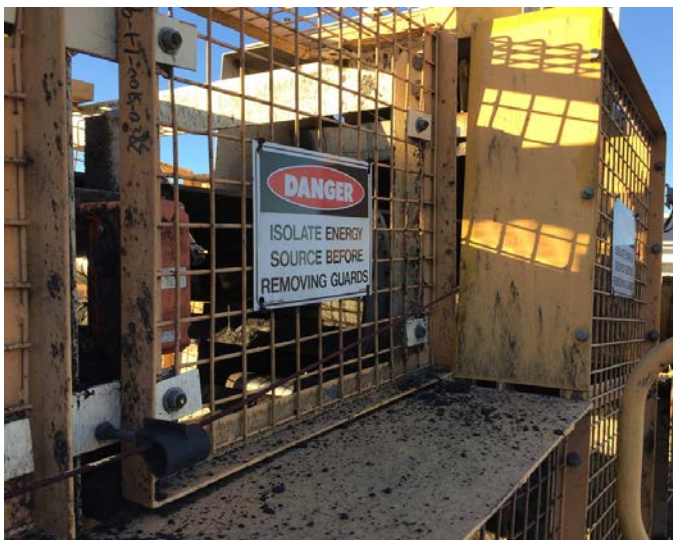
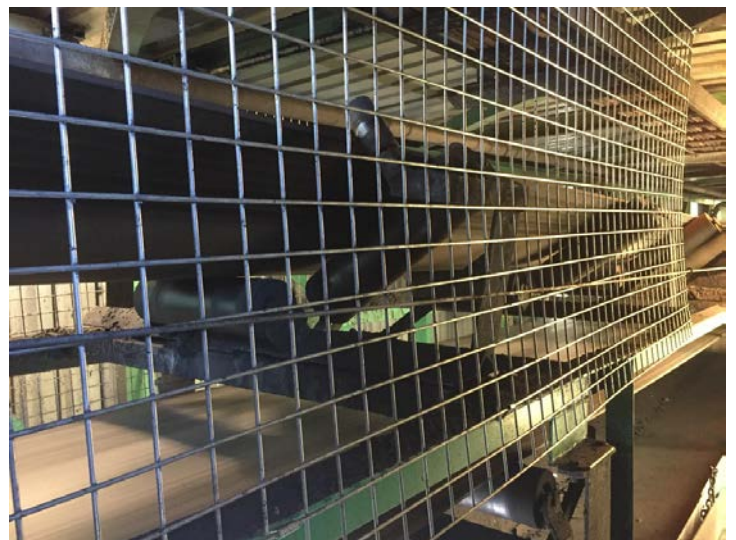
Figures 57 and 58: Lanyard not able to be effectively operated due to proximity to or positioned behind guard mesh.

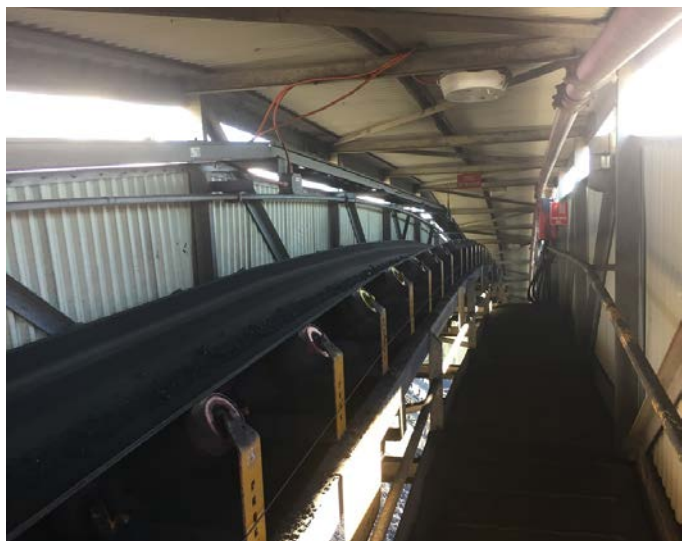
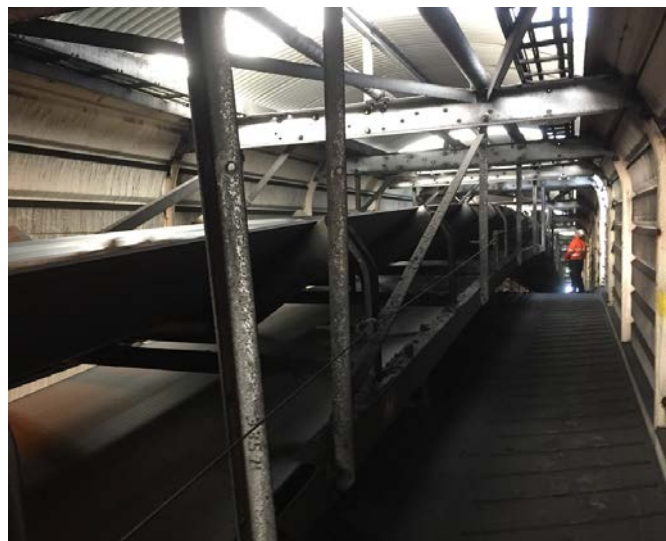
Figures 59 and 60: Guarding of conveyor brow rollers.
