NSW Resources Regulator

INVESTIGATION REPORT

Report into the serious injury of an operator at the Mannering Colliery, Doyalson, NSW on 22 January 2016

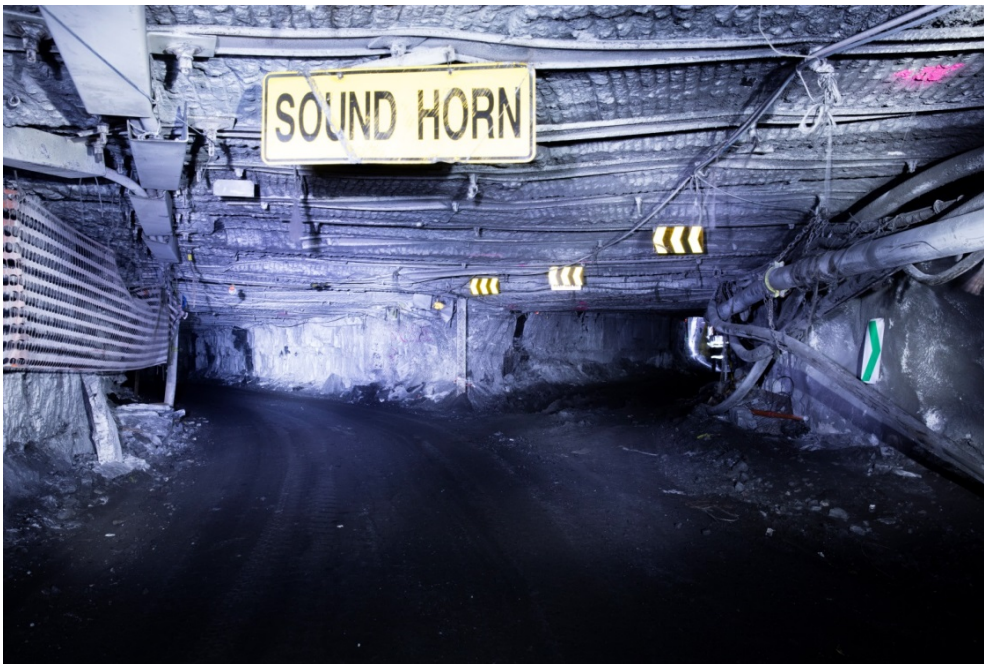
The contact with the broken W strap occurred at the entrance to the roadway that leads to Longwall 7. The entrance to the roadway was at a junction with the main travel road as shown below.

Figure 3: The incident scene looking inbye (from the side closest to the entrance of the mine) toward the scene. Roadway to Longwall 7 to the right.

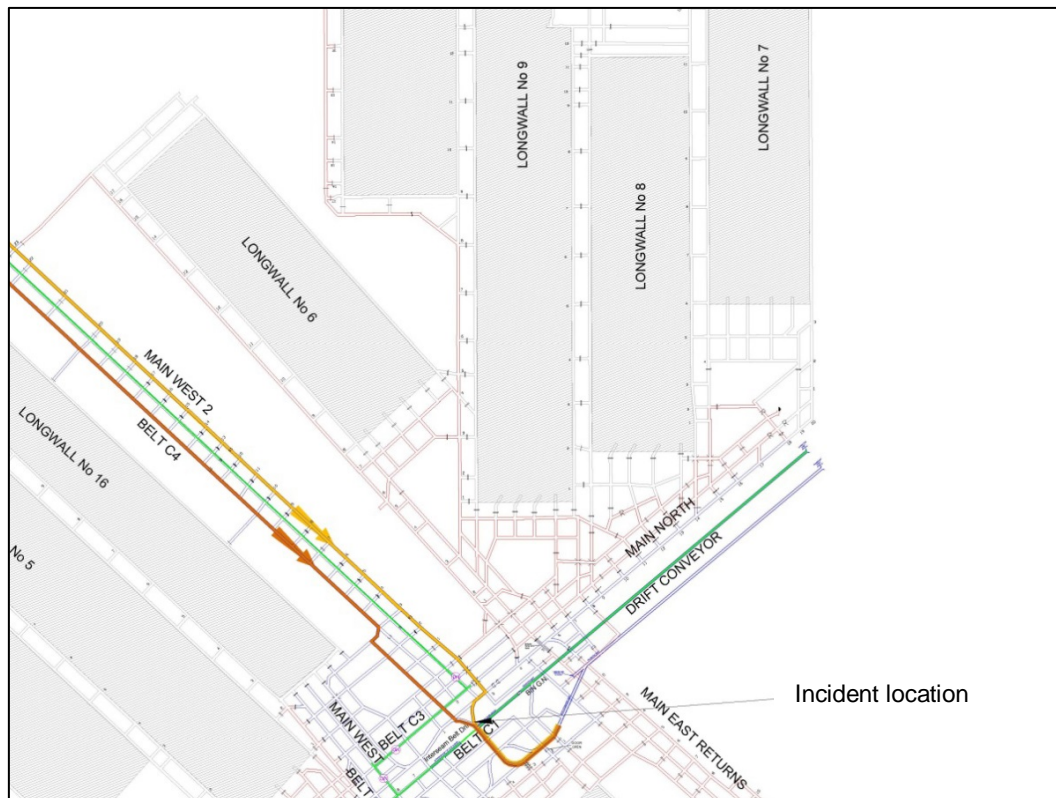
The arrangement of the junction of the roadways and incident location can be seen below, the main travelling road is identified as Belt C4 roadway with the entrance to the secondary egress roadway identified as Main West 2 which in turn has a branch identified as Main North that goes to Longwall 7.

Figure 4: Map showing incident site and Longwall 7.

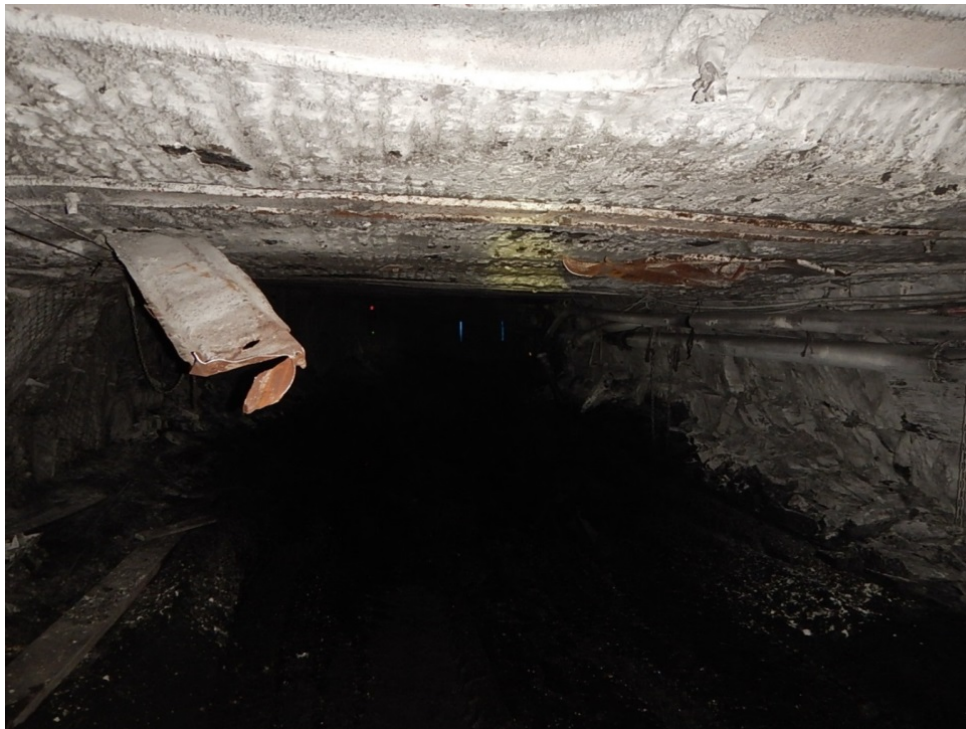
The other electrician then drove SMV003 out from the pump on his own and reported making similar minor contact with the roof at the same location. He did not stop and inspect for damage as he again felt the contact was of a minor nature. These circumstances suggest that this contact most likely caused the W strap to be broken in two as shown in figure 5.

Figure 5: Damaged W strap hanging in roadway looking inbye at the scene

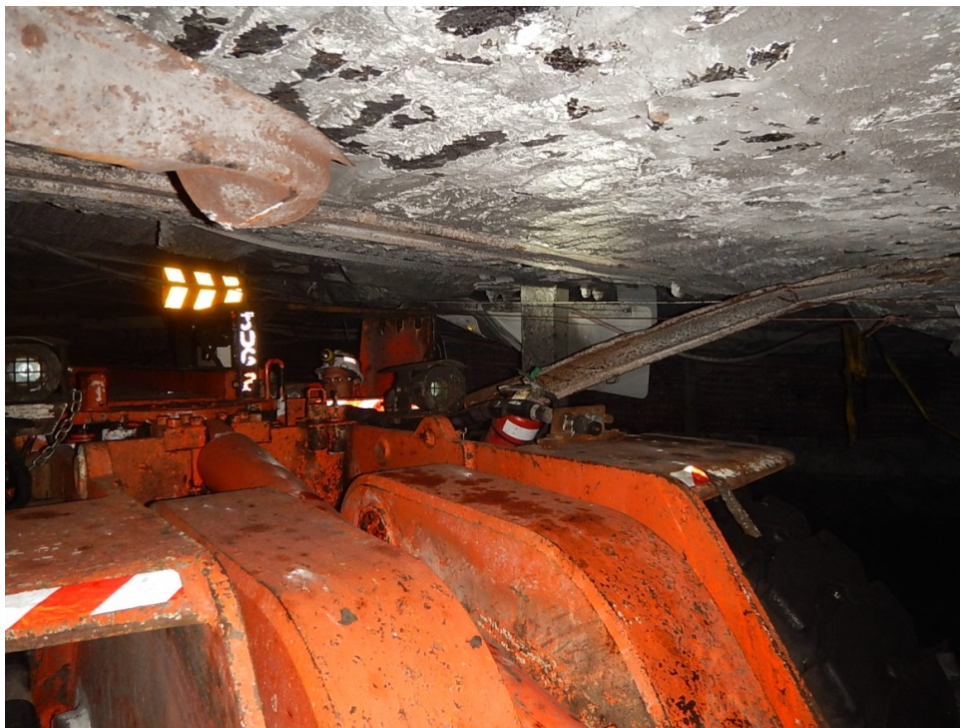
The operator said he was concentrating on the vehicle ahead of him at the same time as navigating the right hand bend in the roadway. The operator heard the W strap make contact with the canopy of the LHD as it entered the cabin and hit his head. Although the operator was wearing a hard hat, the broken W strap made contact near his left ear. Figure 7 shows the probable location of the LHD at the time of the incident and the broken W strap hanging from the roof.

Figure 7: Position of W strap and similar type of machine - looking outbye toward the scene.

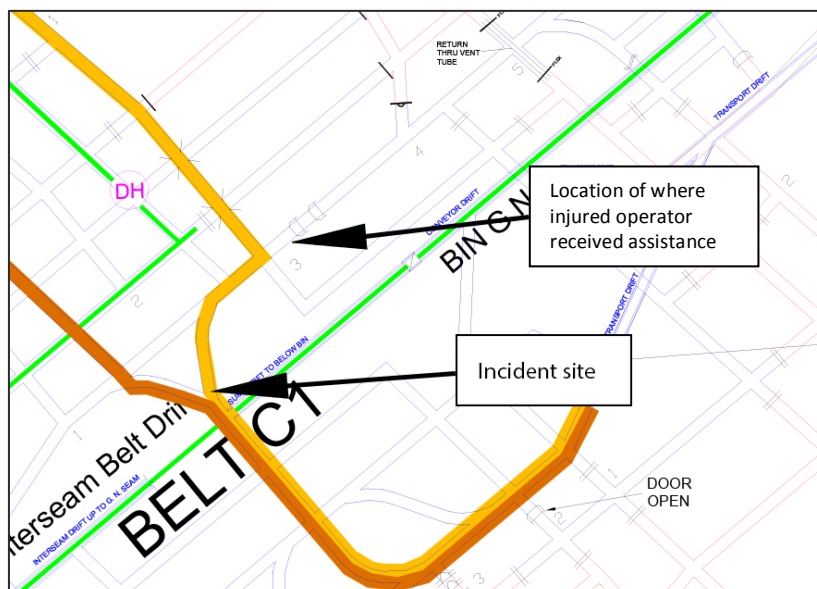
The vehicle in front had stopped about 120 m inbye from the incident site to wait for the arrival of the LHD to allow both vehicles to go through the doors together. The doors and the incident site can be seen in the figure 8.

Figure 8: Map showing incident site and double doors.

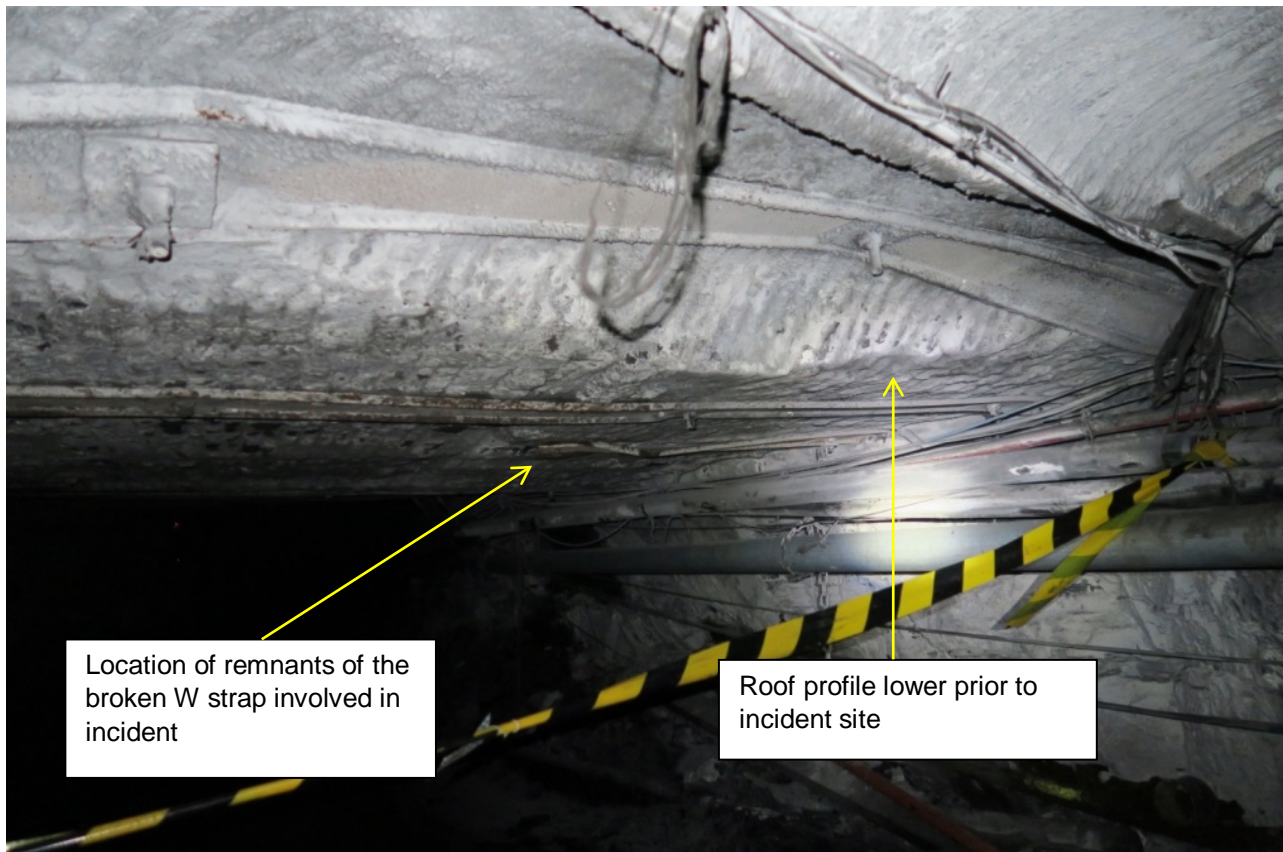
The incident occurred where the mine roof profile lowers.

Figure 9: The incident scene looking inbye. Visible lowering of the roof.

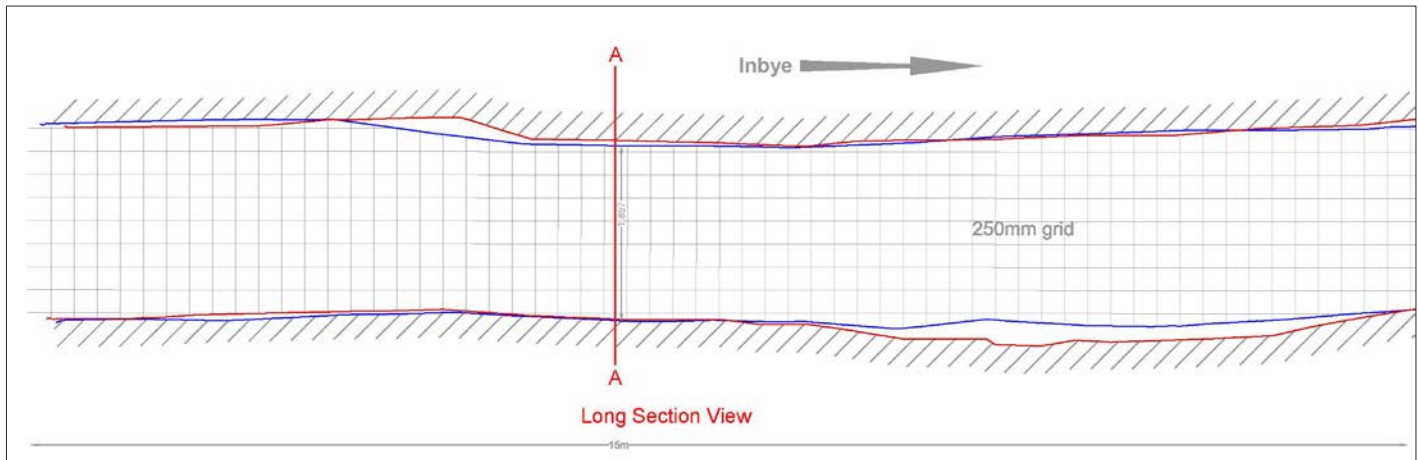
Plans produced by the mine after the incident show that the roof of the roadway lowered by approximately 0.28 m at the incident site. There was also a depression in the floor about 2.8 m inbye of the incident site to depth of approximately 0.28 m.

Figure 10: Long section of the incident scene, section AA location of W strap

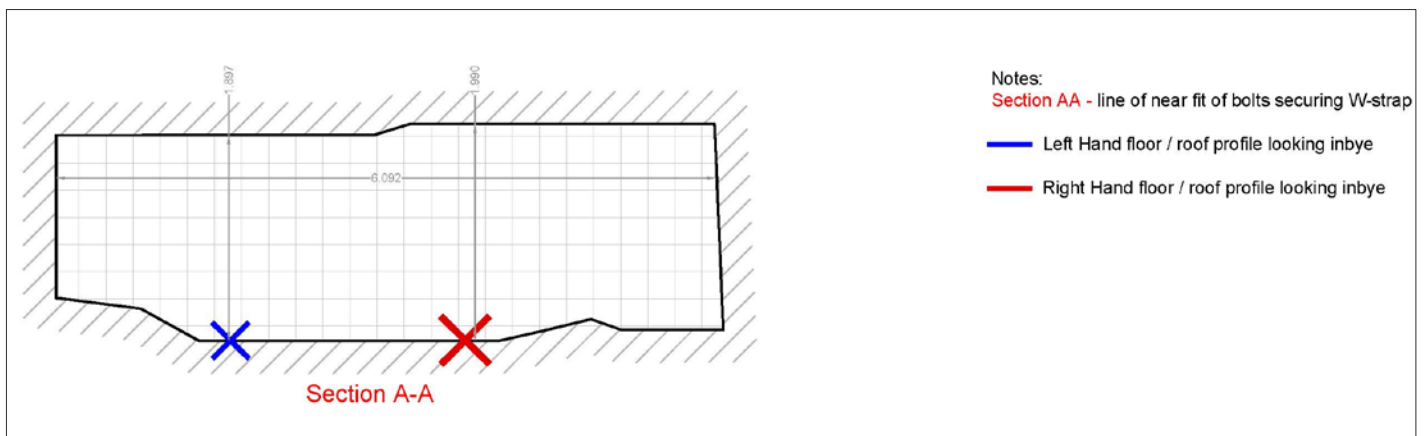
The cross section of the roadway at the incident site shows that the roadway height was 1.897 m on the left hand side of the roadway and 1.990 m on the right hand side of the roadway as shown in figure 11 below.

Figure 11: Cross section at the incident scene.

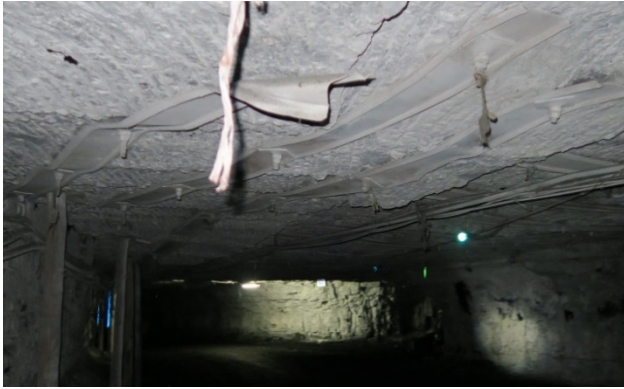
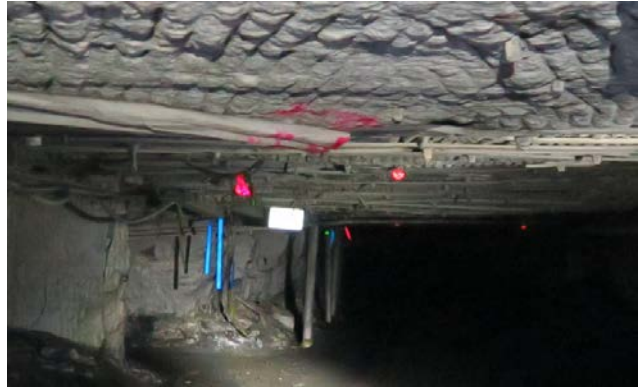
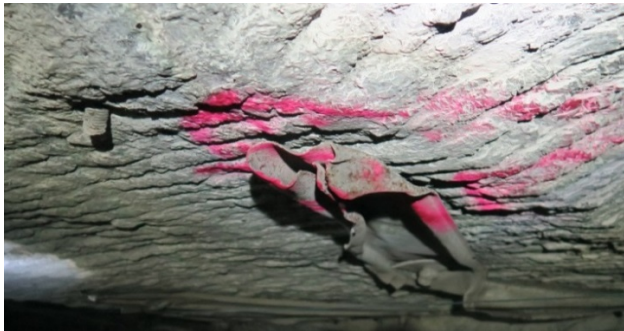
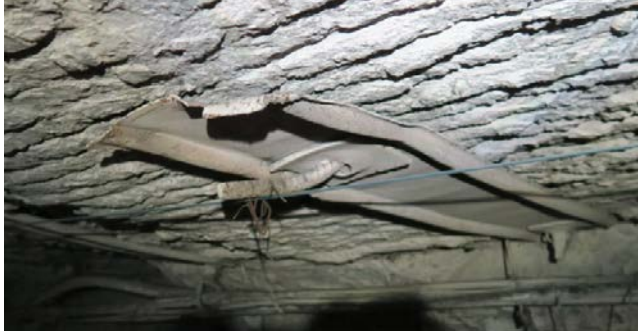
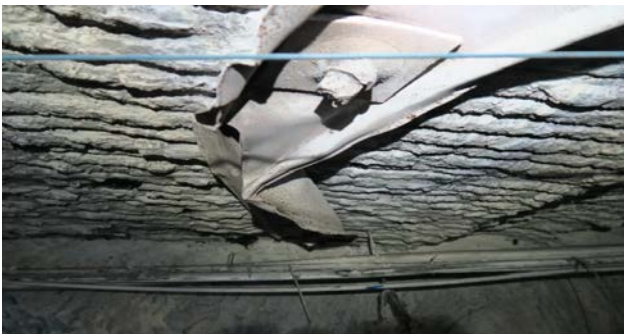
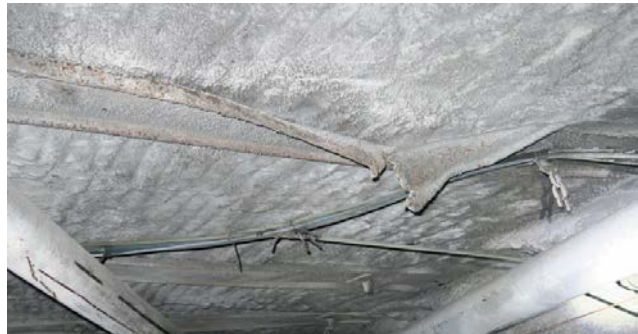
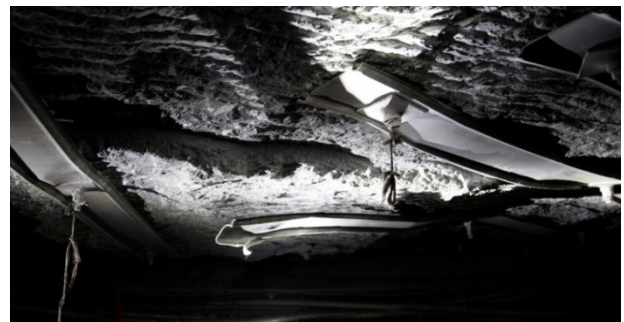
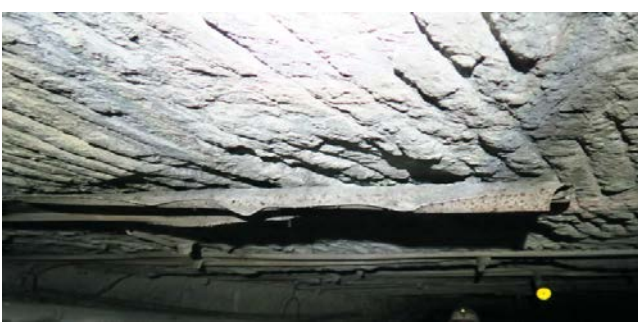
An examination by investigators of other W straps in the vicinity of the incident site identified numerous W straps that had been damaged from impacts.

Figure 12: Damaged W straps the vicinity of the incident.

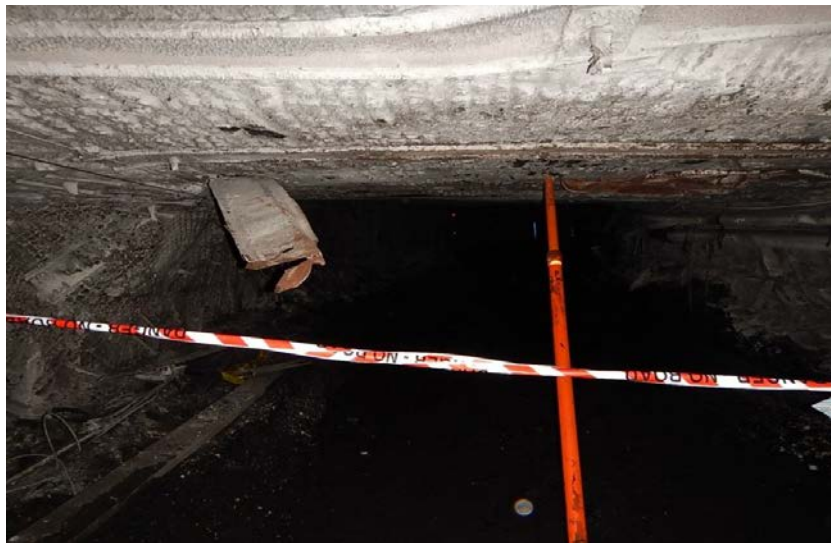
The W strap was torn into two sections with the section on the right hand side of the roof being mostly intact and attached to the roof, whereas the section on the left hand side of the roof was loosely attached to the roof with the remainder hanging down into the roadway pointing toward oncoming traffic.

Figure 13: The incident scene looking inbye at the damaged W strap hanging from the roof.

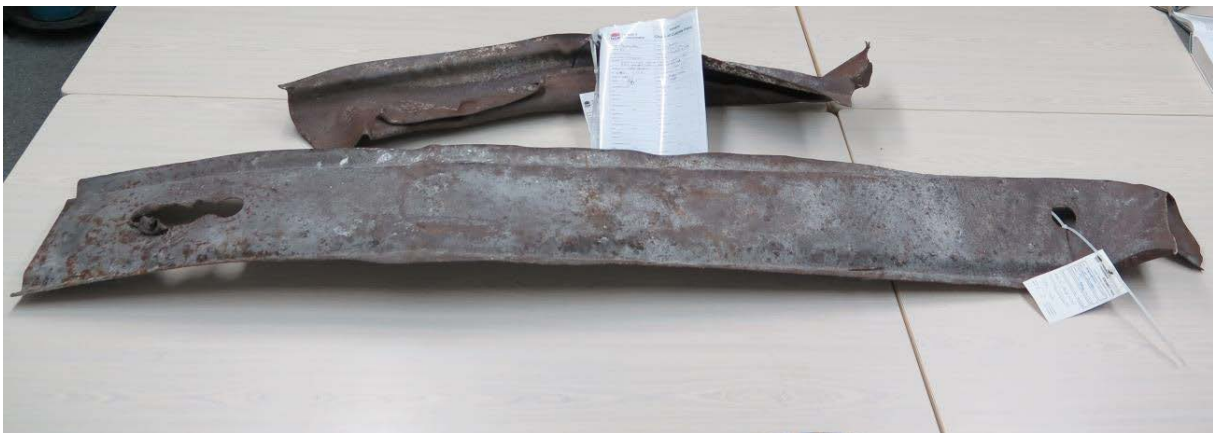
Both sections of strap were corroded and the shorter section had more mechanical damage than the longer section. The strap had fractured transversely about 180 mm from the centre of a roof bolt hole, as can be seen on the right hand of the longer section of W strap.

Figure 15: The two sections of damaged W strap.

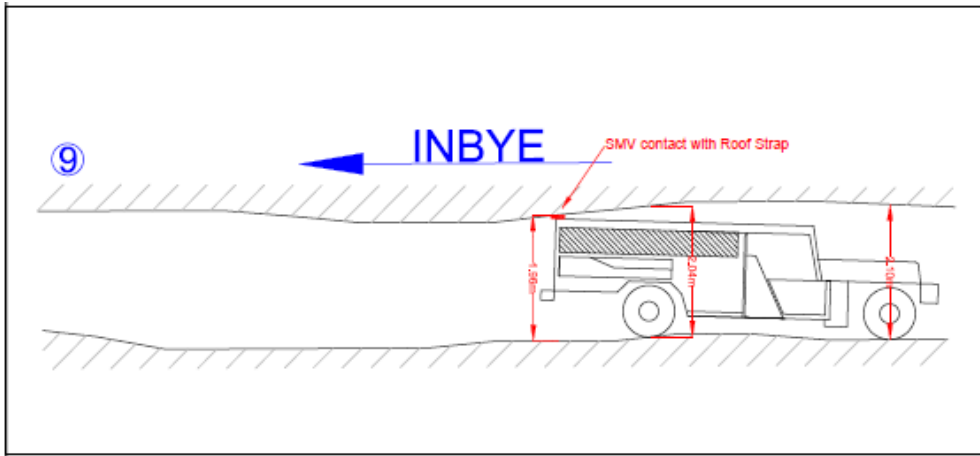
- the roadway measured as spot points was mostly to the required 1.9 m (1.897 m on the left hand side of the roadway and 1.990 m on the right hand side) as shown in figure 11
- spot measurements did not take into account the length of the vehicle and the effect of undulations in floor and roof, which results in the operational height being lower than 1.9 m
- the position of the strap in the roadway immediately before hitting the operator as indicated by the survey was as a result of SMV003 making contact with it when travelling outbye as shown in figure 16.

Figure 16: Survey plan of SMV travelling outbye and likely contact point.

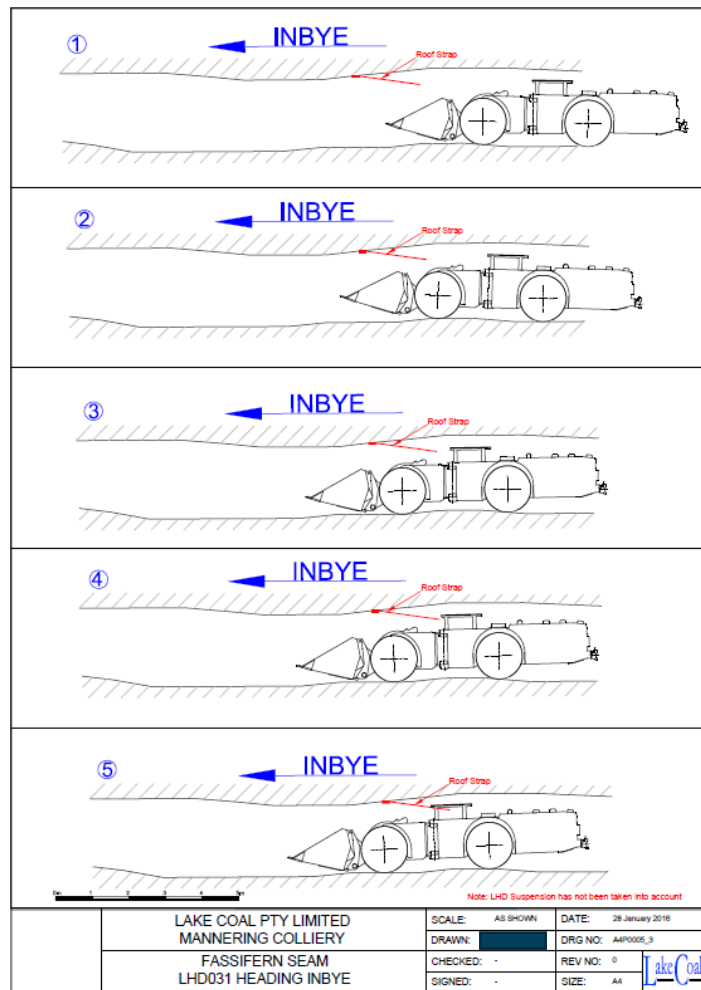
The mine survey also documented how the broken W strap interacted with the LHD as shown below.

Figure 17: Interaction of W strap and the LHD 031

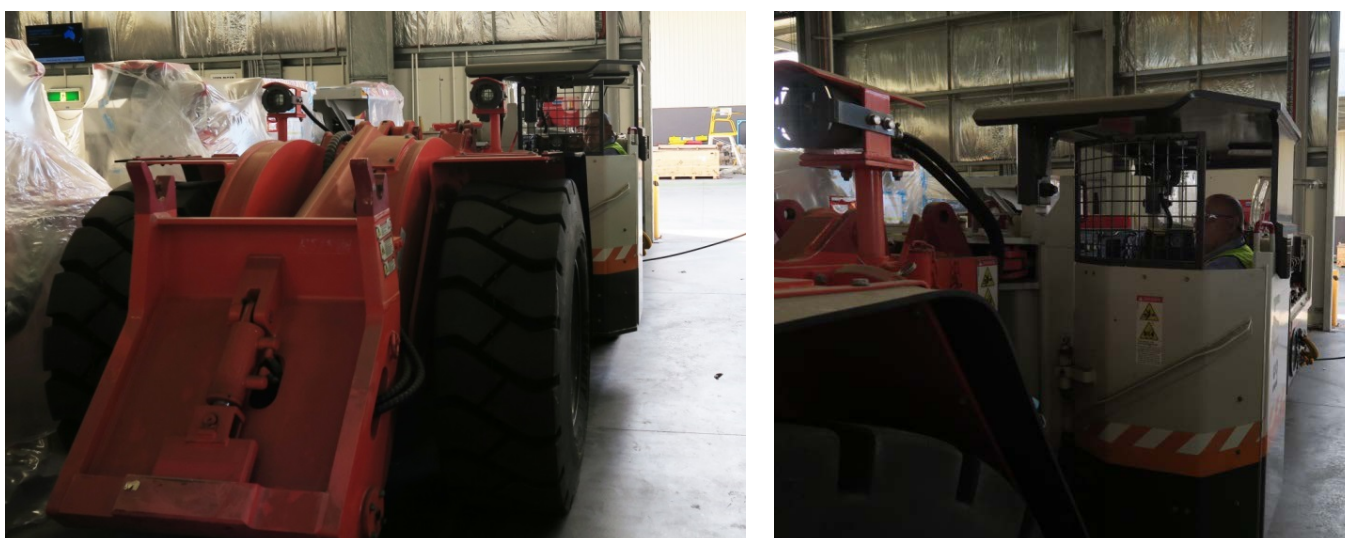
Figure 18: Guarding on a 7 Tonne LHD.

Mobile plant operator cabins should make provision for operator protective structures (refer clause 214 and 215 of the Work Health and Safety Regulation 2011 and clause 28 of the Work Health and Safety (Mines and Petroleum Sites) Regulation 2014). The investigation considered operator protective structures that are being installed on new types of LHDs that are similar to LHD 031. These structures are being installed to prevent operator interaction with the articulation of the vehicle but such structures would also guard against material entering the operator's cabin as can be seen in figure 18.

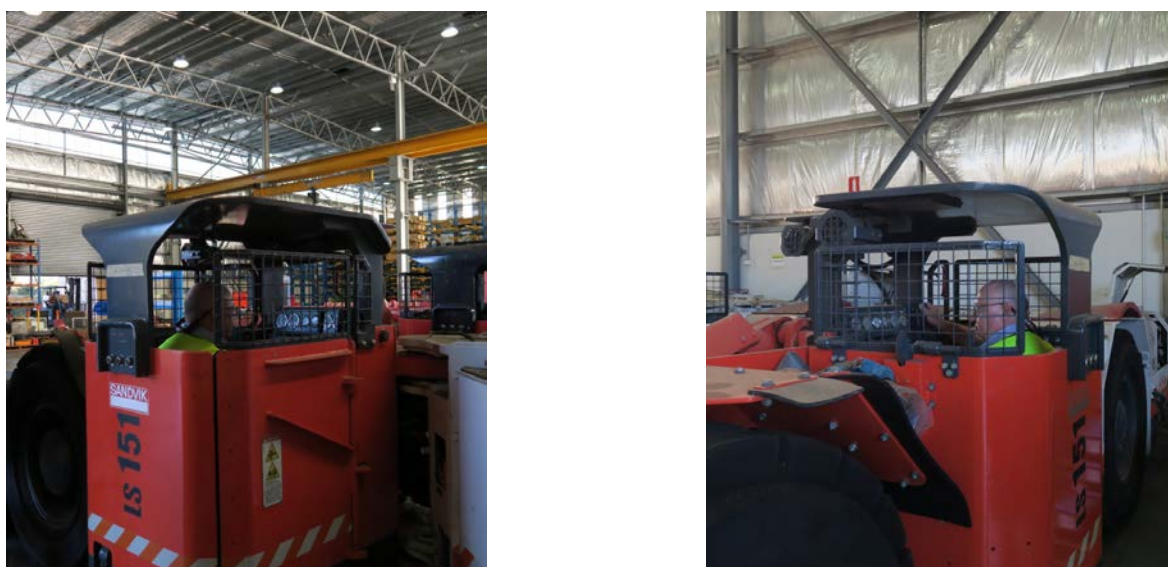
Figure 19: Guarding on a 5 tonne LHD.

Another type of new LHD had more comprehensive structure on the operator's cabin. This LHD was smaller in size and the articulation was located on the other side of the cabin when compared to LHD 031. The structures were on the three open sides of the canopy as shown in figure 19.

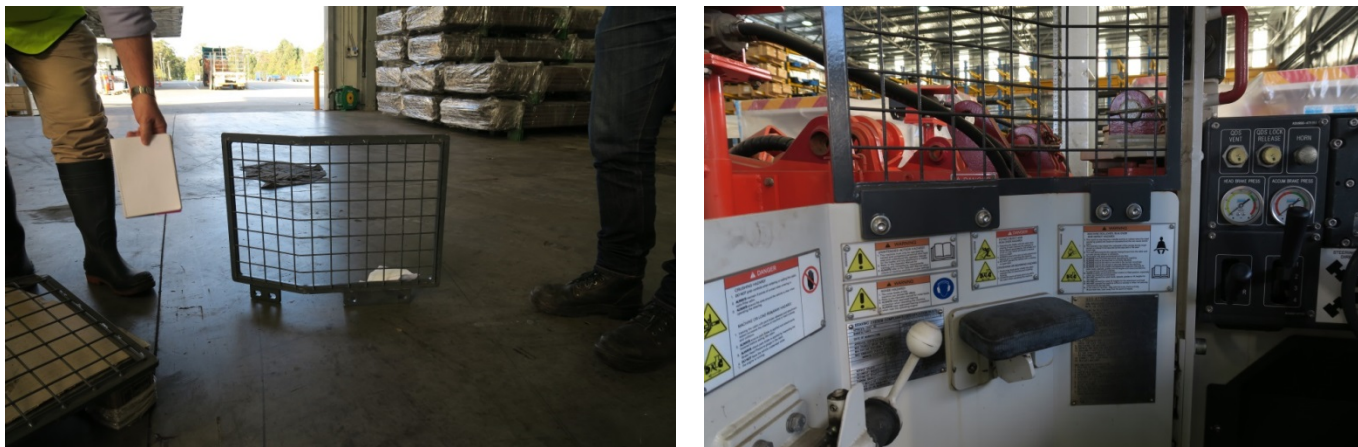
Figure 20: Guarding before and after installation.

These operator protective structures are easily installed as seen in figure 20.

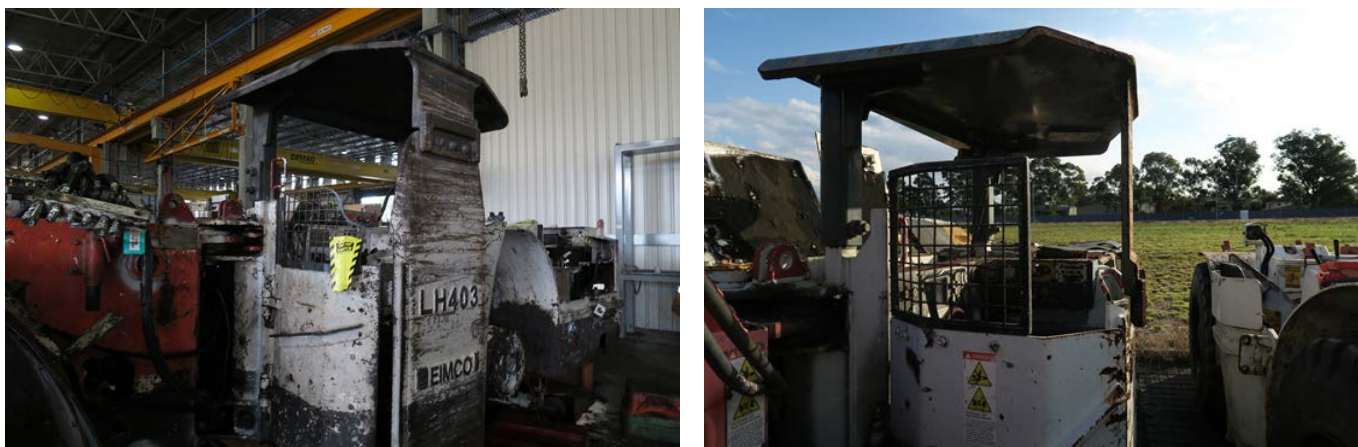
Figure 21: Retrofitted guarding on LHD vehicles.

Investigators also viewed a number of older LHDs that had protective structures retrofitted to the operator cabins. Investigators were informed that they were also installed to prevent operators accidentally accessing the articulation area. The retrofitted structures are bolted onto the existing cabin frame in a similar fashion to the new LHD vehicles as shown in figure 21.
