Week ending 8 November 2017

This incident summary provides information on reportable incidents and safety advice for the NSW mining industry. To report an incident to the NSW Resources Regulator: phone 1300 814 609 24 hours a day, 7 days a week.

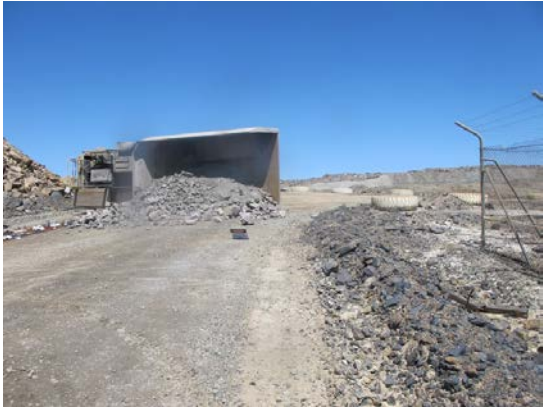
<p>Dangerous incident SinNot-2017/01773</p>	<p>An operator drove a truck out of the pit and in the process of turning the truck around, the truck rolled over. No injuries were reported.</p>

<ul style="list-style-type: none"> • Trucks should be travelling at appropriate speeds when doing U-turns. • Turning areas should be flat with minimal cross grade. • Ensure tyre pressures are correct and suspension systems are in good condition. • Operator practices should be periodically checked. <p>Refer to: SB17-01 Industry reports more truck rollover incidents</p>
<p>Serious injury SinNot-2017/01770</p>	<p>Two fitters were changing a strut on a mining truck. After completing the work, they began replacing the hub. It was unsecured during this process and came loose. The hub struck one fitter, fracturing his arm and dislocating his knee cap.</p>

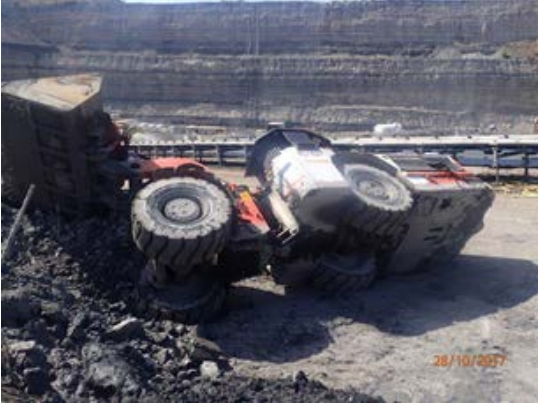
<p>room that had an operator inside.</p>	
<p>Dangerous incident SinNot-2017/01751</p>	<p>A load haul dump (LHD) vehicle, was preparing to dump a load of shot-fired roof material at a nominated surface dump. The LHD travelled up a ramp and turned into the dump site, placing the LHD across the grade of the ramp. Approaching the dump site, the operator began raising the bucket. He brought the LHD to a stop and continued raising the bucket to full height to allow him to tip the load. The operator felt the front off-side (down dip) of the machine subside then the machine tipped over/rolled until the bucket and boom of the machine stabilised on the muck-pile. The operator assessed his position and determined a safe exit from the cab. He climbed over the door and down the top of the machine on the low side then reported the incident.</p>

<ul style="list-style-type: none"> • Articulated loaders should not be tipping on a cross grade when the bucket is lifted and the machine is articulated. • Pads and areas where LHD-type vehicles are required to tip should be checked as being suitable by a supervisor. • LHD vehicles should be operated within the OEM specified limits, including tipping lines for stability. • Training packages should be reviewed for all machinery to ensure that it includes the limitations of the machine. • Seat constraints fitted must be worn.
