## **NZ Safety Alert**

August 2019

## Nut failure on truck drawbar

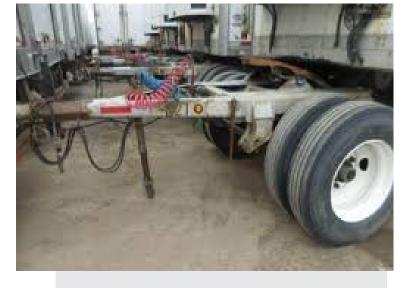
A loaded truck and trailer was entering a quarry when a loader operator spotted the 'A' frame drawbar pin had dropped out. The loader operator alerted the truck driver.

The drawbar pin was replaced and taken to the engineering workshop where it was discovered the lock-tight nut had failed. The pin was repaired, checked and put back into service.

This potentially serious incident could have caused a road accident and endangered lives. The failure of the lock-tight nut would have been hard to spot during pre-start checks and will require extra scrutiny.

- Vehicles are regularly inspected, and maintenance conducted in accordance with Original Equipment Manufacturer requirements.
- 2. Pre-start vehicle checks are conducted at the start of each shift on which a vehicle is to be operated. Particular attention should be given to safety critical parts such as pins on drawbars and other locking devices.
- Operators are trained and assessed as competent to operate mobile equipment, including safety checks. This needs to include model/equipment specific training and assessment.
