<b>Date of Event:</b>	<b>02/10/2019</b>	<b>Time: 12:30 AM</b>
-----------------------	-------------------	-----------------------

**Event Worksite (Name, Location)**  
Marrickville RTO1 Tunnel XP 14

# **SYDNEY METRO CITY & SOUTH WEST – TSE WORKS**

## **PRELIMINARY EVENT NOTIFICATION**

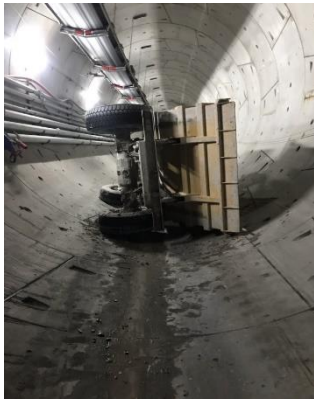
*Figure 1: Rear View*

**Description of event/Issue:**  
An empty dump truck assigned to move spoil from cross passage excavations was travelling outbye toward the Marrickville Dive site to collect materials. The operator claims that after moving off the truck's steering was not responding correctly. This caused the truck to climb the tunnel wall and tip onto its side as shown in Figures 1 & 2 below.

1. Mechanical assessment of all similar plant with dual direction steering controls. (The mechanical post-incident inspection on the Dieci dump truck has not identified any mechanical faults with this item of plant.)
2. Reassess the operator for capability and competency to operate this item of plant safely
3. Any actions arising from the preliminary investigation.
