**NSW
Resources
Regulator**

Investigation report

The death of Mark Siegel at mineral claim 44507 near
Lightning Ridge on 4 November 2016

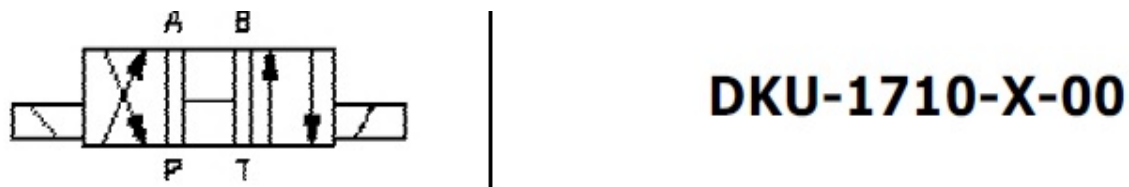
Figure 16: Converted solenoid valve configuration in the system at the time of the incident.

Inquiries made with Southcott Pty Ltd identified Southcott used to be authorised to convert valves, however Atos removed conversion approvals by all distributors worldwide about 10 years ago.

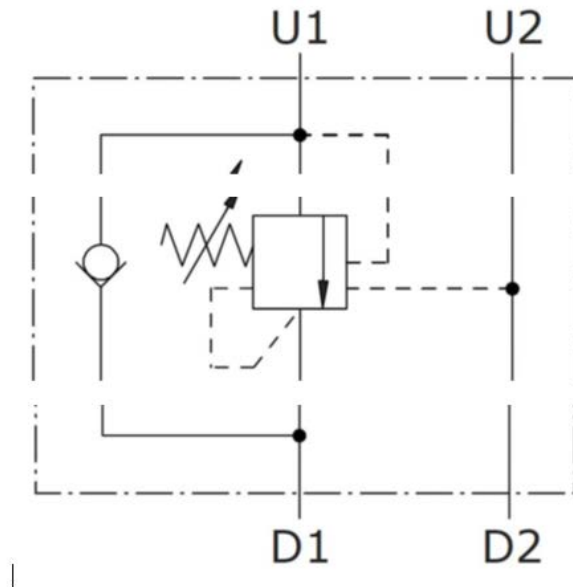
Figure 18: Schematic of the counter balance valve.

The valve on the Ag-Fab hoist's hydraulic system is a Walvoil 4 port- single acting counter balance valve (Single acting – allowing flow in one direction only with a spring-loaded return actuator), part No. VOS/SC 38/TR.S.p4.PG (figures 18 and 19). An example of the counter balance valve in its rest position, that is when the hoist is not in operation, is shown in figure 20.

'Freewheeling of the hydraulic motors is prevented in only one direction, the reverse direction, this type of counter balance is called a single acting counter balance valve.'

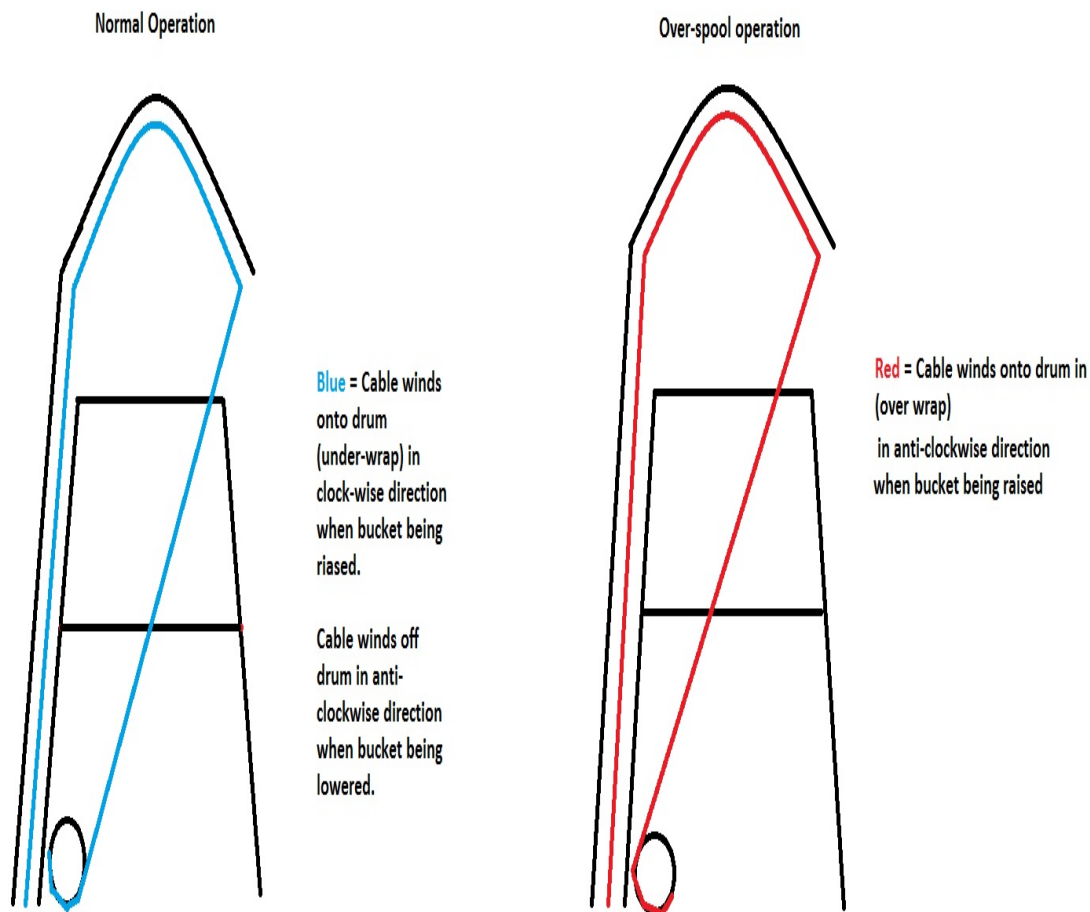
Figure 24: Normal and over-spool operation of the hoist's drum and cable.

The hoist bucket is raised and lowered by the hydraulic system turning the drum, which houses the steel cable. The steel cable is attached to the drum via a U-clamp at one end and attached to the bucket at the opposite end. In the event that the limit switch inside the underground sump is not activated, the cable continues to unwind. When fully unspooled, the drum continues to turn causing the cable to wind onto the drum in the wrong direction (figure 24). This causes the bucket to unintentionally rise back to the surface.

Due to the limit switch not being activated, the hoist's drum continued to turn, unspooling the cable. This caused the cable to wind onto the drum in the wrong direction and lifted the bucket unintentionally back to the surface.

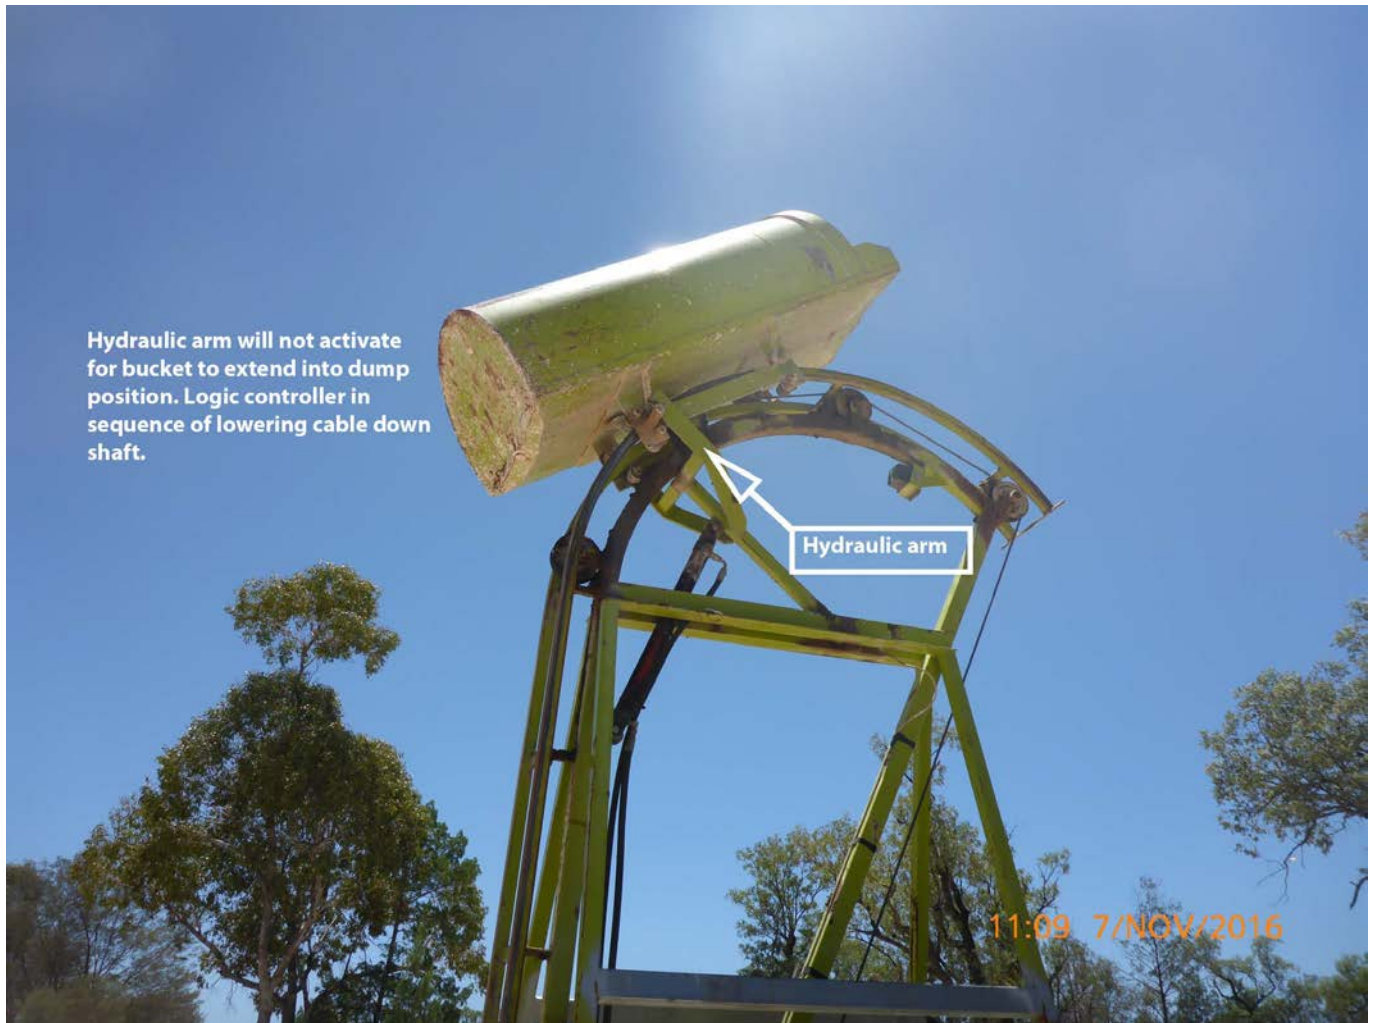
Figure 25: The bucket unable to fully engage into the tip position.

As the bucket reaches the arc of the hoist, it hits the hydraulic arm brackets. However, as the hoist's electrical system has not detected the lower limit switch being activated, it will not allow the bucket to engage with the hydraulic arm (figure 25). The bucket remains in this position with the hoist's motor still running.
