HIGH POTENTIAL NEAR MISS FALLING OBJECT

SR-75 CONCRETE SWIVEL STEADY BAR RETAINING BOLTS

EXECUTIVE SUMMARY

Date: 27th January 2021

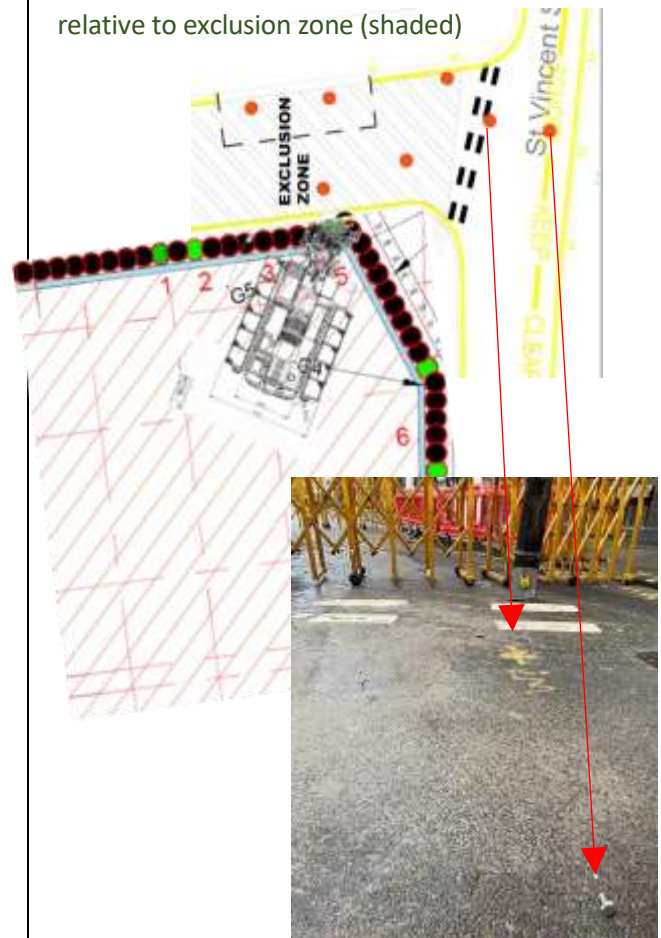
The Kelly Pole Extension was disengaged and thought to be placed in its locked position. The Rig Operator then continued to reverse rotate the augers out of the bore. The rig operator stopped reverse rotating the augers when the rotary table reached 1.5mtrs from the top of the mast. Immediately after doing so, the auger and Kelly Pole then slipped down into the borehole. Resulting in the underside of the Kelly Pole impacting onto the rotary table. Causing 7 retaining bolts, holding the steady pole bottom bracket to the rotary table, to shear off. The bolts all fell within the exclusion zone. The bolts proceeded to roll outside of the exclusion zone onto the adjacent footpath at low speed.

Indicative plan of bolts (red dots)

relative to exclusion zone (shaded)

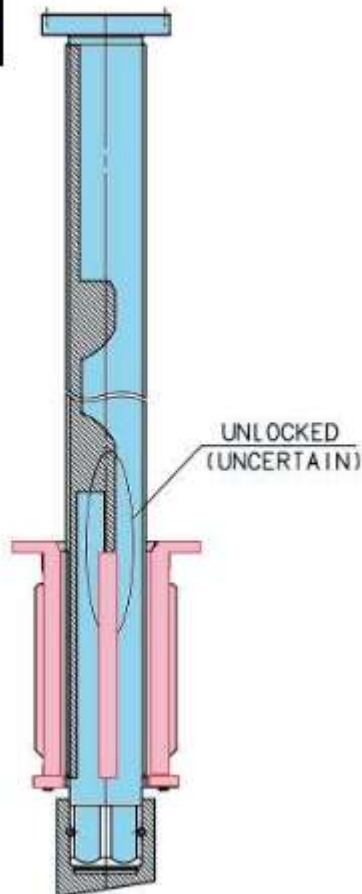
Fig 1. (Unlocked)

Initial investigations and trials indicate that the Kelly Bar was not locked correctly as per (Fig 2.) and was incorrectly locked as per (Fig 1.)

1. Review GSS Procedures (Procedural changes implemented)
2. Implement an internal Training Event for Both Rig Operators and Rig Attendants.
3. Review exclusion zones and management procedures.
4. Provide constraint to bolts to prevent falling as per (Fig 3.) above.
5. Share findings with manufacturer to reduce risks on subsequent models.
(External Locking Indicator lights being fitted on top of the cab plus explore the feasibility of an audible alarm indicating the Kelly Pole is in the Un-locked Position)
6. Share findings with other piling contractors through the Federation of Piling Specialists.
