NZ Safety Alert

28 July 2023

Rock hits front of truck

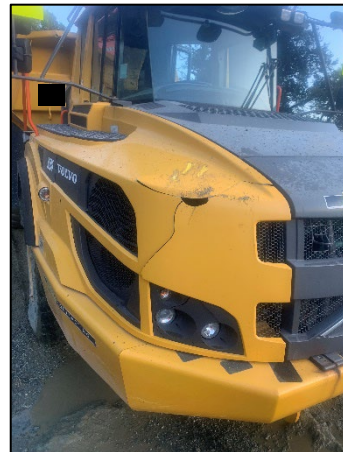
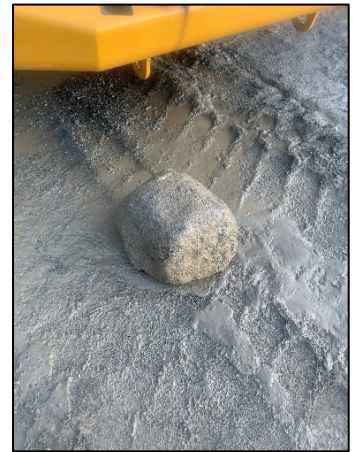
As the bucket slewed around to empty into the dump truck, a rock dislodged from the contents of the bucket.

The rock bounced onto the roof of the dump truck and then onto the bonnet, before landing on the ground in front of the truck.

No one was injured however there was damage to the dump truck.

1. When excavating material, large rocks or other unusual material is identified and safely removed from the face or stockpile.
2. Operators maintain clear visibility when loading or excavating material, taking into consideration potential impediment from the sun or weather events.
3. Regular workplace inspections are conducted to verify that work is being conducted safely.
