Mineral Mines & Quarries Inspectorate | Alert | No.385 V 1 | 09 February 2021

Rockfall injures jumbo operator

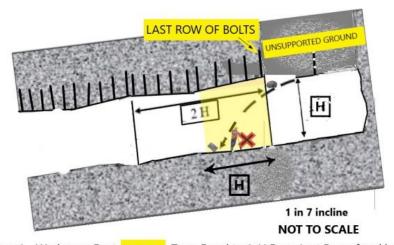
Figure 1 - Worker on Foot CAUTION Zone Equal to 1xH From Last Row of rockbolts

Figure 1 shows a schematic diagram of the layout of the scene of the incident, showing the approximate trajectory of the rock.

The operator retracted both booms so they were positioned just inside and beneath the last row of fully installed splitsets and mesh. A rock dislodged from the back, slid down over the partially secured sheet of mesh, struck the raised left-hand boom and deflected to the ground, striking the operator on the back of his shoulder.

- The positioning of heavy mobile equipment being prepared for maintenance activity in relation to nearby unsupported ground.
- Insufficient separation between the edge of fully supported ground and support being installed on the incline to allow for trajectory of potential rockfall into supported ground that is assumed safe.

Prior to servicing, inspecting or maintaining plant underground, the plant must be withdrawn to a safe location under supported ground. The distance of withdrawal from unsupported ground should be defined in the plant's operating procedure.

Workers carrying out ground support activities in front of the operator's cabin should be trained how to 'read the ground' and always be vigilant for rockfall hazards from any nearby unsupported ground.
