## Significant Incident Report No. 245

**Subject:** Worker injured by low-voltage switchboard arc flash

**Date:** 17 August 2016

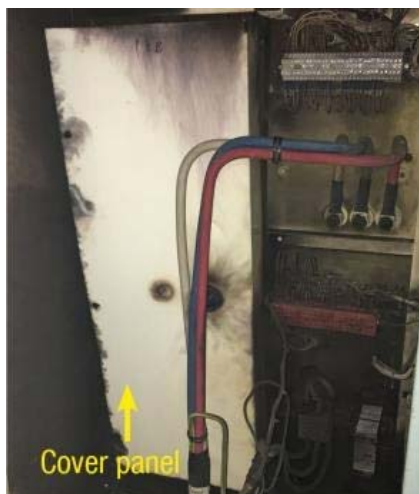
As the electrician touched the cover panel to check if it was secure, it moved and there was an arc flash and blast. He received minor flash burns to his right forearm and left hand. The worker was not wearing personal protective equipment (PPE) that was adequate for the energy released in the arc flash.

Left, Arc flash damage to the rear compartment of switchboard. Right, Protruding fuse-holder bolts in busbars.

- The loose busbar cover panel was moved, making contact with the fuse-holder bolts protruding from the energised busbars.

- Design, install and maintain electrical installations and equipment in accordance with Australian Standard AS/NZS 3000 and other relevant standards, and complete to a trade finish.
- Maintain required clearances in a switchboard by rigidly fixing exposed energised and/or conductive parts.
- Conduct an arc flash energy assessment of all switchboards and MCCs, and attach arc flash hazard labels so workers are aware of the hazards and can use appropriate arc flash PPE.

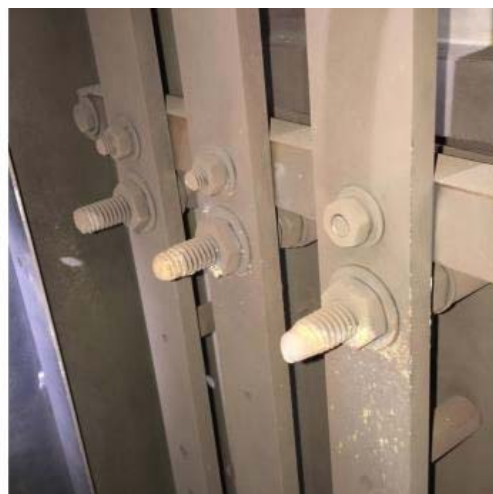
The subsequent investigation found that the cover panel had come in contact with fuse-holder bolts protruding from the energised busbars behind the cover panel.

- The busbar cover panel was not secured.
- Moving the cover panel was not in the original scope of work.
- The busbars in the rear compartment were not isolated prior to moving the cover panel.
- The electrician was not wearing PPE that was adequate for the energy released in the arc flash.
