# NZ Safety Alert

30 September 2022

## Threaded rod failed on cap press

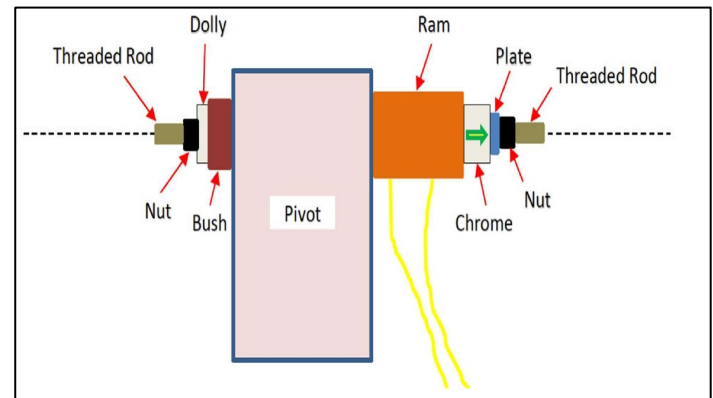
This is completed by inserting a threaded rod of about 25mm diameter and 600mm long through the bush with nuts securing it at each end (see diagram).

During the task, the rod has failed adjacent to one of the nuts and the rod has been propelled across the workshop - about 5m distance and 3m above floor level.

The rod has penetrated the cab window of a drill rig parked adjacent and came to rest on the operator's seat.

1. The correct tools and equipment are used when conducting any maintenance task.
2. No-one is in the "firing zone" of work involving equipment under hydraulic or other extreme pressure.
3. When routine tasks change, or equipment is not available, a suitable risk assessment is conducted to identify and manage hazards and risks.
