INCIDENT ALERT

TITLE

Catwalk failure on mobile screener

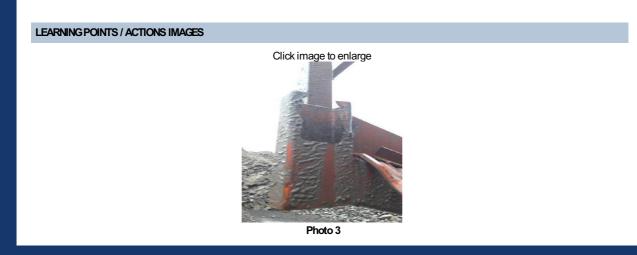
Photo 1 shows the collapsed catwalk after the incident. It is designed to fold up for transportation. Whilst this is not a new machine it was still in original condition around the catwalks. The screener was subject to regular inspection and the staff say that the catwalk was stable and gave no indication that it was likely to collapse before the incident. There was no movement, sway or bounce when it was in use.

Photo 2 shows the catwalk collapsed in on the rail that should support it.

Photo 3 shows the area where the walkway upright tore away from the support rail. Both the supports for the catwalk were damaged in the incident. A thorough examination of the other catwalk showed a hairline crack in the metal beside the weld once the paint was removed. Another screener was inspected following this incident and it was found to have a 10mm hairline tear in the steel at one of the upper supports once the paint was removed. Continued vibration during use appears to be the reason for the damage occurring.

- Both screeners had remedial repairs undertaken using a heavier gauge steel than the original construction to prevent future damage.
- · Inspect similar equipment for defects and take remedial action where necessary.
- Amend inspection regimes to include an examination for this type of fault, where necessary.
