NZ Safety Alert

10 February 2023

Slip of material hits excavator

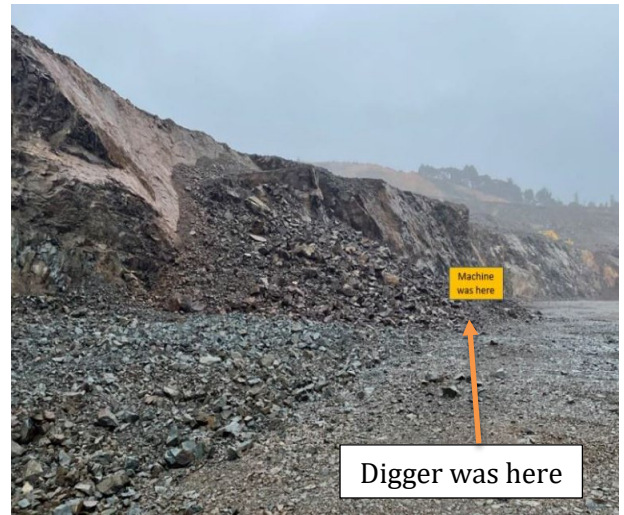
An excavator was sitting on a muck pile loading dump trucks at the face, when the bench behind the shot slipped resulting in rock hitting the excavator.

The face had been excavated clean and while loading the last couple of trucks, material slipped on a greasyback or natural weathered fault.

No one was injured and there was no major damage to the excavator.

1. Regular site inspections for ground instability are conducted, particularly after significant rainfall.
2. That a catch bench is established between the excavator and face when working on a muck pile.
3. When operating an excavator on a shot, that the cab of the excavator is on the free side of the shot i.e. not facing the bench.
